APPENDIX C
Dive Inspection Report – Existing Welded Tank

**INSPECTION REPORT FOR THE
TWIN HARTE COMMUNITY SERVICE DISTRICT'S
MILLION GALLON TANK #2
DECEMBER 29TH, 2017**

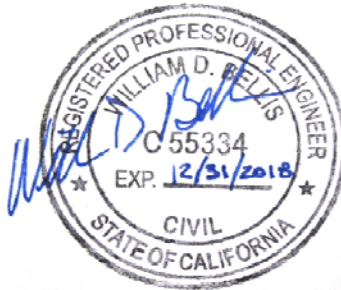
Registered Civil Engineer, CA C55334

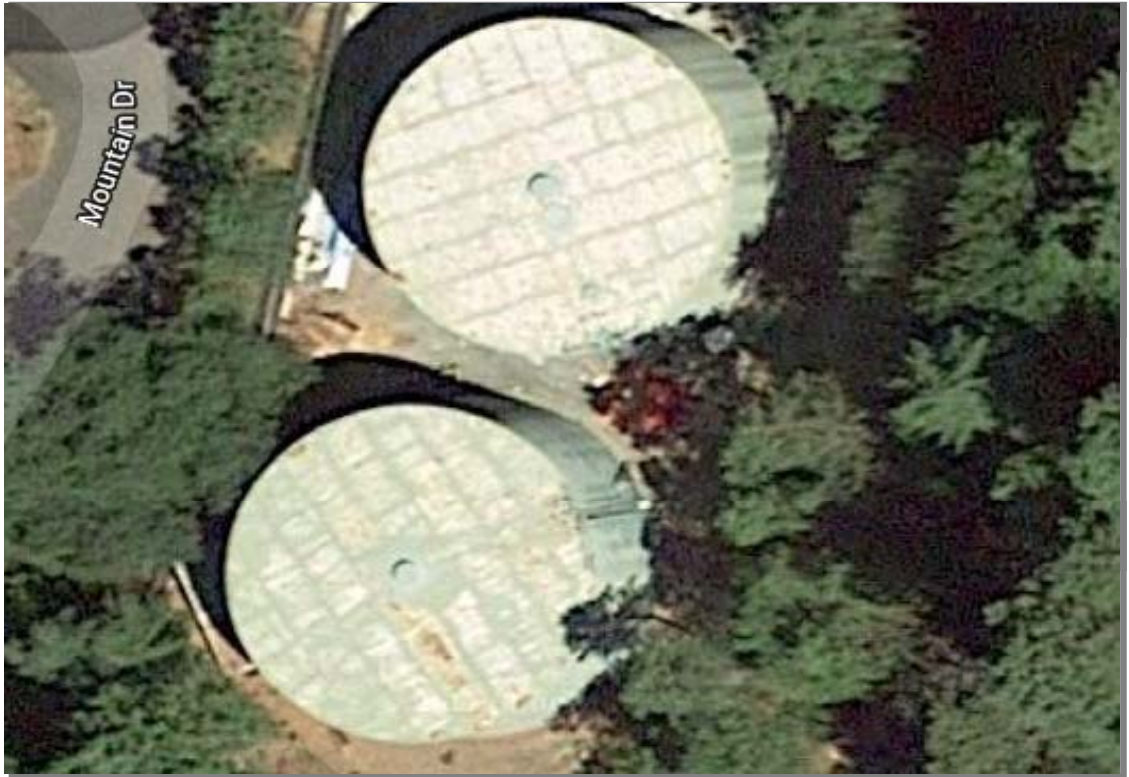
Plan view of tanks and site (courtesy of Google).

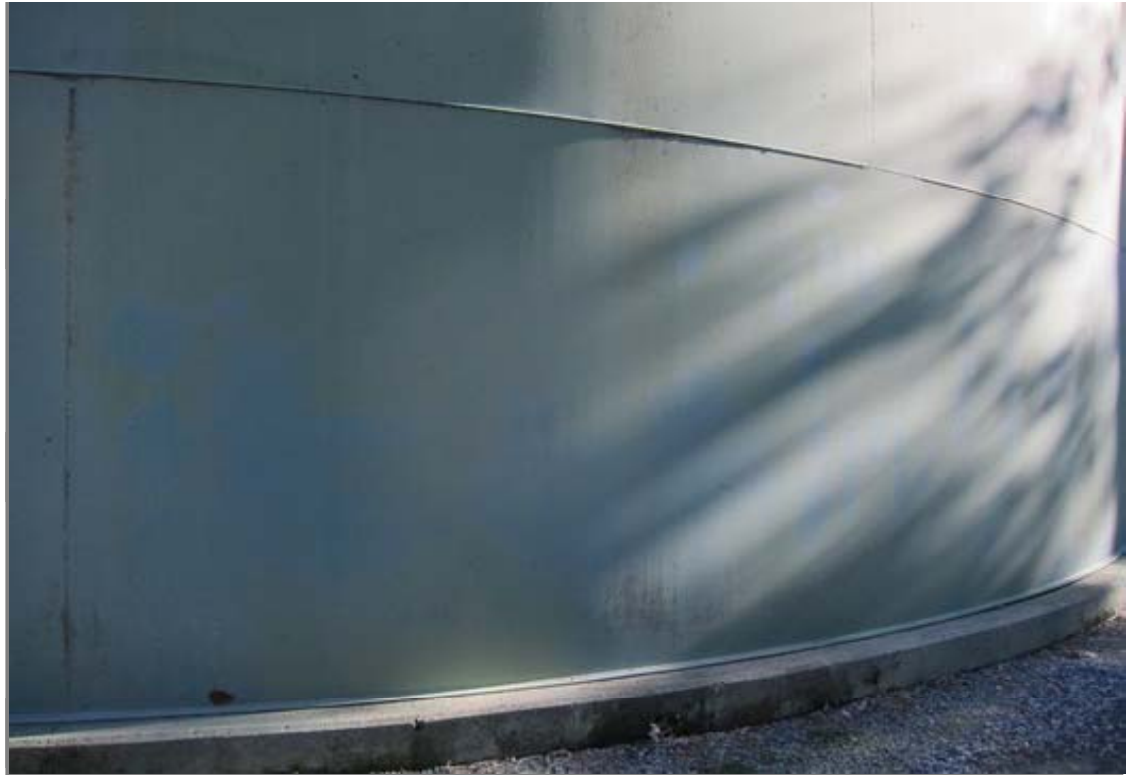
Lower shell and concrete footing. No significant corrosion points were identified.

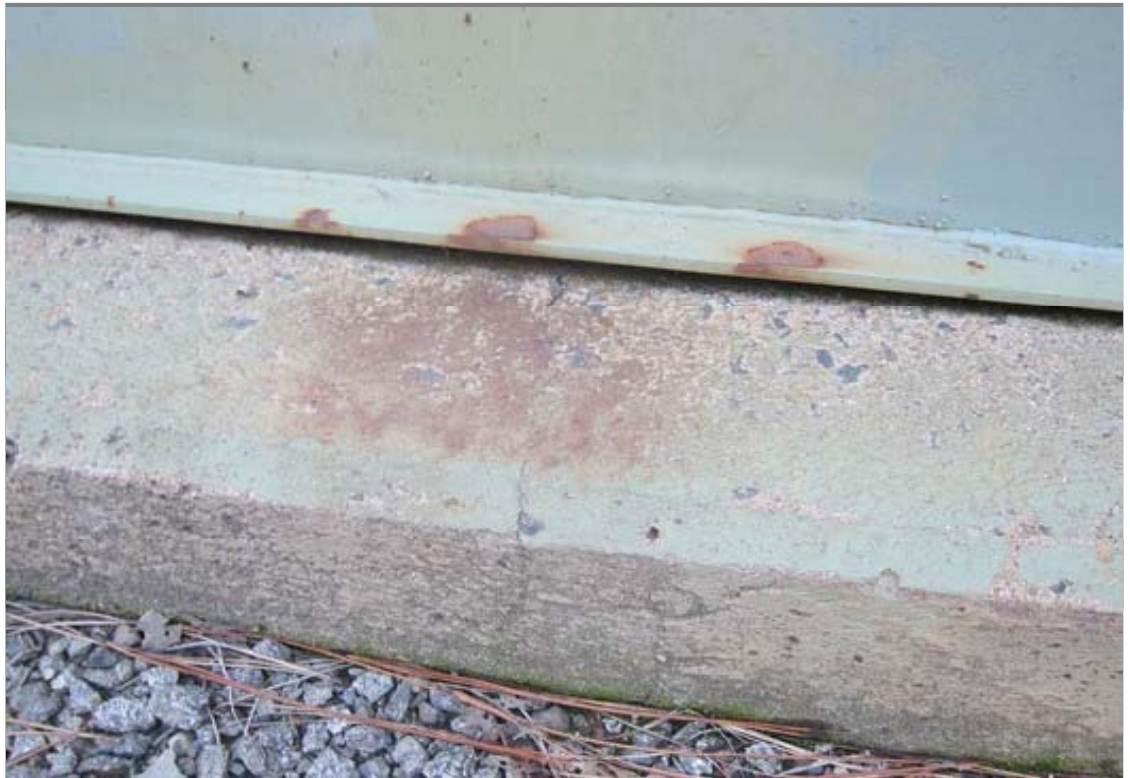
This view of the concrete footing and lower shell shows the typical condition found.

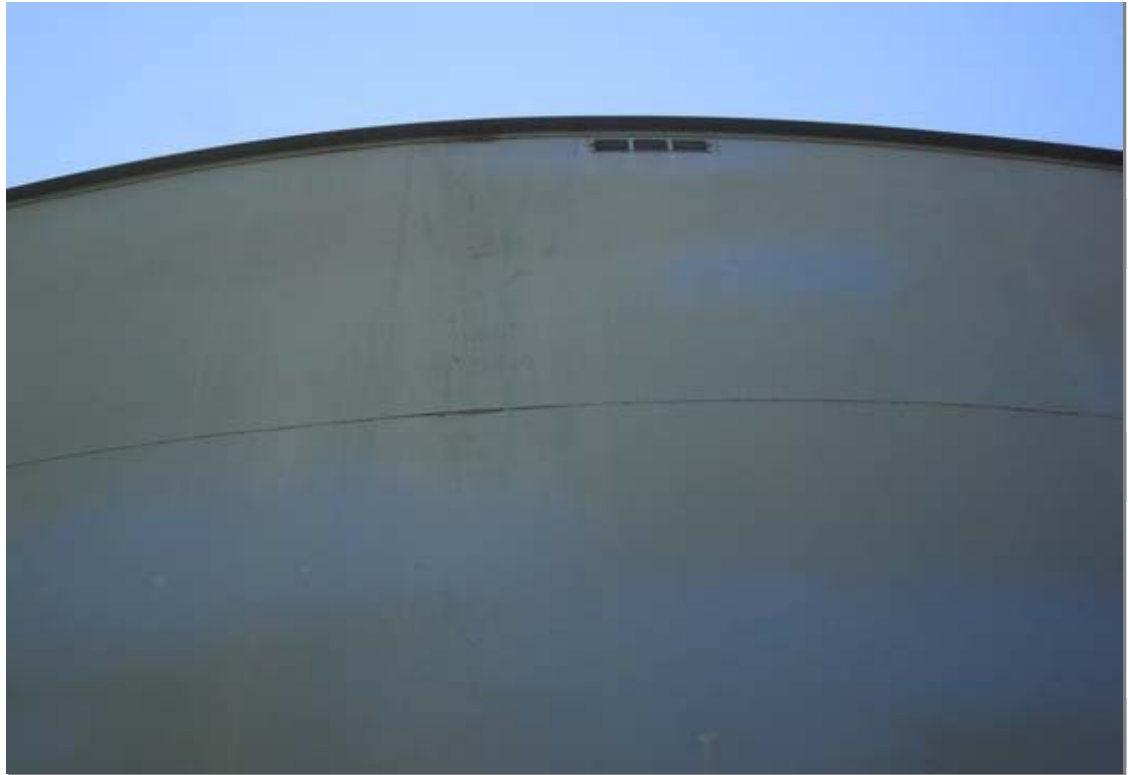
This view represents the typical conditions on the upper shell and shell to roof joint. The upper shell is in good condition with only minor corrosion points noted.

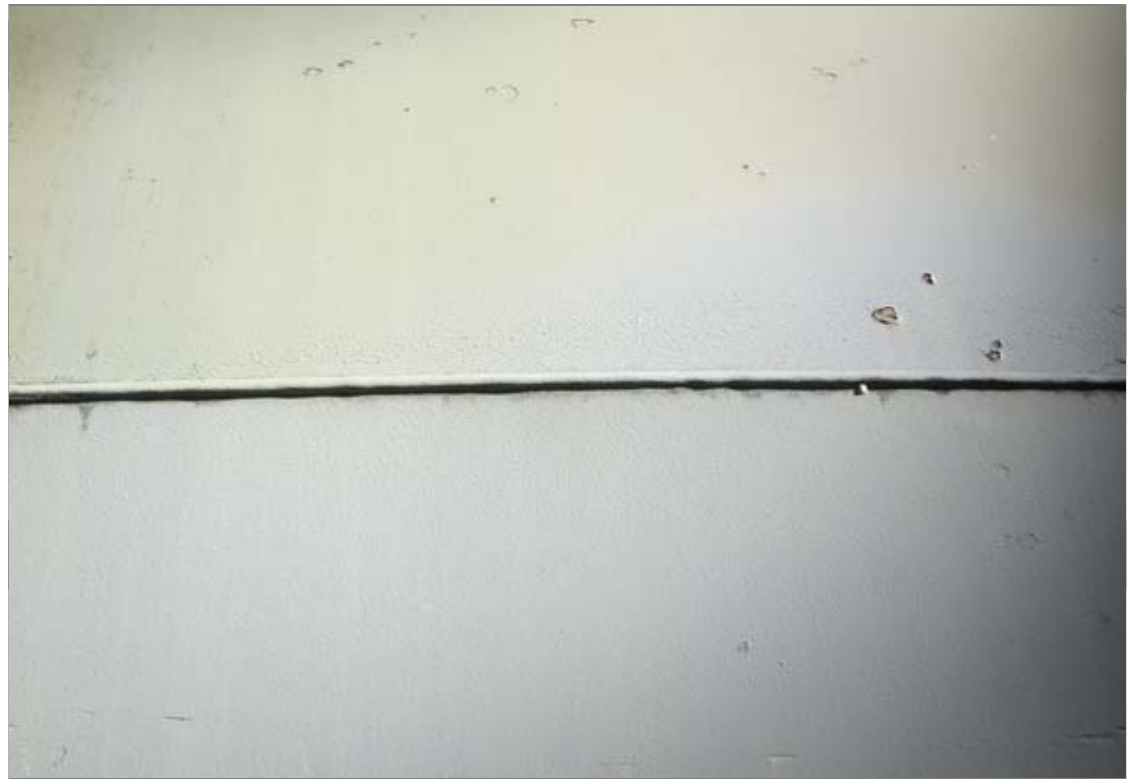
Welds on the exterior shell are generally smoother than the older tank #1 because the welds on this tank are mostly by a mechanized system. Some scattered spatter is present particularly in the areas of welded repairs completed manually.

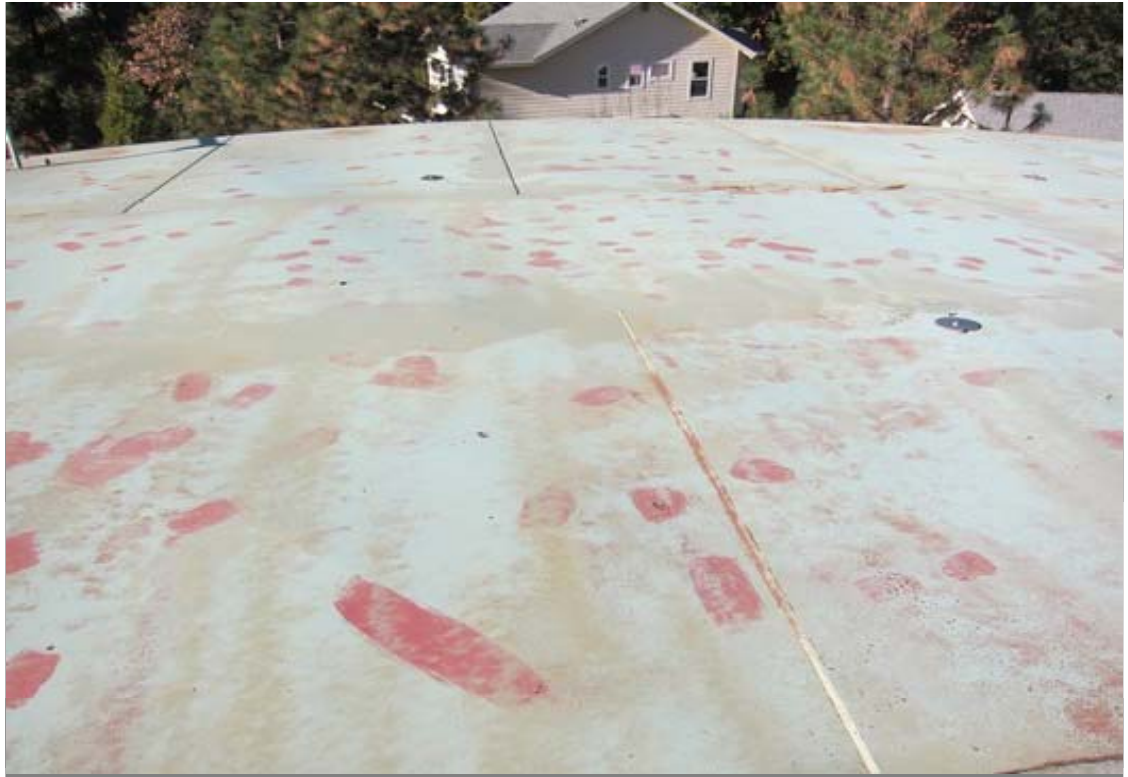
This view indicates the overall condition of the roof. The roof plate (steel) is in good condition but coatings are in poor condition.

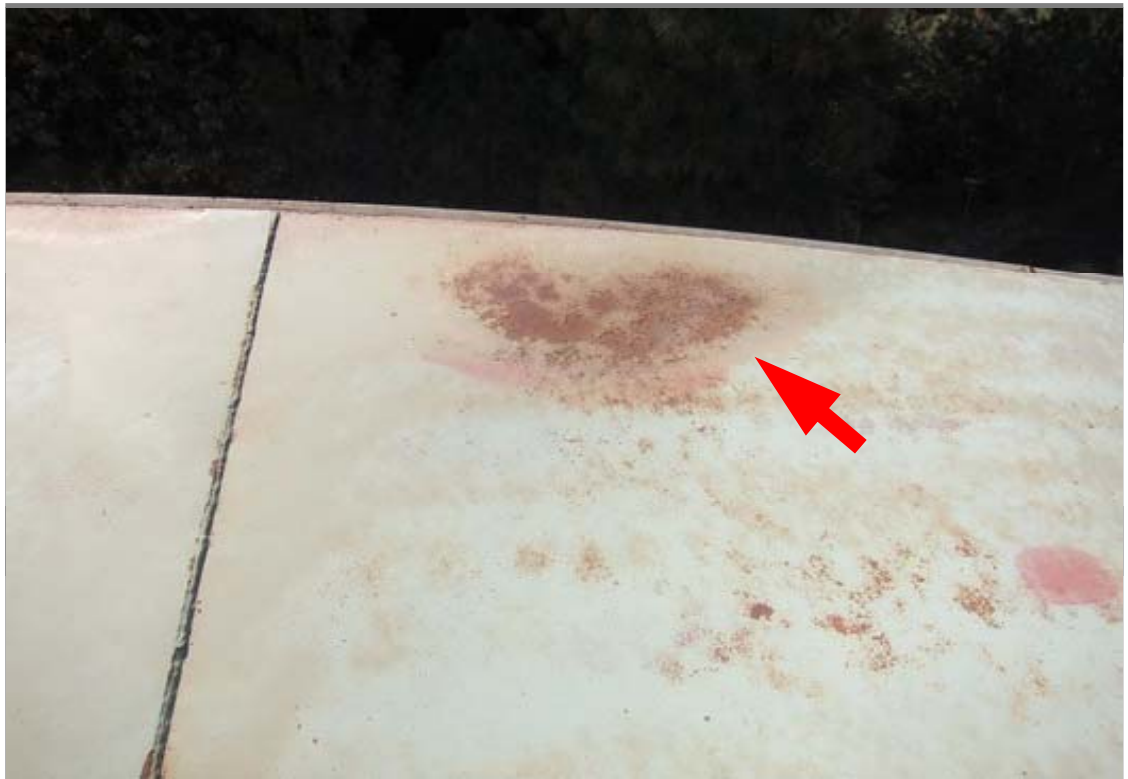
Close view of a ponding area with corrosion. Submersed exterior coatings pose a maintenance challenge.

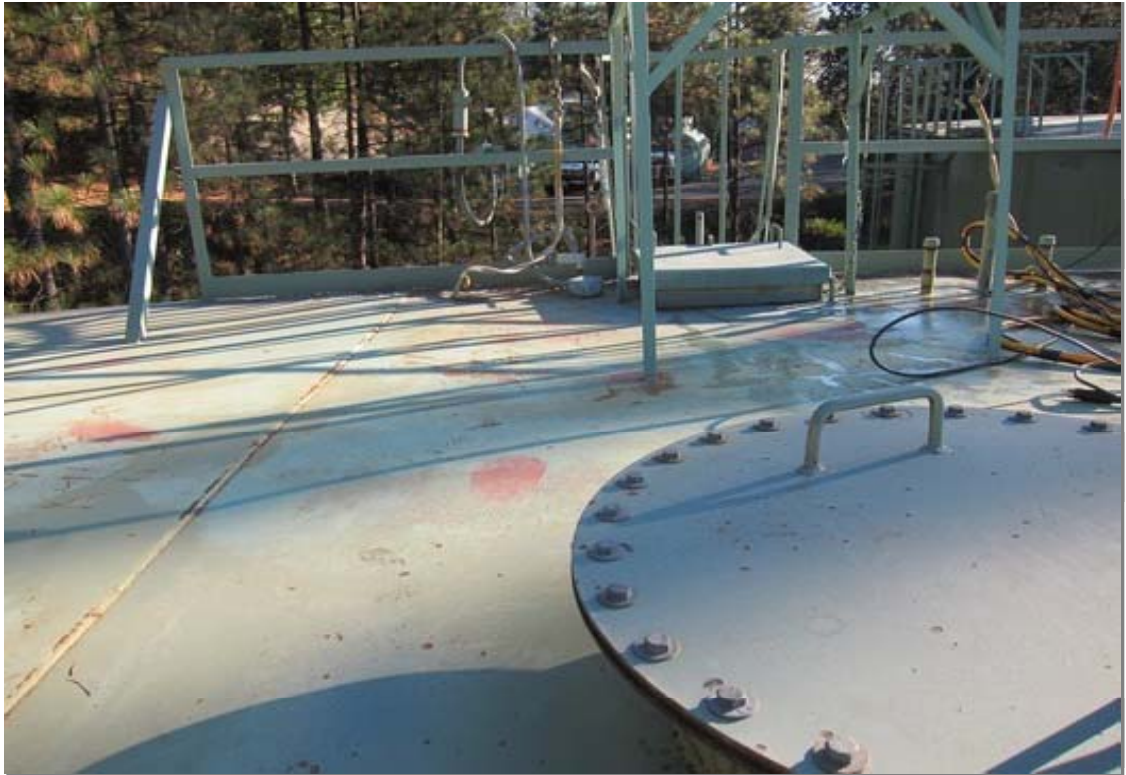
The photo above shows the roof hatch area with guardrail. A second hatch is visible in the foreground.

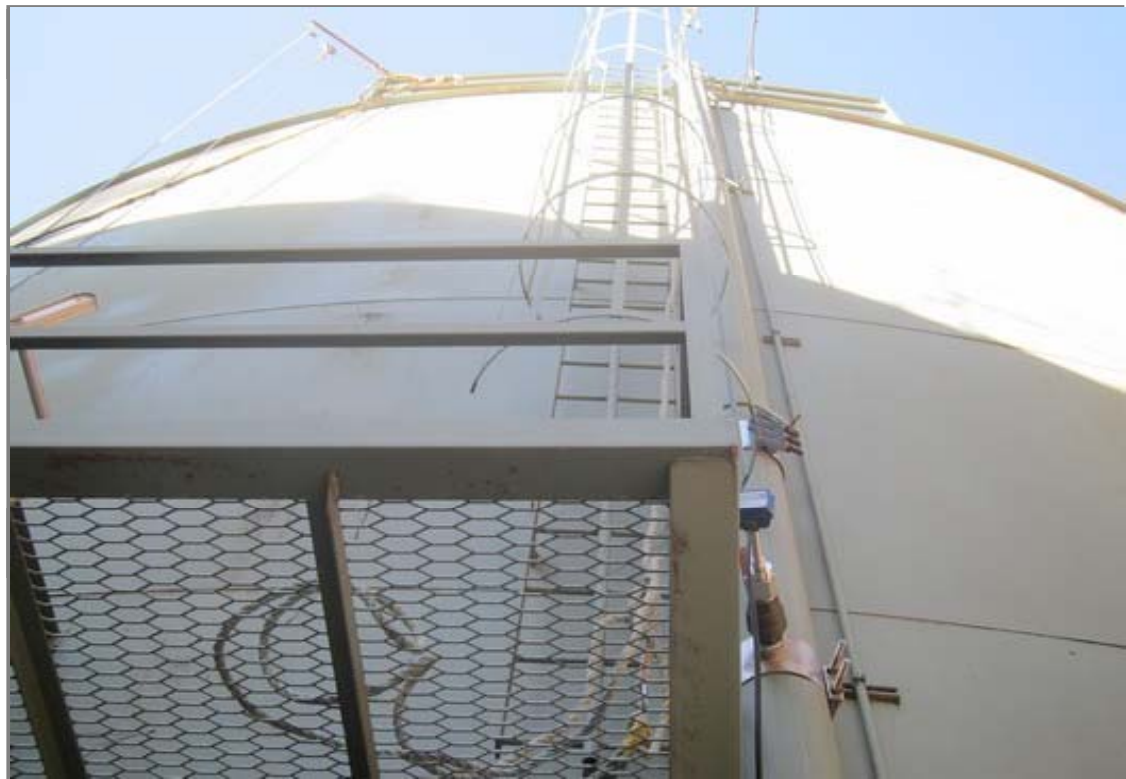
This view from the ground shows the platform, exterior ladder and cage. No significant corrosion is present. The climber safety rail has been painted.

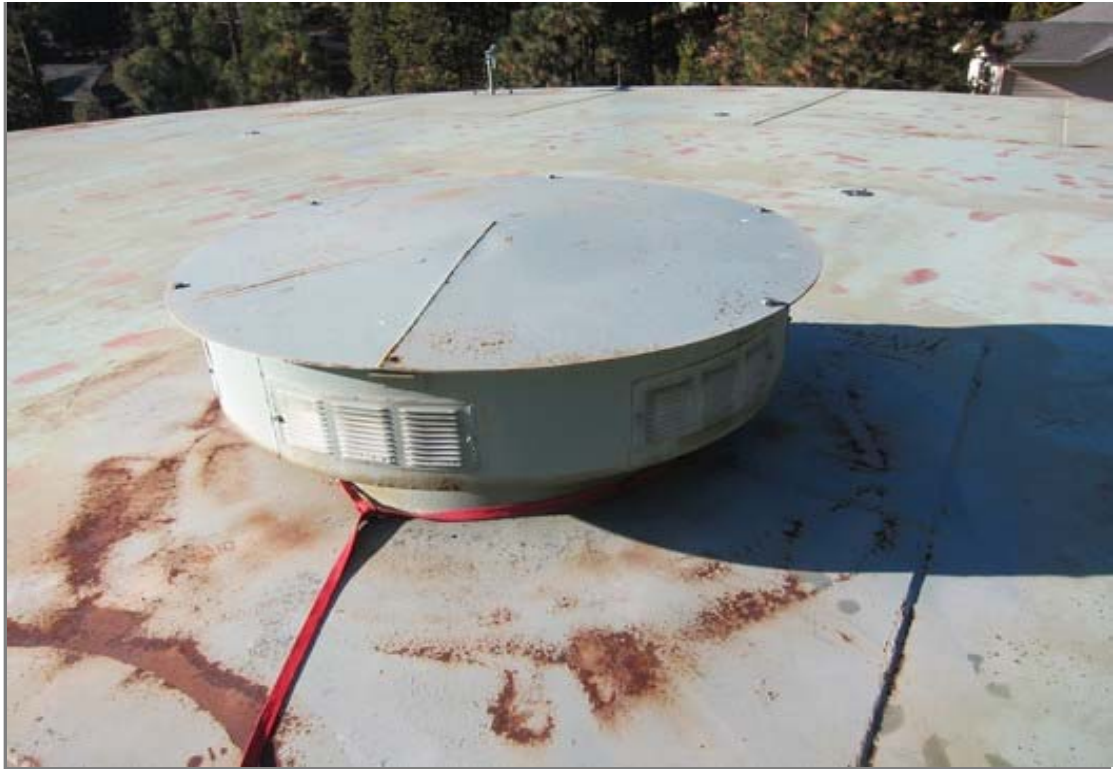
The roof vent consists of a steel cover over a steel riser pipe.

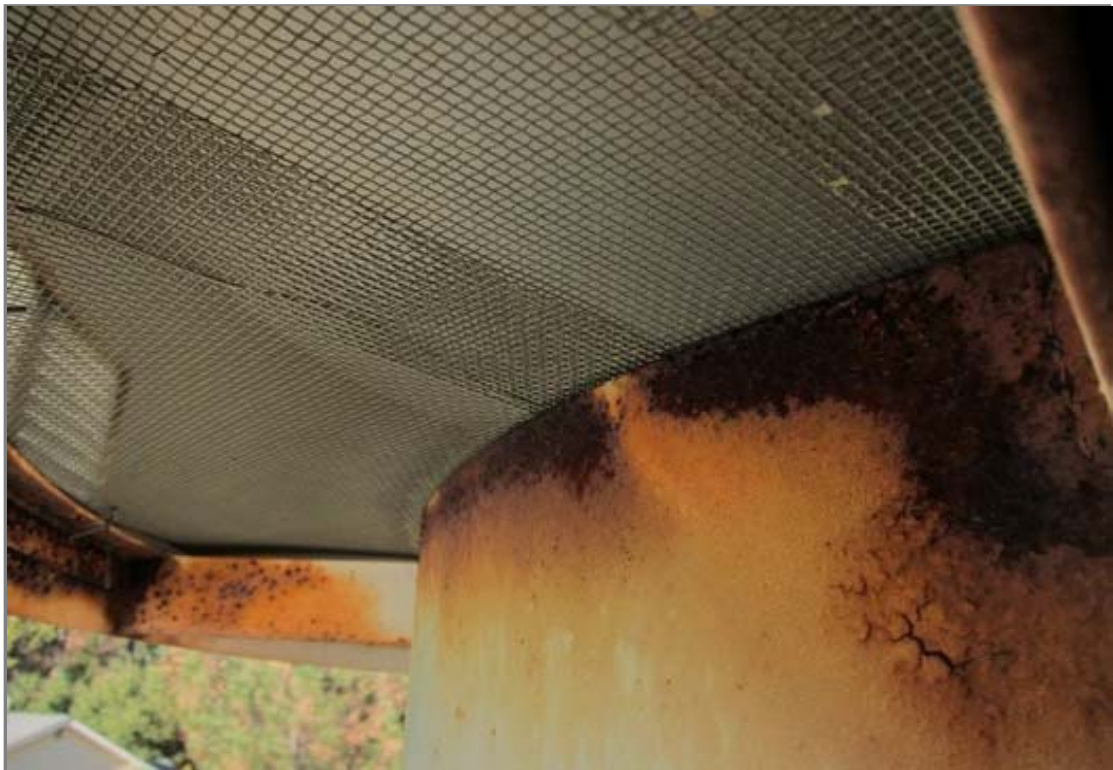
This view of the underside of the vent hood shows that the screen is in good condition. Corrosion is present on the riser but the screen appeared to be bug proof.

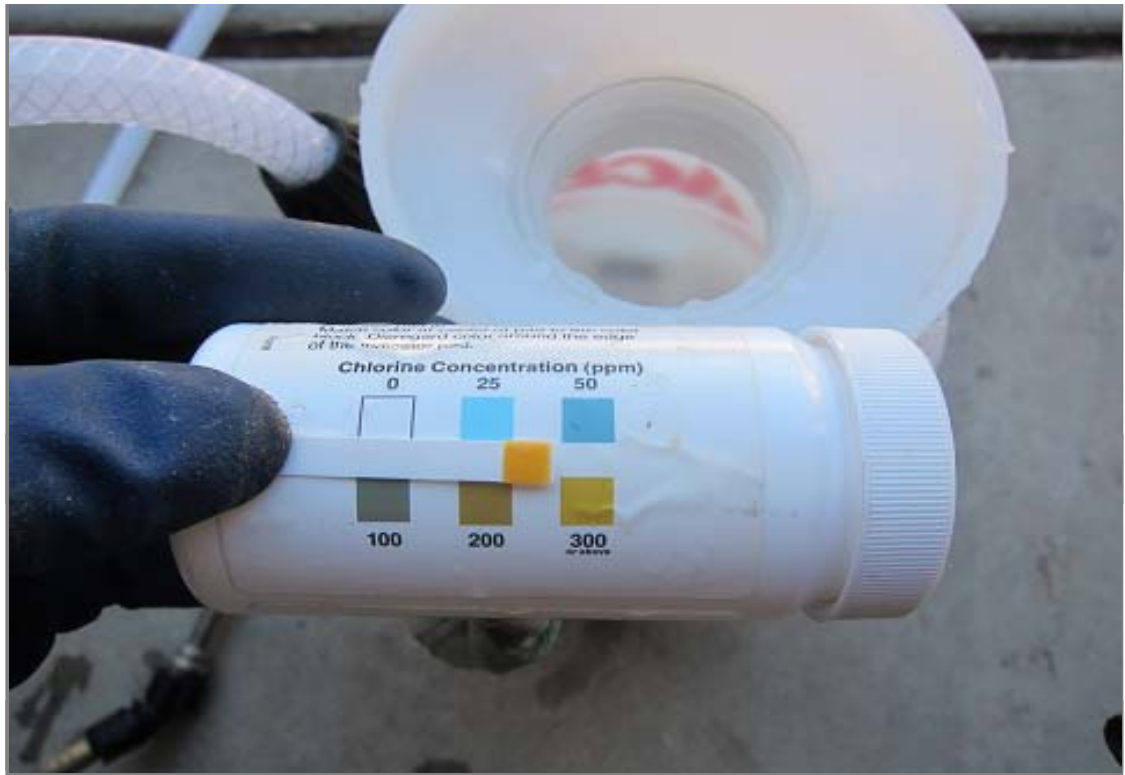
The disinfecting solution is tested to verify that it exceeds the 200 ppm free chlorine concentration level.

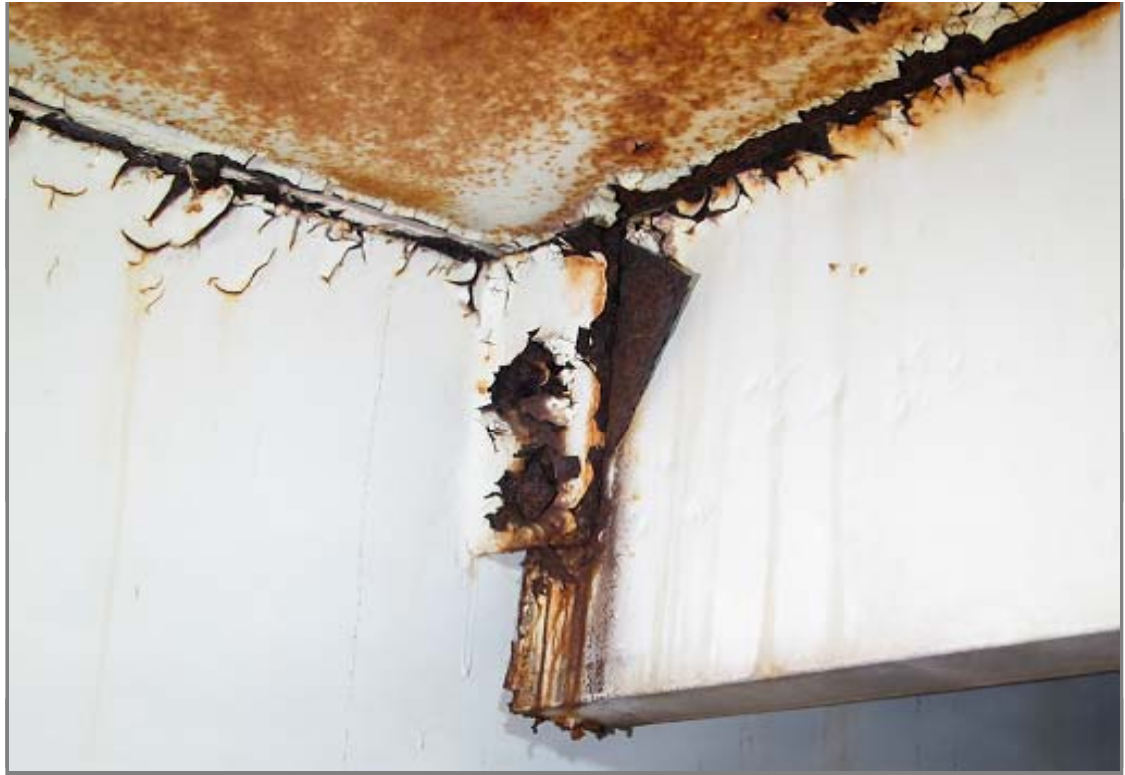
Upper shell, rafter and adjacent roof. Coatings are peeling and general corrosion is present on many surfaces.

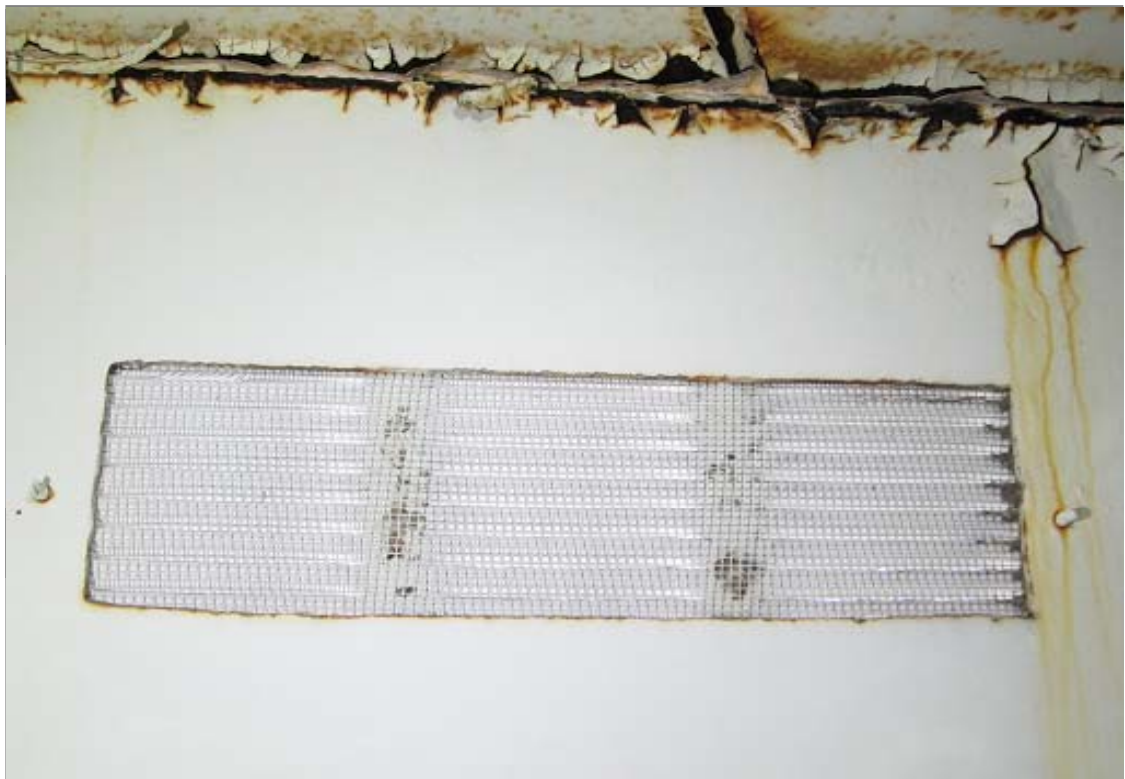
This is a close view of the upper shell showing one of the numerous shell vents.

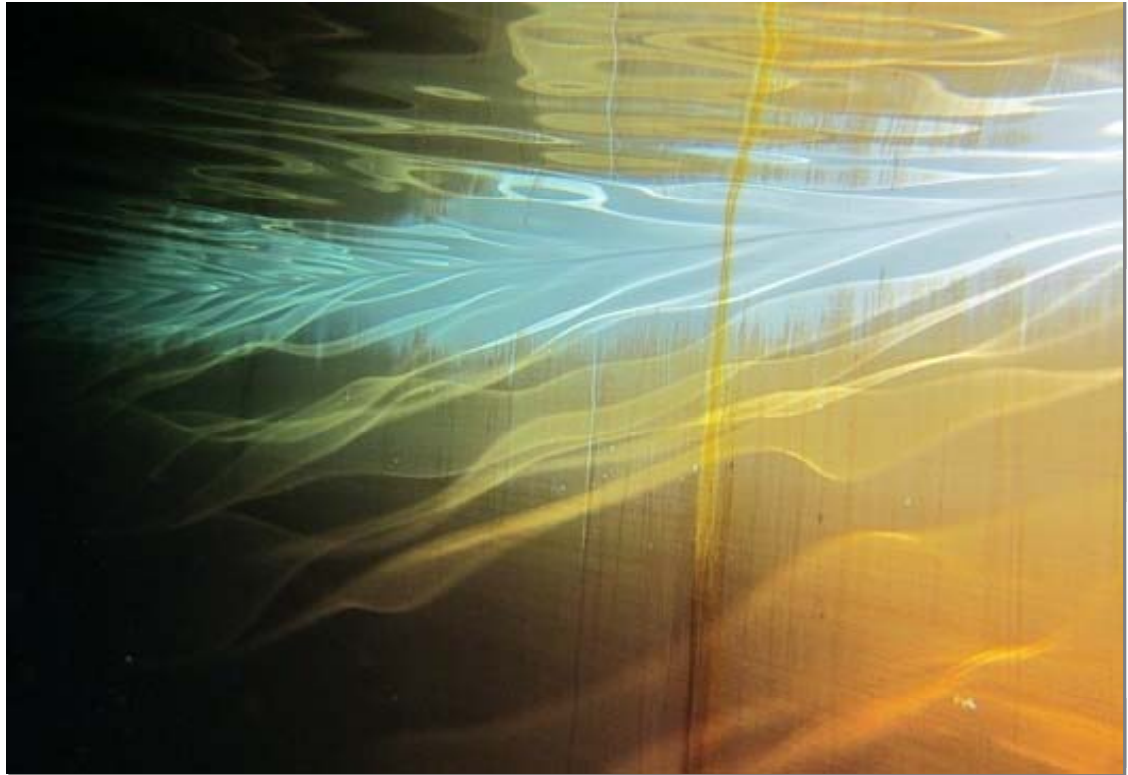
The photo above shows the interior shell just below the water surface (submersion zone). The rust color on the shell is staining.

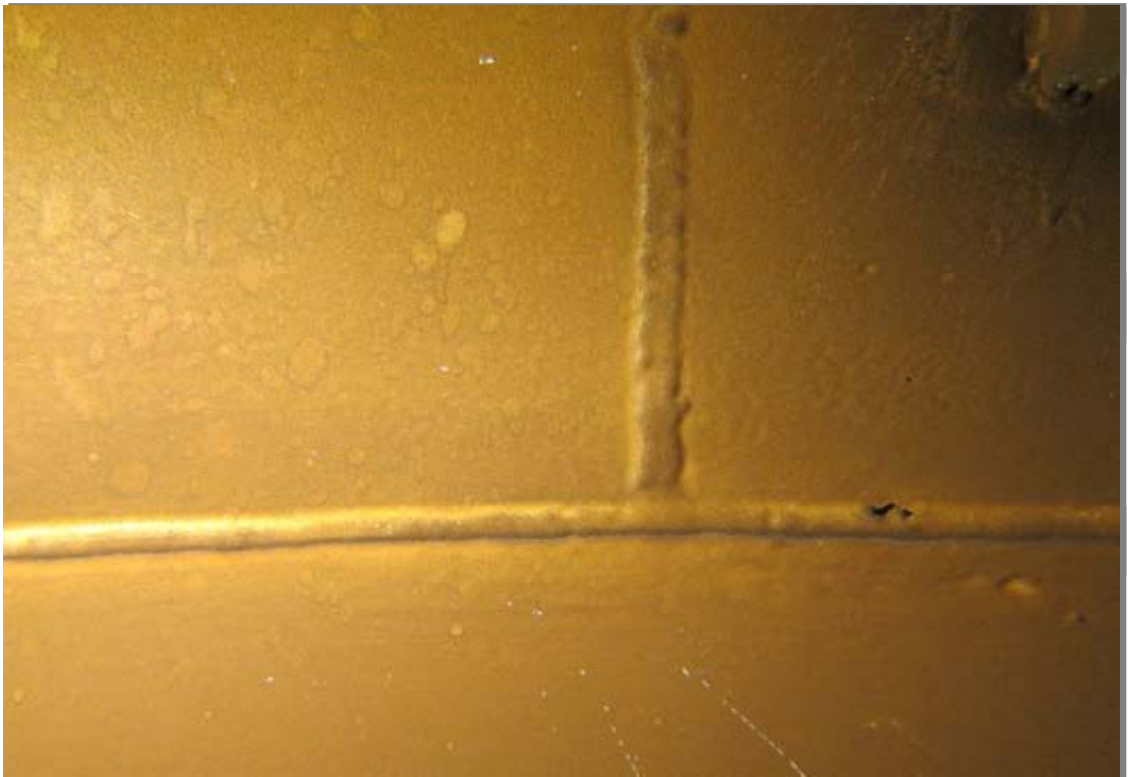
Interior shell in the submersion zone. This view shows a junction between a horizontal and vertical shell joint. The interior shell steel appears to be in good condition overall.

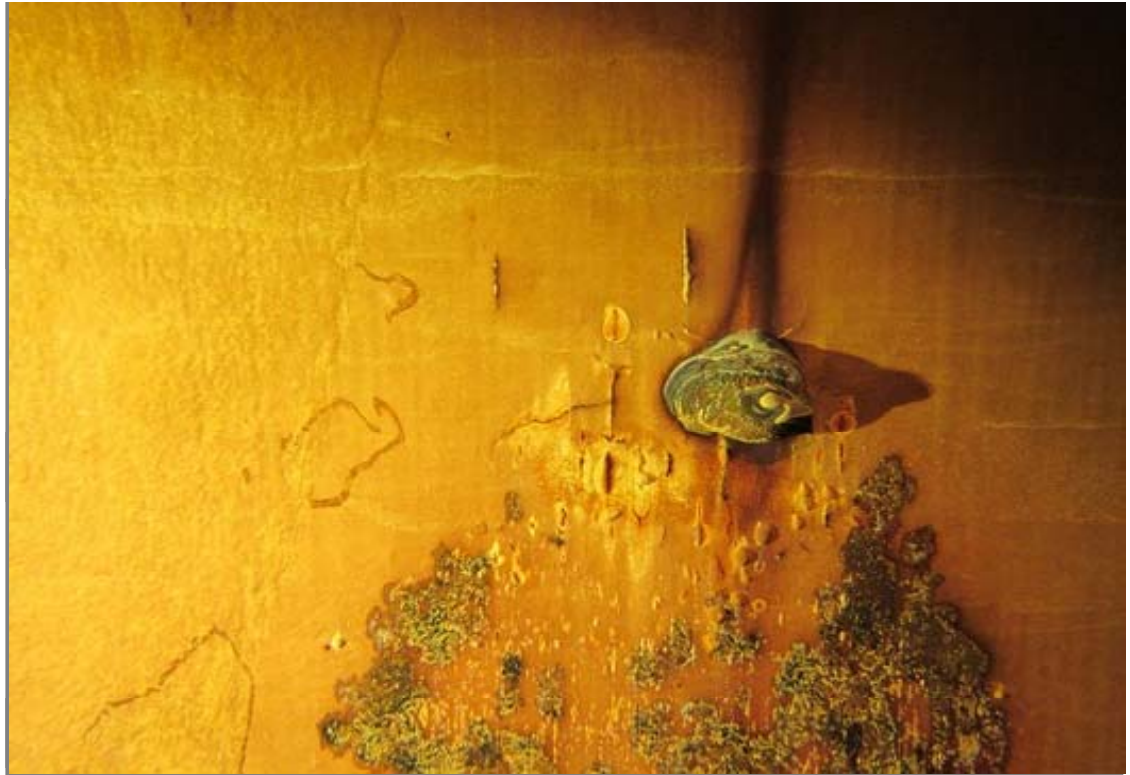
Interior shell in the submersion zone near the manway in quadrant 1. The coatings are cracking and corrosion is present.

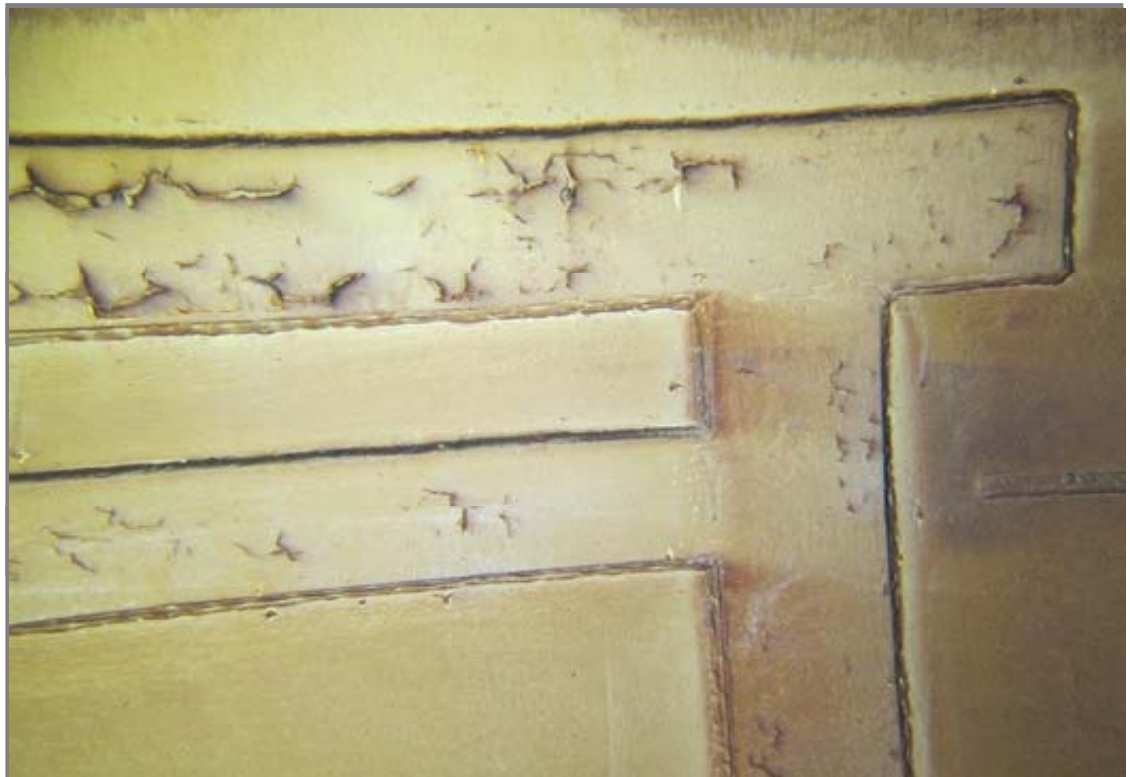
This view of cracked coatings is where a shell opening (door sheet) was cut and re-welded upon completion of the work. This area has a particularly high concentration of coating failures.

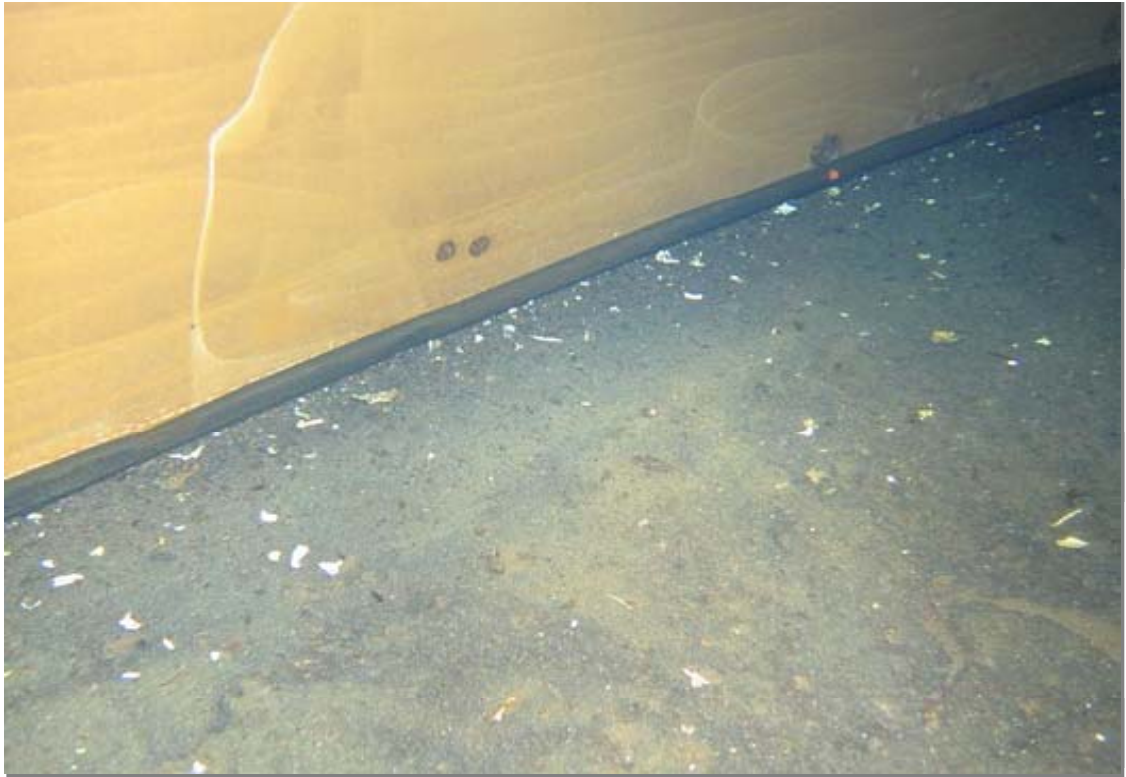
Lower shell and tank bottom. Coatings are in fair condition overall in this zone.

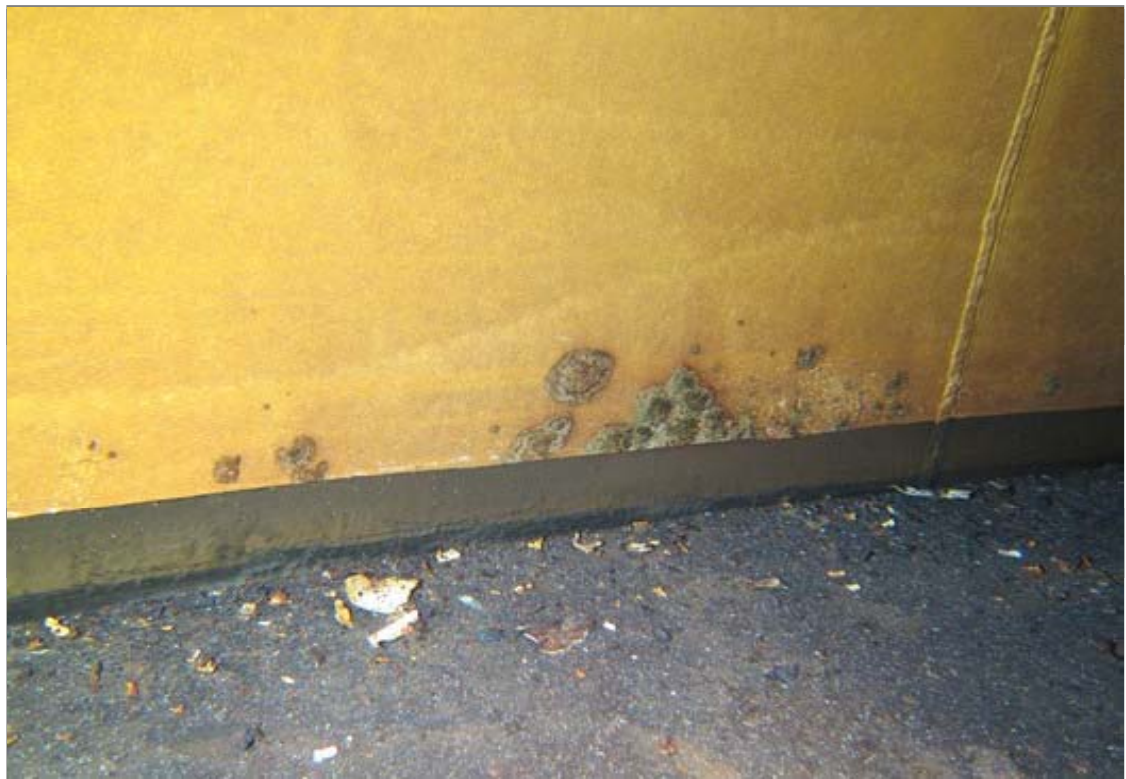
This photo shows an area of the lower shell where coatings are failing. This is an example of the worst condition in this zone.

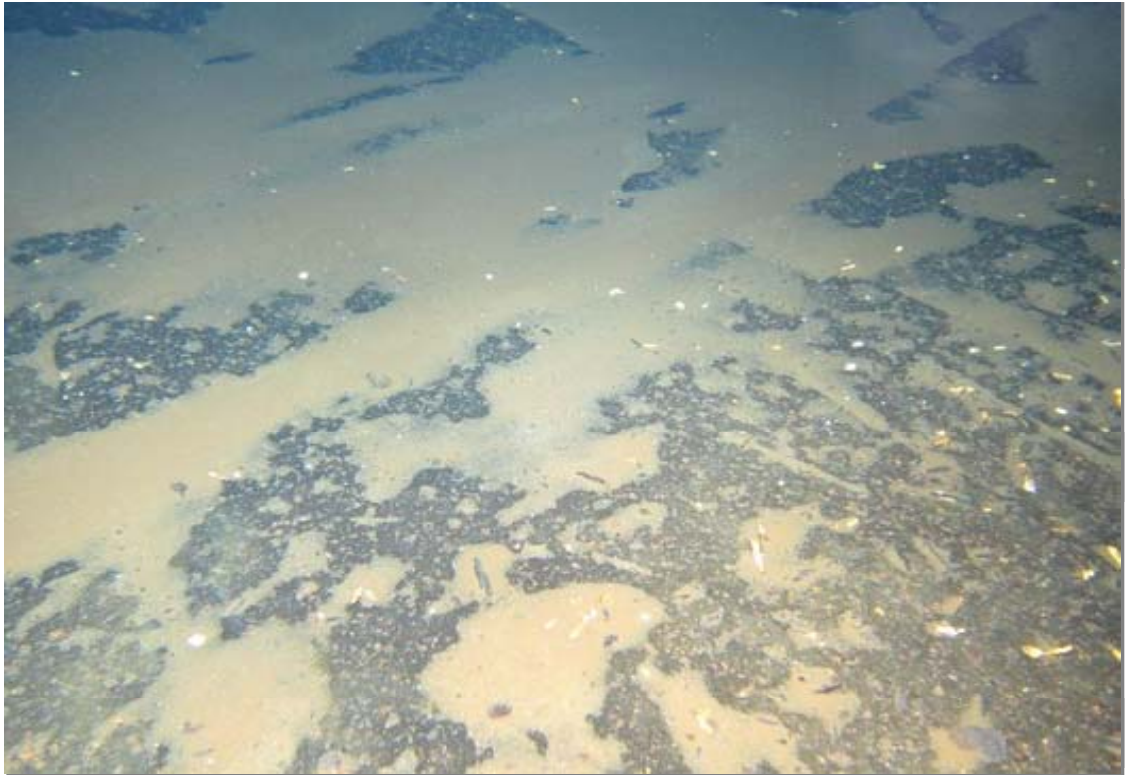
This photo shows the typical condition of the bottom. Sediment removal was not completed with this inspection.

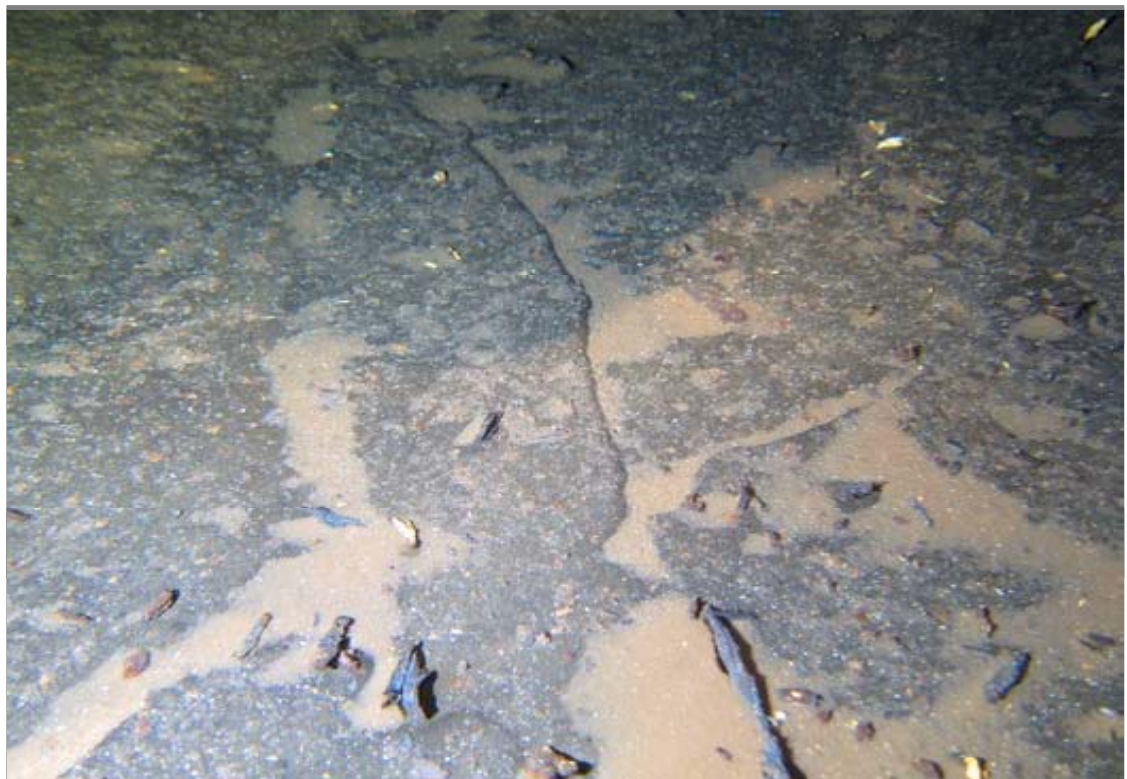
This additional view of the bottom shows some of the corrosion product from the rusting roof rafters above.

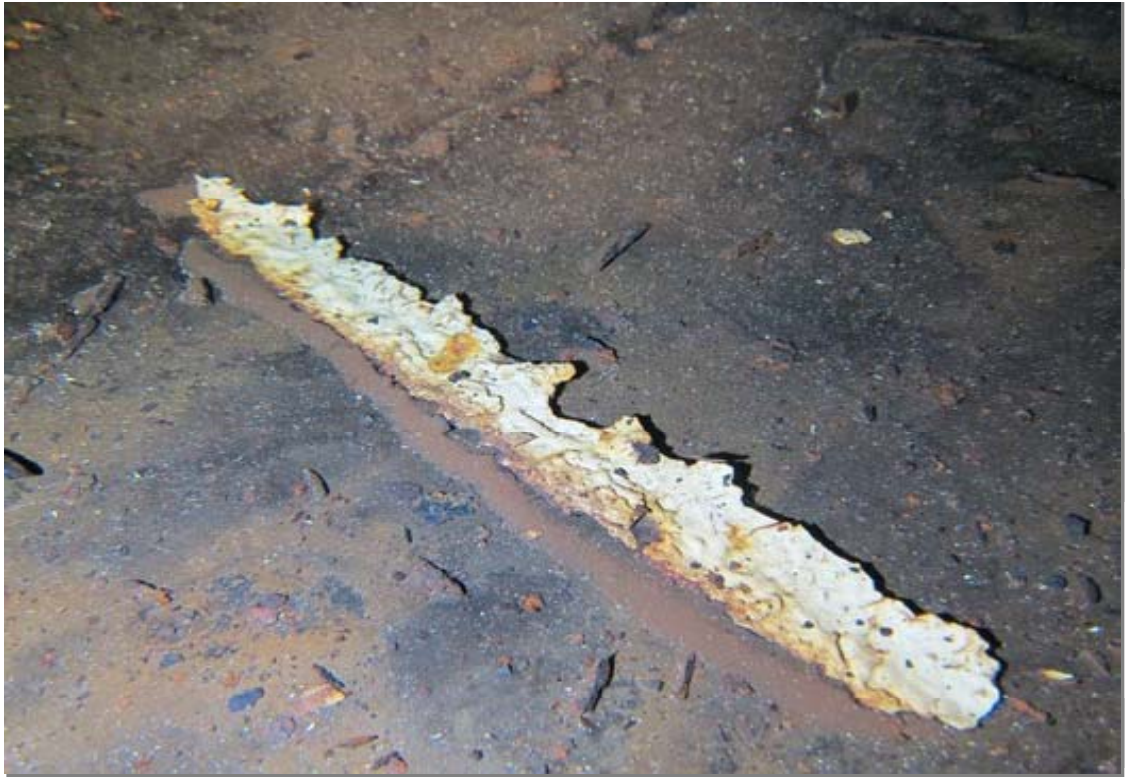
Additional view of interior bottom with coating chip from a roof rafter.

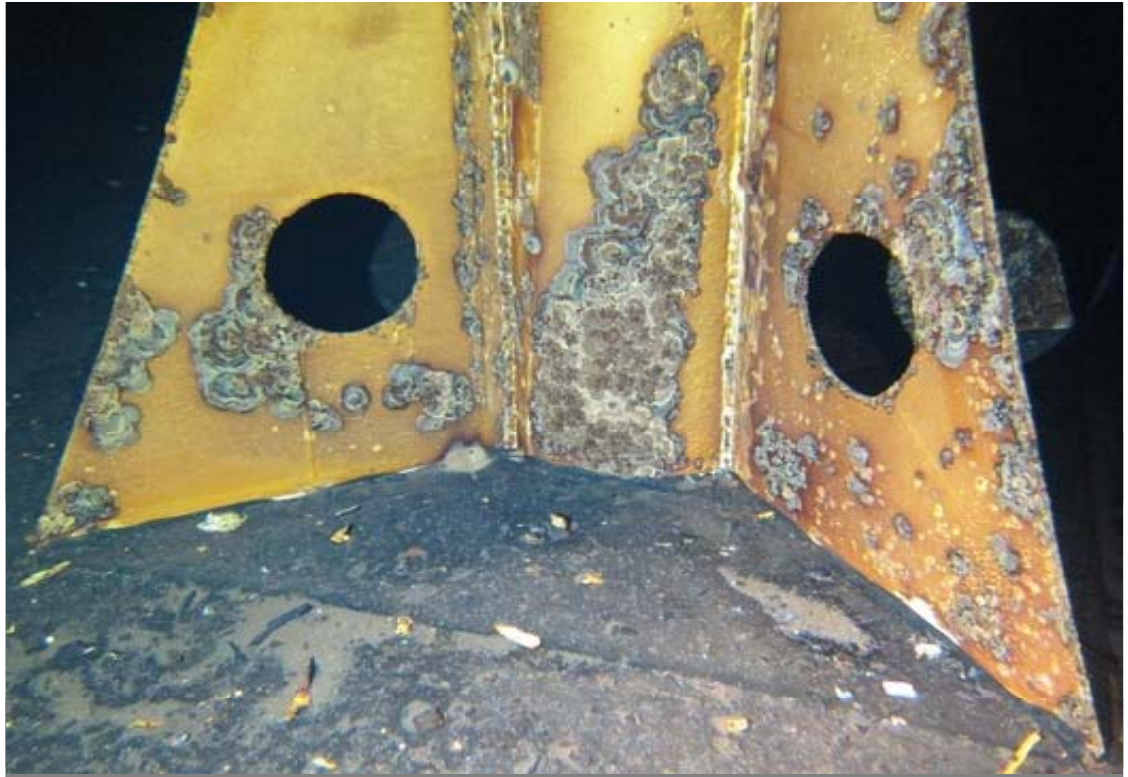
This view shows the column base plate and adjacent bottom plate. Coatings are in poor condition overall on the column and base plate.

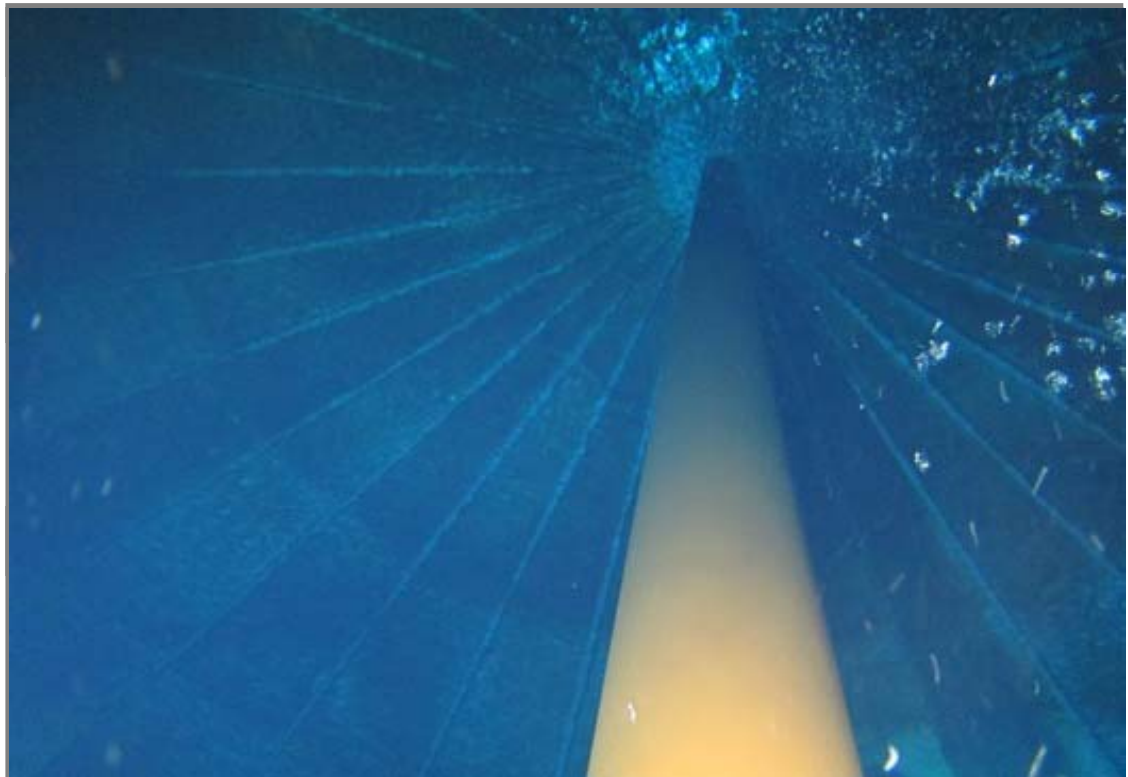
This shot was taken looking upward at the center column. The column is in good condition overall.
