APPENDIX C
Dive Inspection Report – Existing Welded Tank

**INSPECTION REPORT FOR THE
TWIN HARTE COMMUNITY SERVICE DISTRICT'S
MILLION GALLON TANK #2
DECEMBER 29TH, 2017**

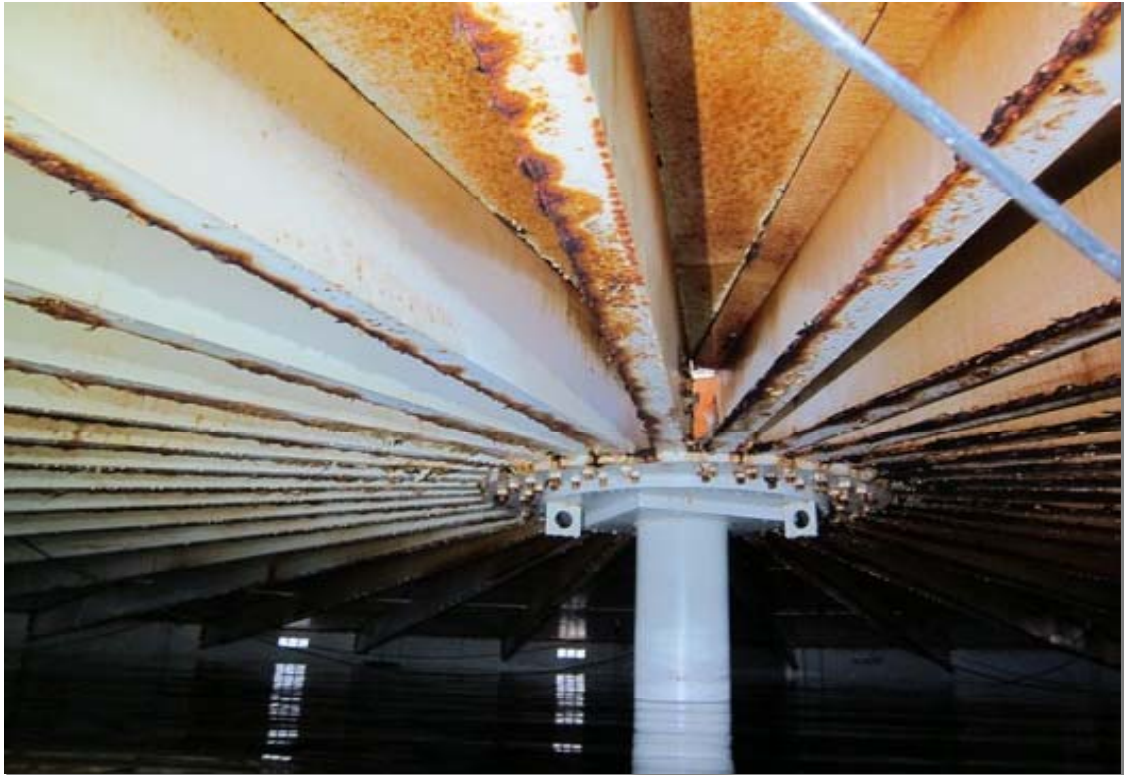
Upper center column, rafters and roof plate. Significant corrosion and associated metal loss are present.

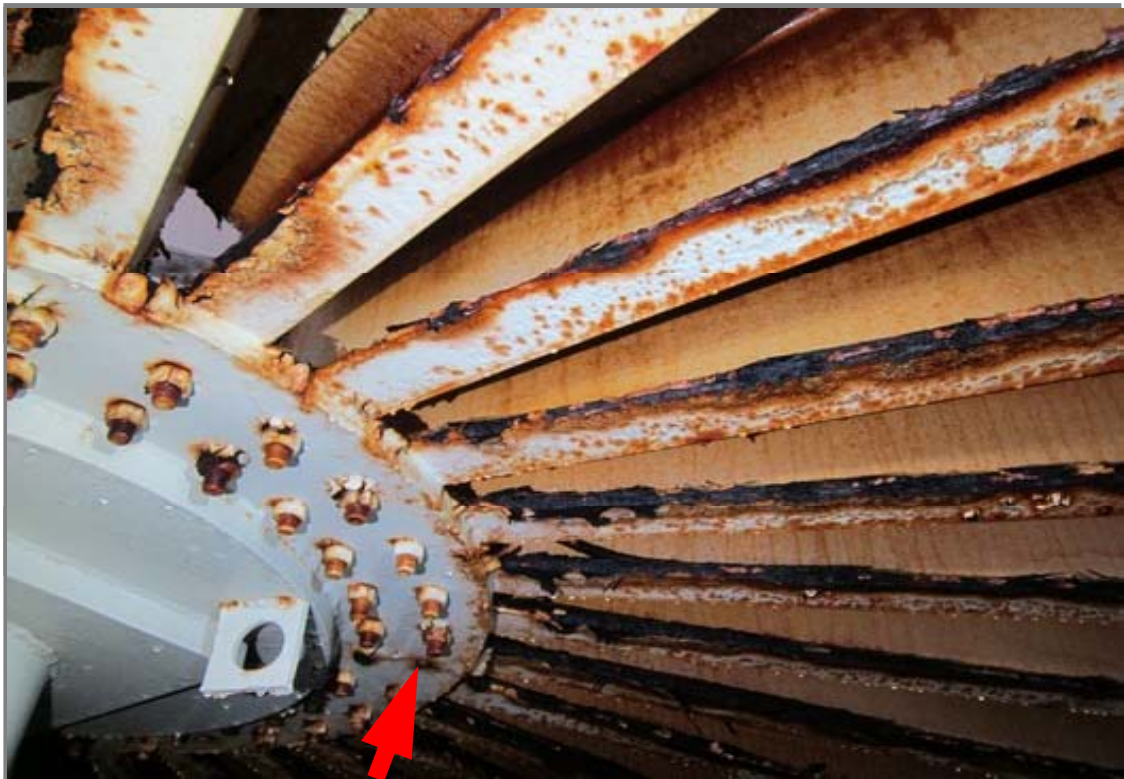
Close view of the center support and rafters. Coating failure and associated corrosion are visible. Several sets of bolts are also missing one of which is shown at the arrow.

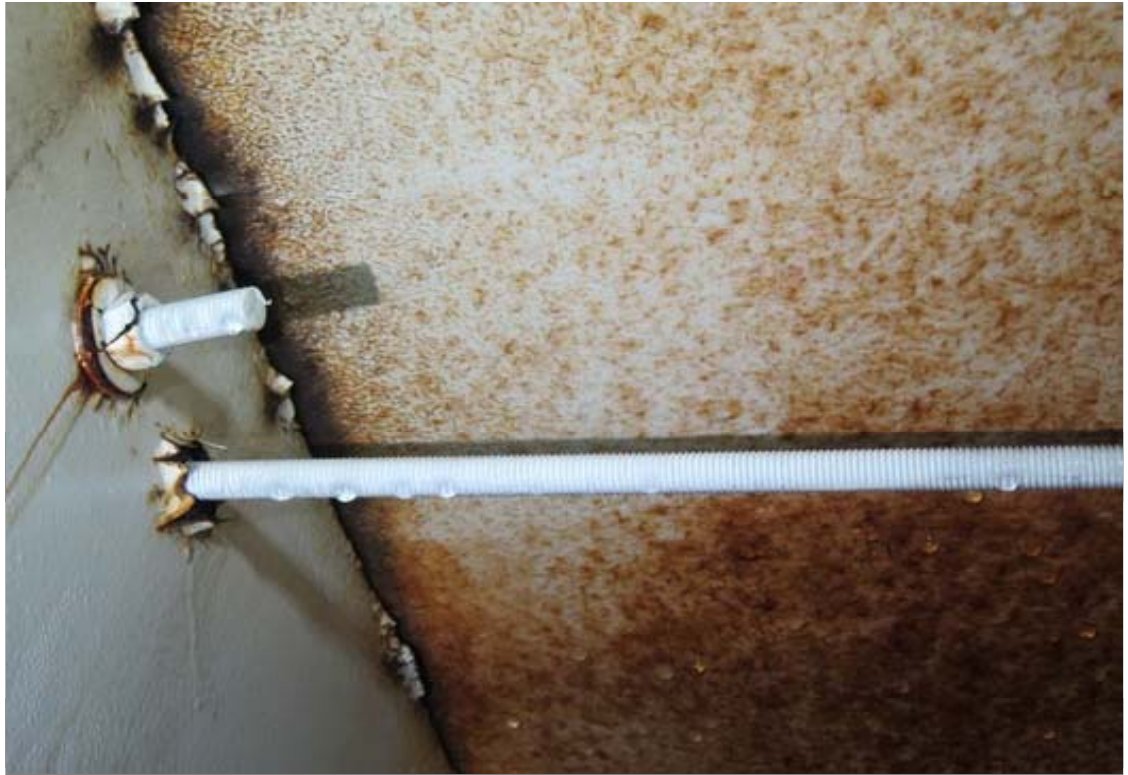
Rafter bracing at the connection to the web of a channel rafter on the interior roof.

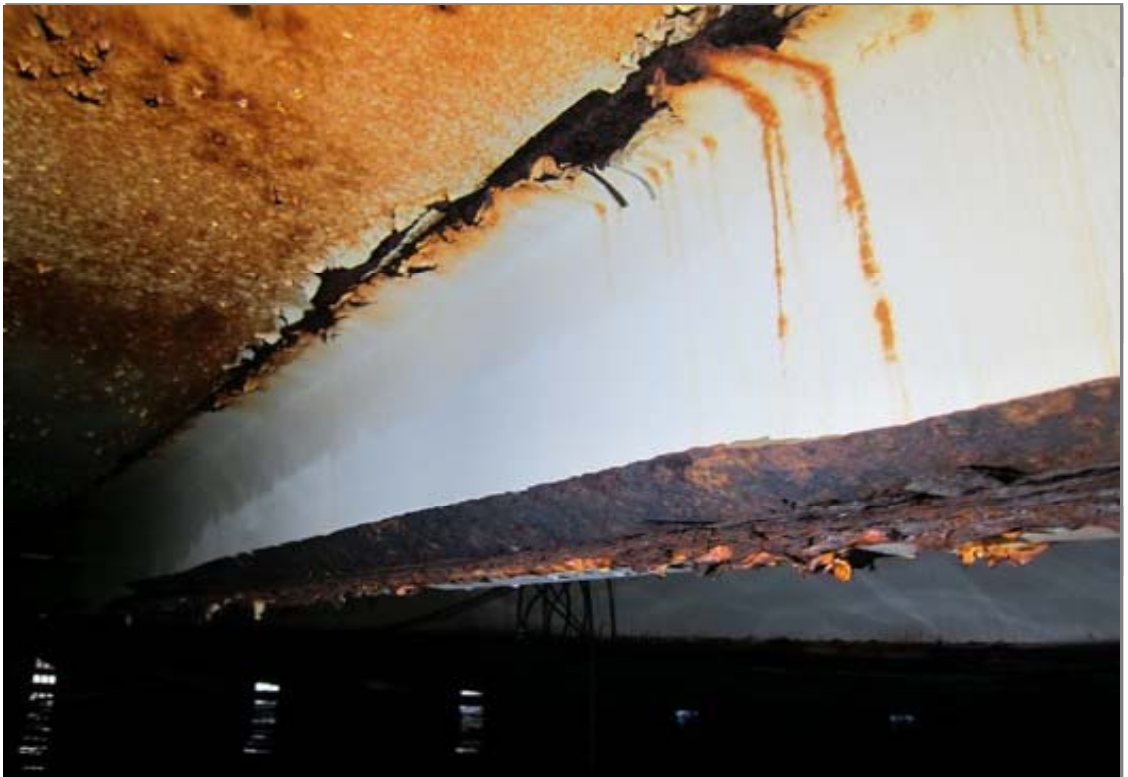
A typical rafter with serious metal loss due to corrosion on the flanges.

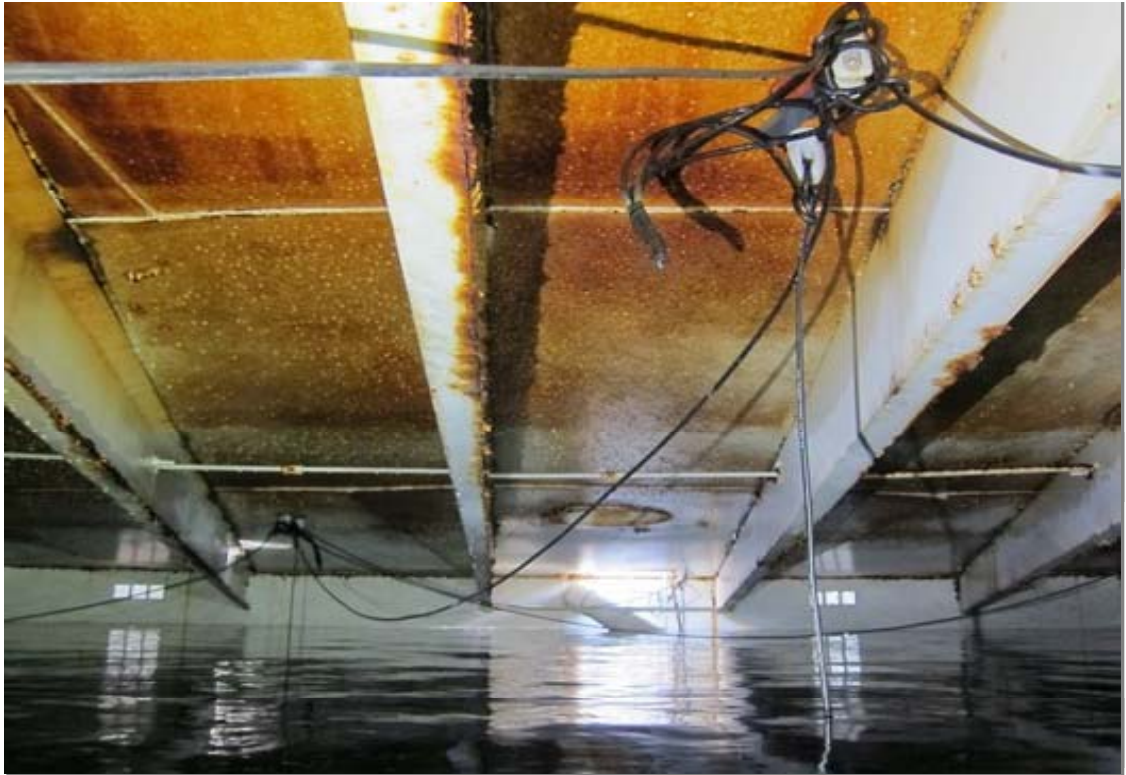
This broad view of the roof is looking toward the roof hatch from near the center.

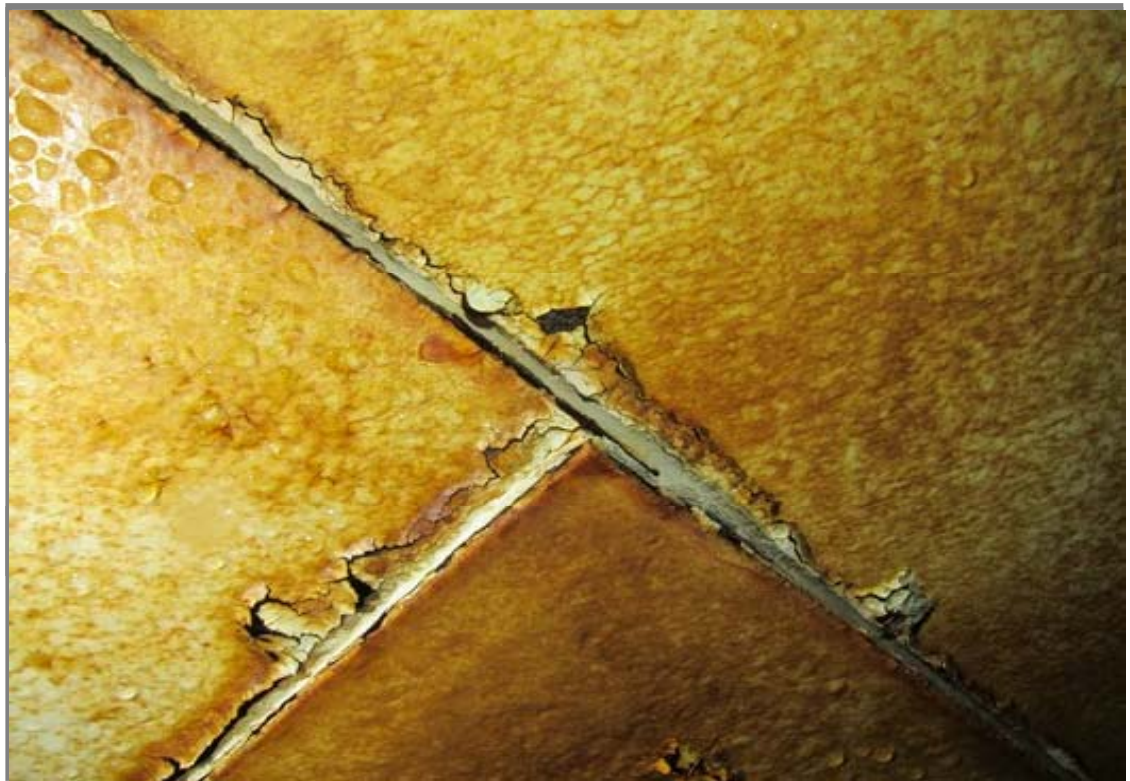
Interior roof plate lap. This view shows the concentrated corrosion that is present at lap joints along with the general corrosion on the plate.

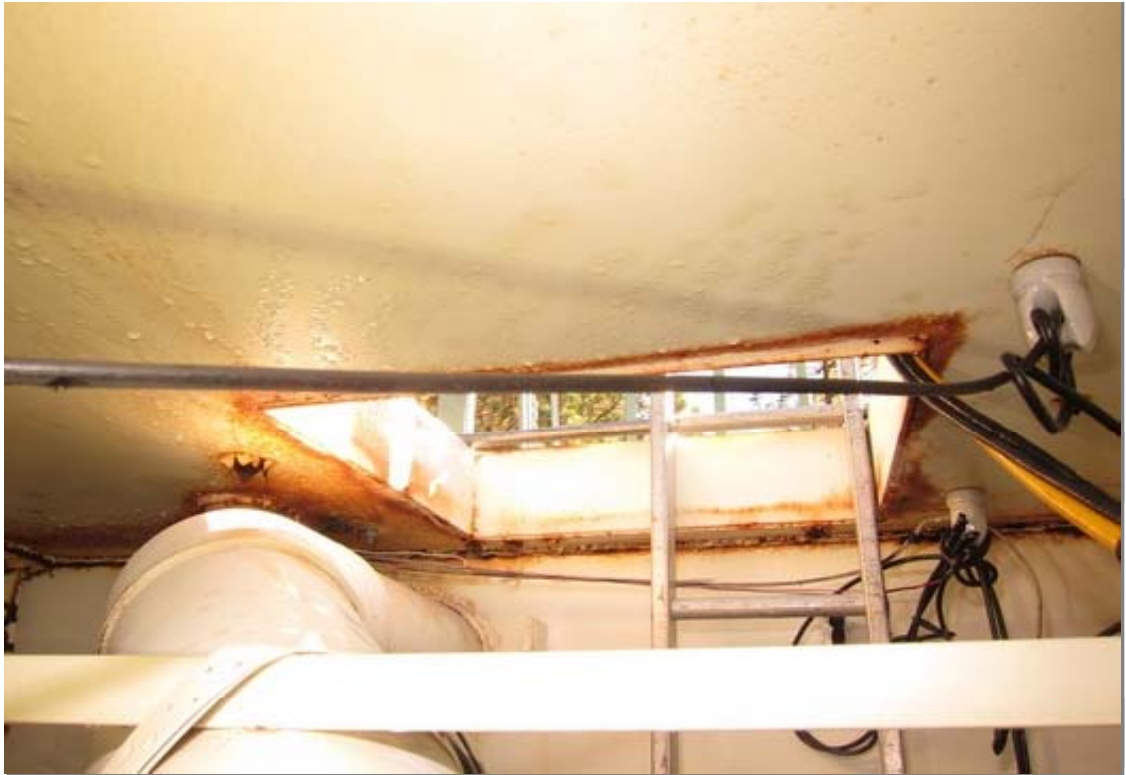
View of the roof hatch from the interior. The diver's entry ladder is visible.

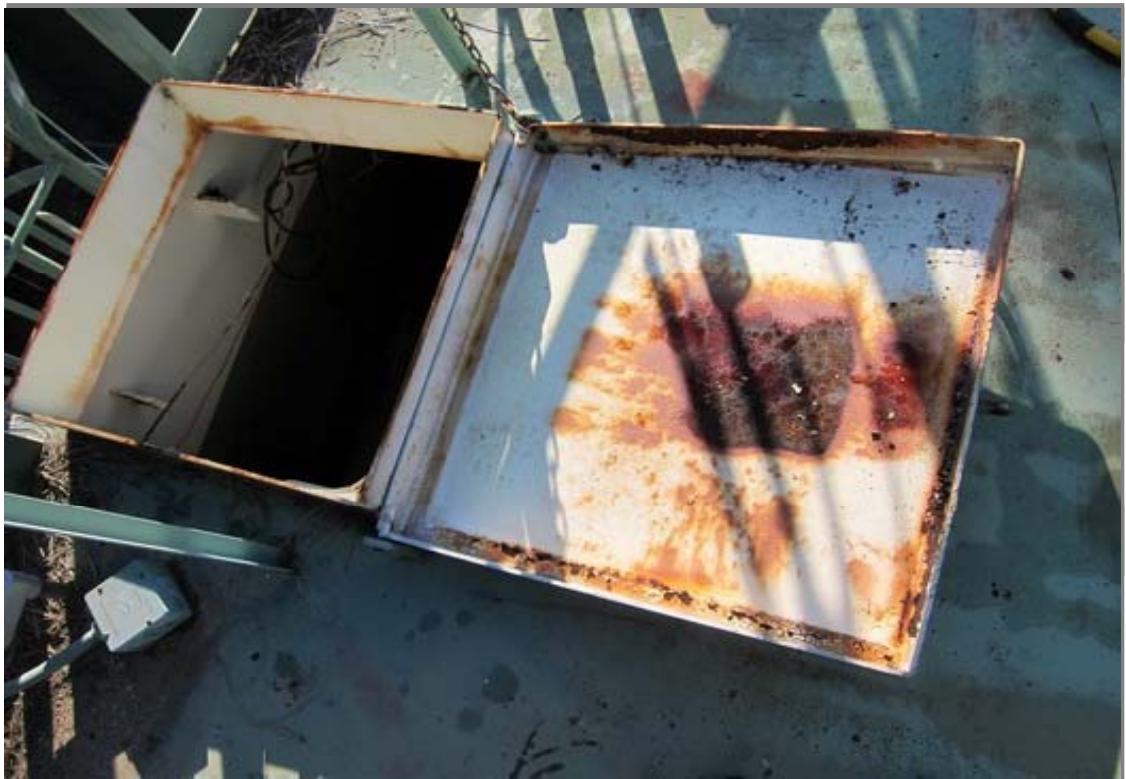
Corrosion on the interior side of the roof hatch.

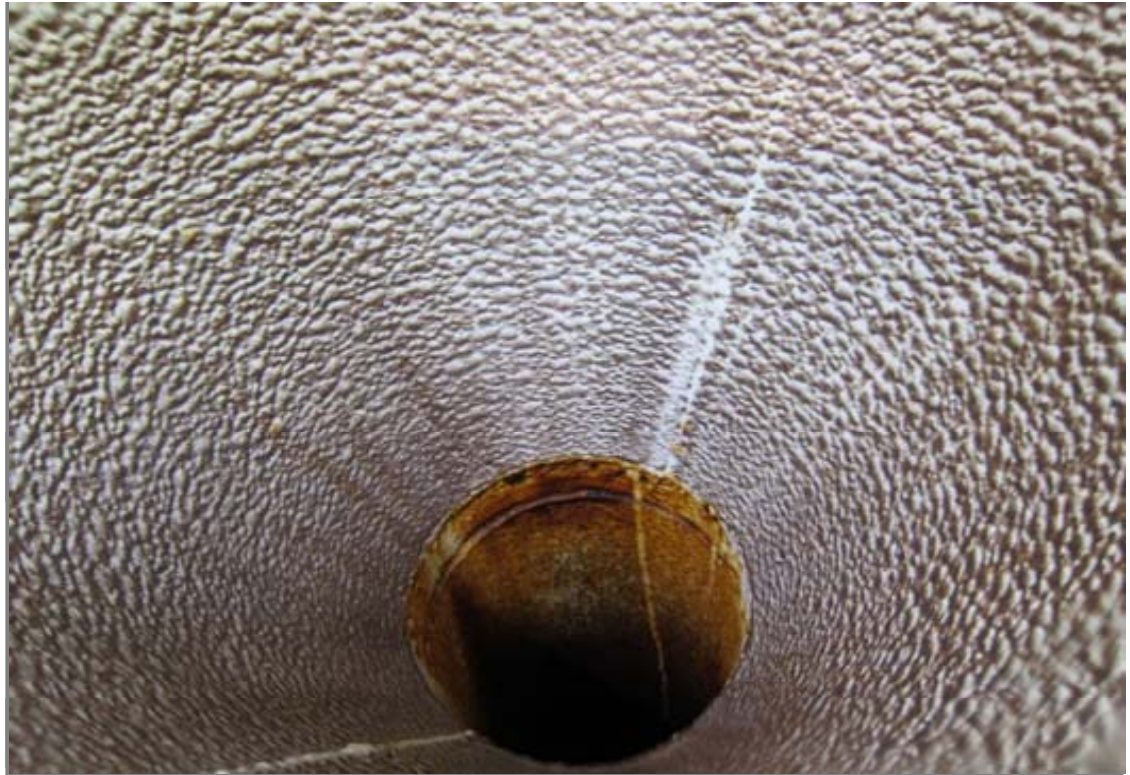
Interior of the overflow weir.

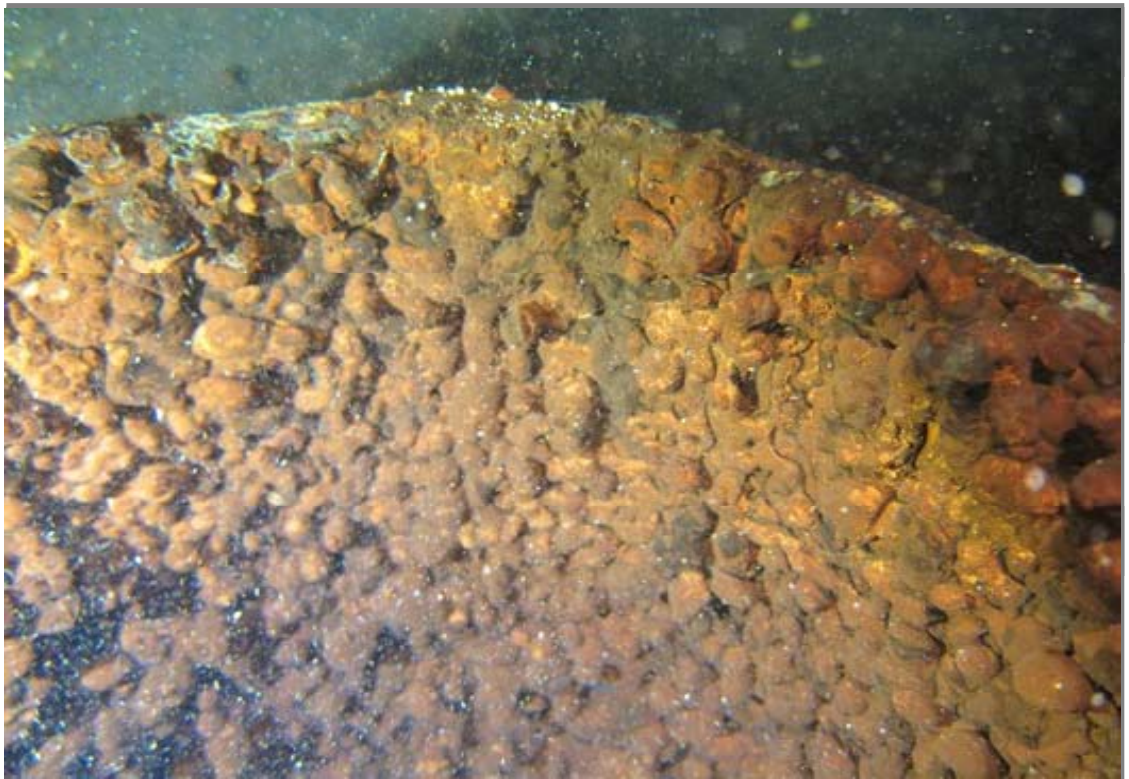
Corrosion nodules on the interior of the outlet pipe.

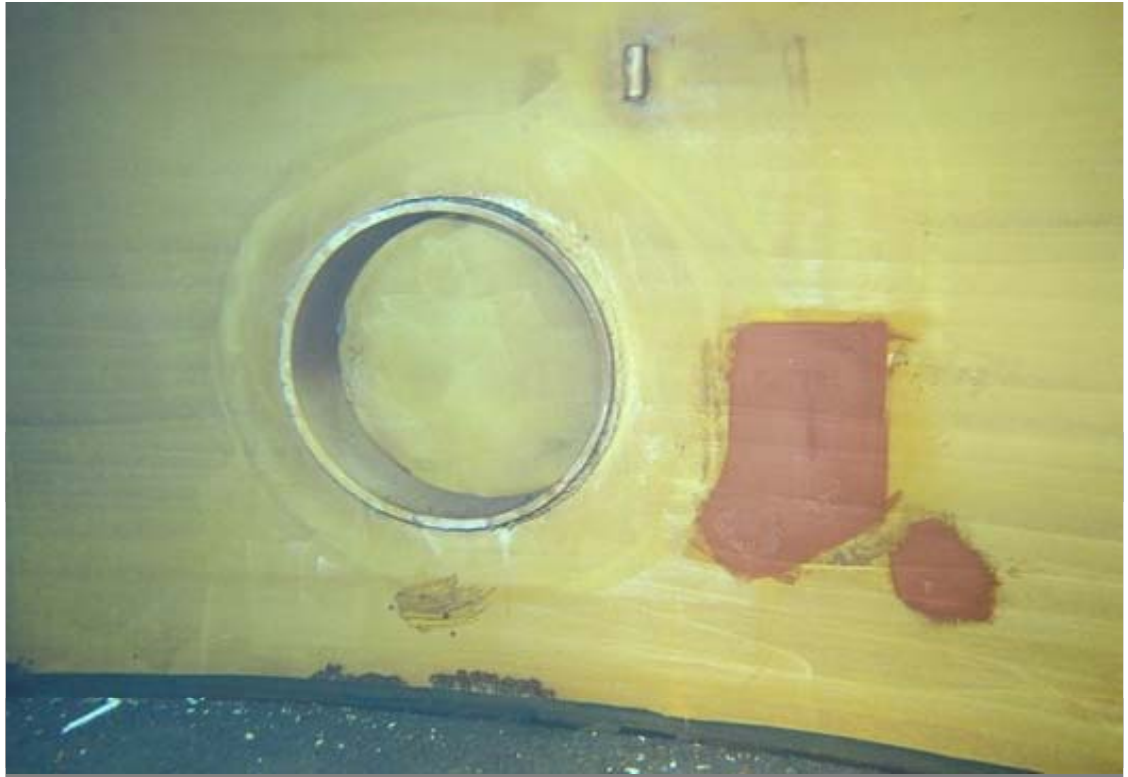
Interior view of the shell manway near quadrant 3. A spot repair is visible to the right and some significant corrosion is present below the manway.

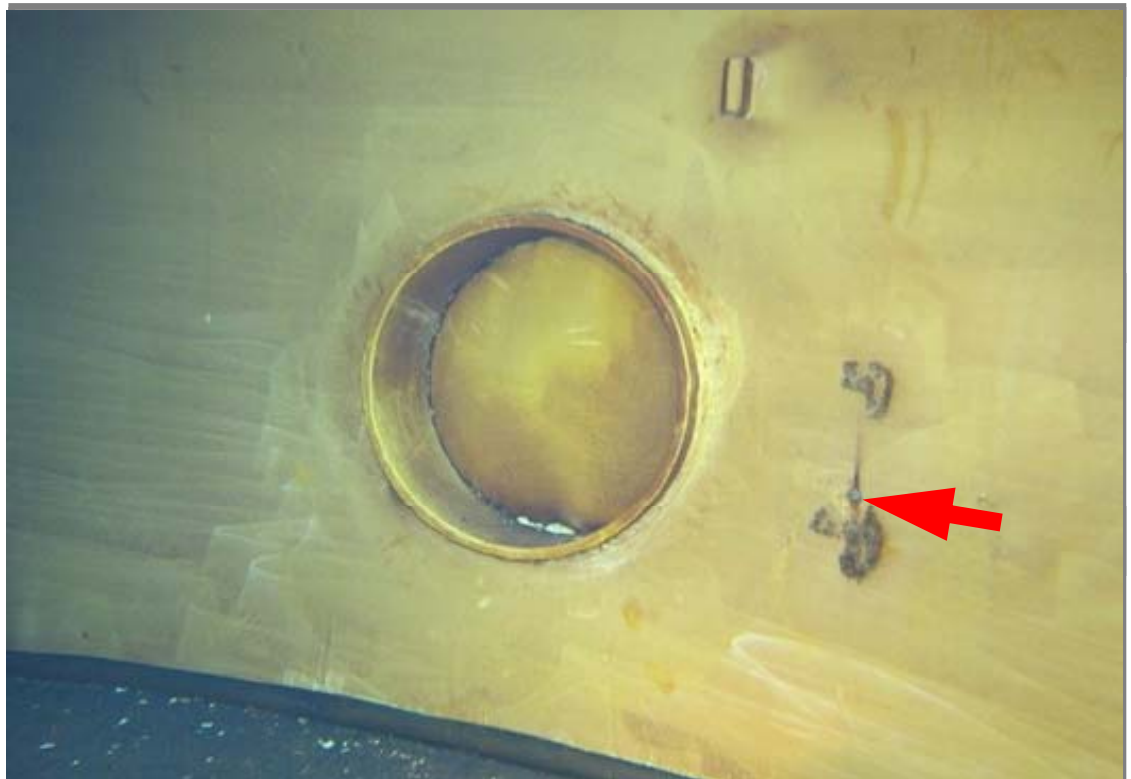
Shell manway in quadrant 1 as viewed from the interior. The spots shown at the right are areas of significant corrosion with a 3/4" diameter nodule at the arrow.

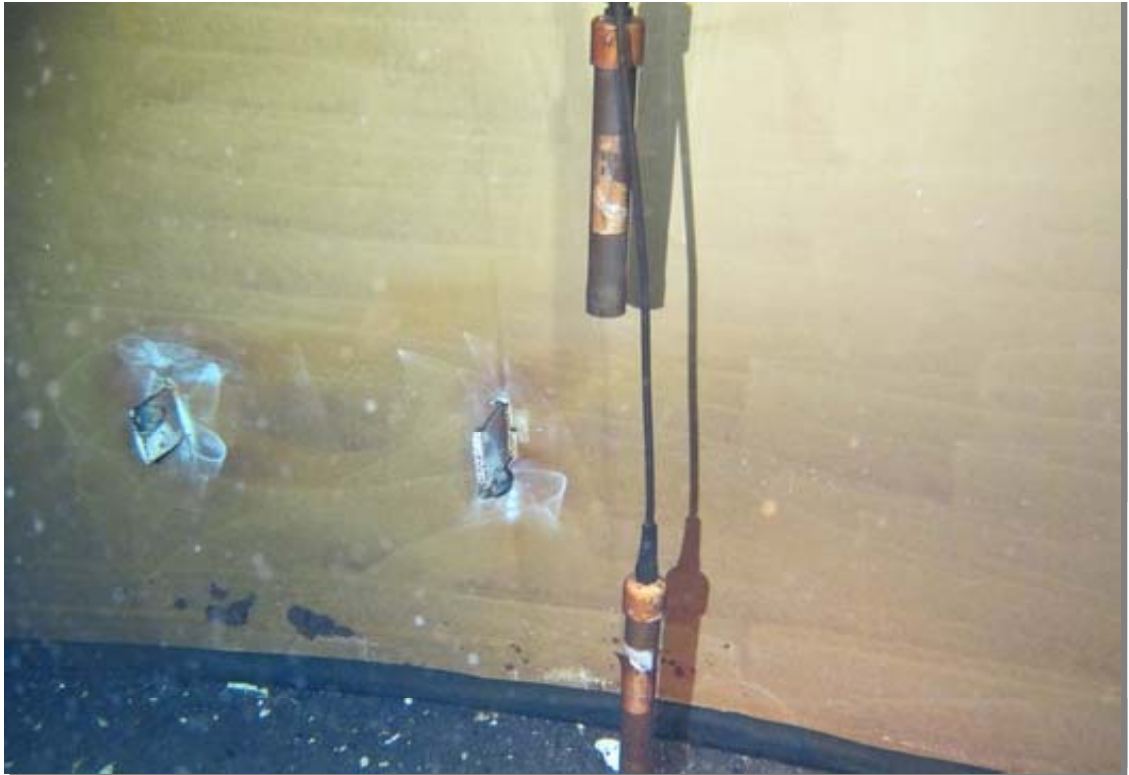
These cathodic protection system reference cells are located below the roof hatch.

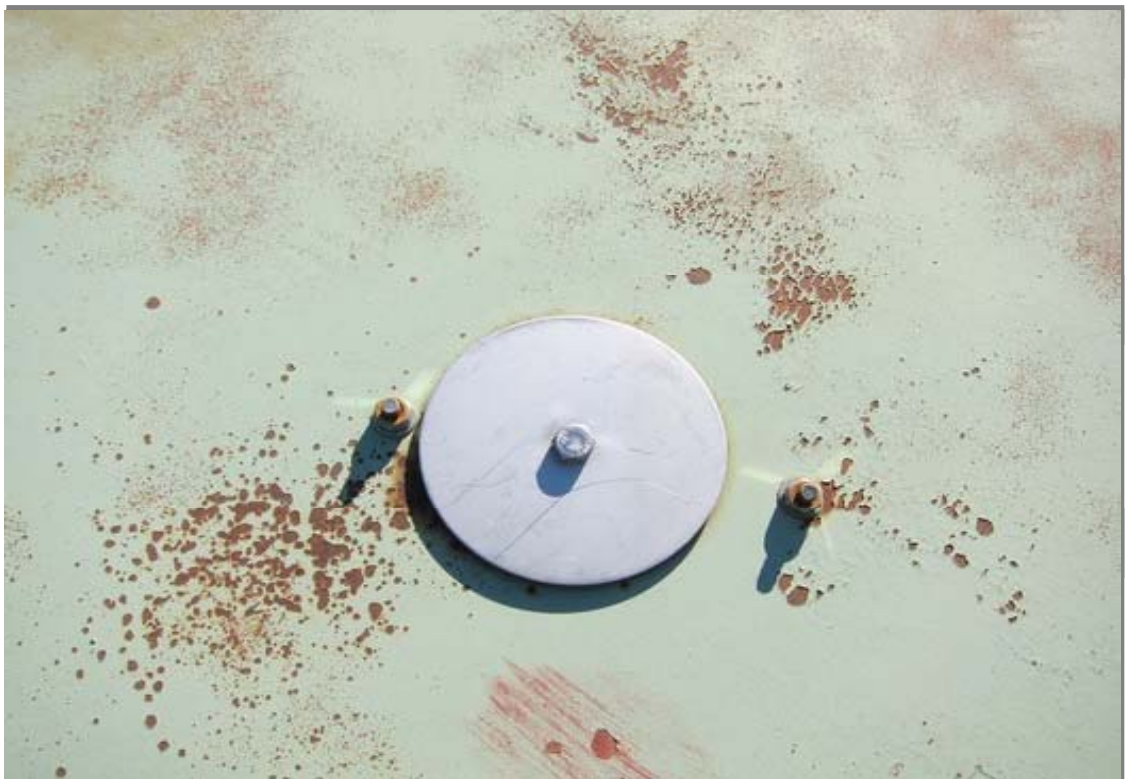
Typical view of a cathodic protection hand hole cover in good condition as viewed from the exterior roof.

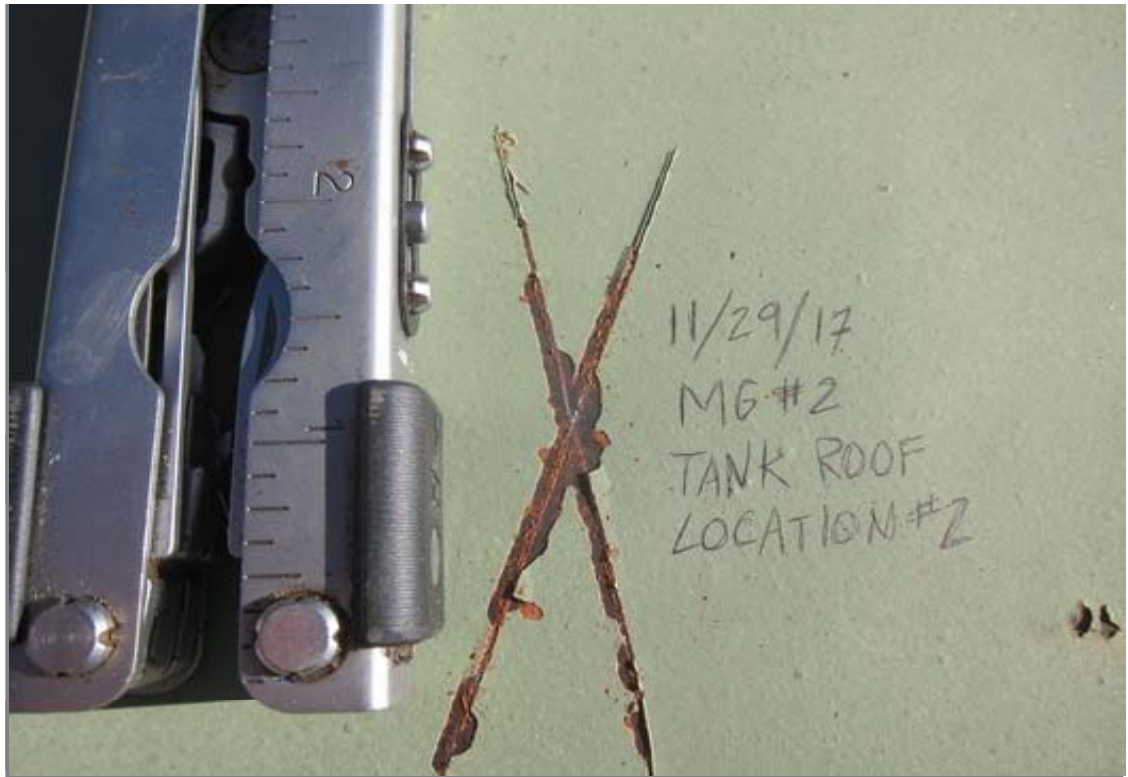
Adhesion was evaluated with a cross cut tape test and found to be 2A-3A.
This location was on the exterior roof.

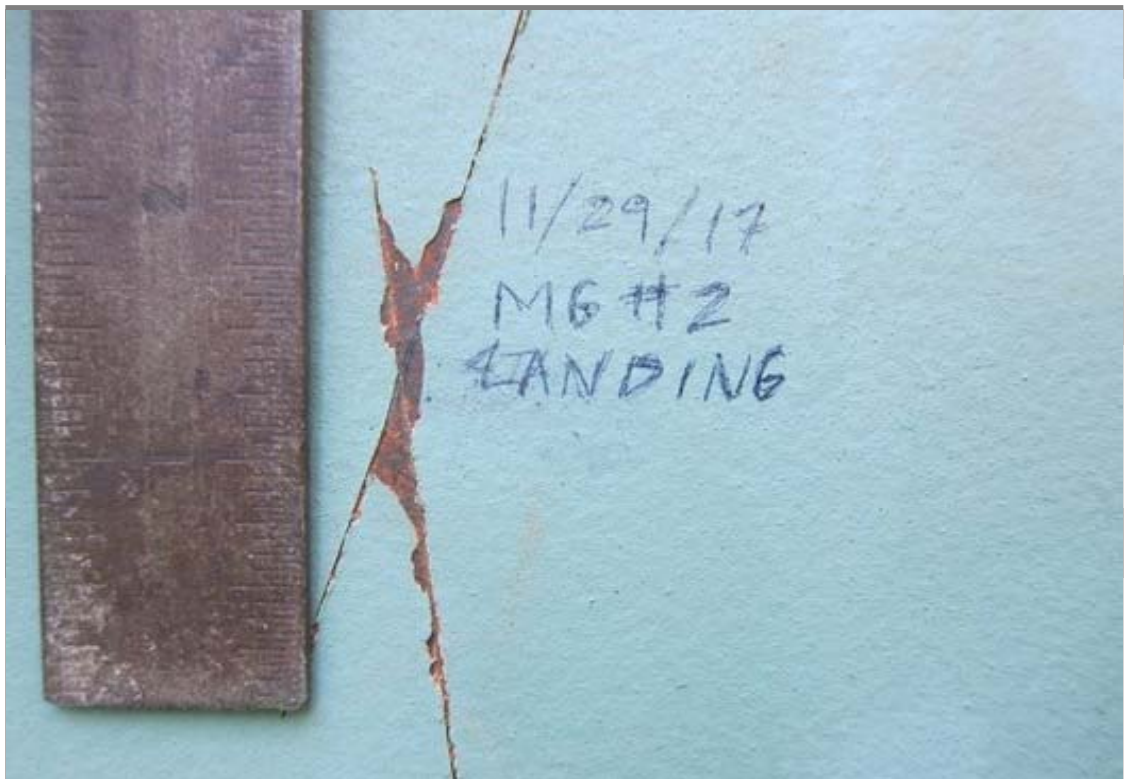
Adhesion was evaluated with a cross cut tape test and found to be 2A-3A.
This location was on the exterior shell at the mid platform.

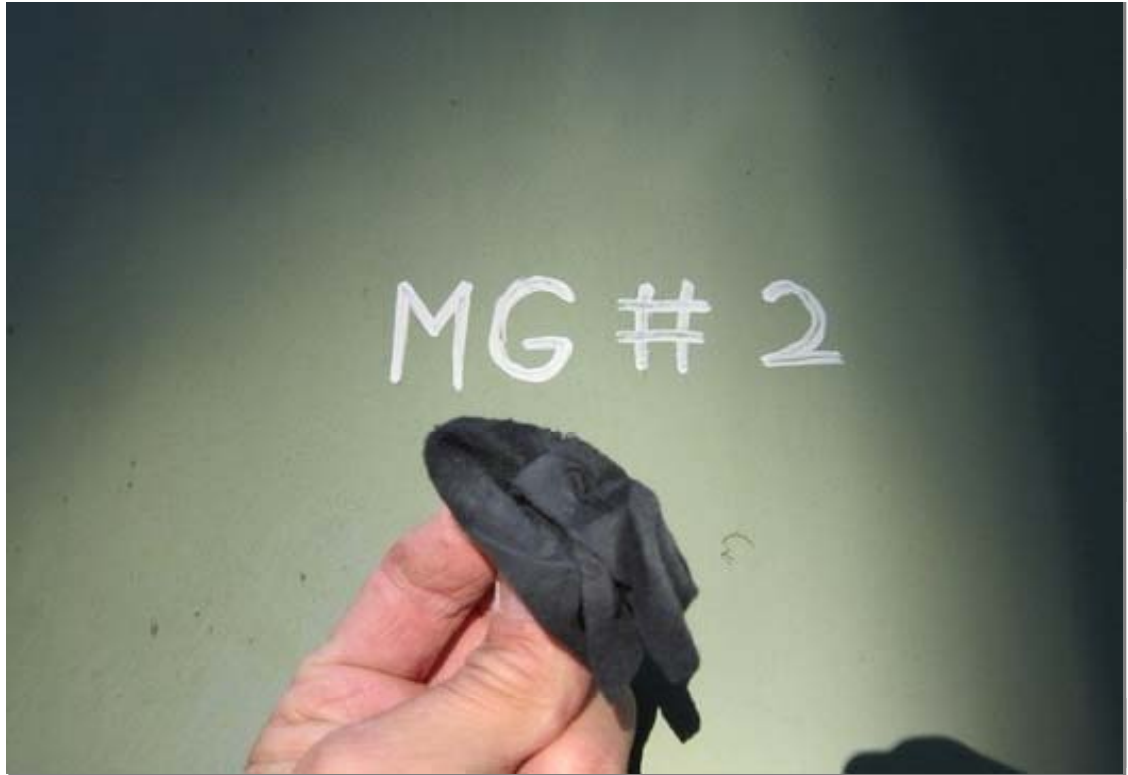
Chalking was evaluated pursuant to ASTM D4214, test method A. Chalking is approximately a No. 7 valuation as compared to photographic reference standard No. 1

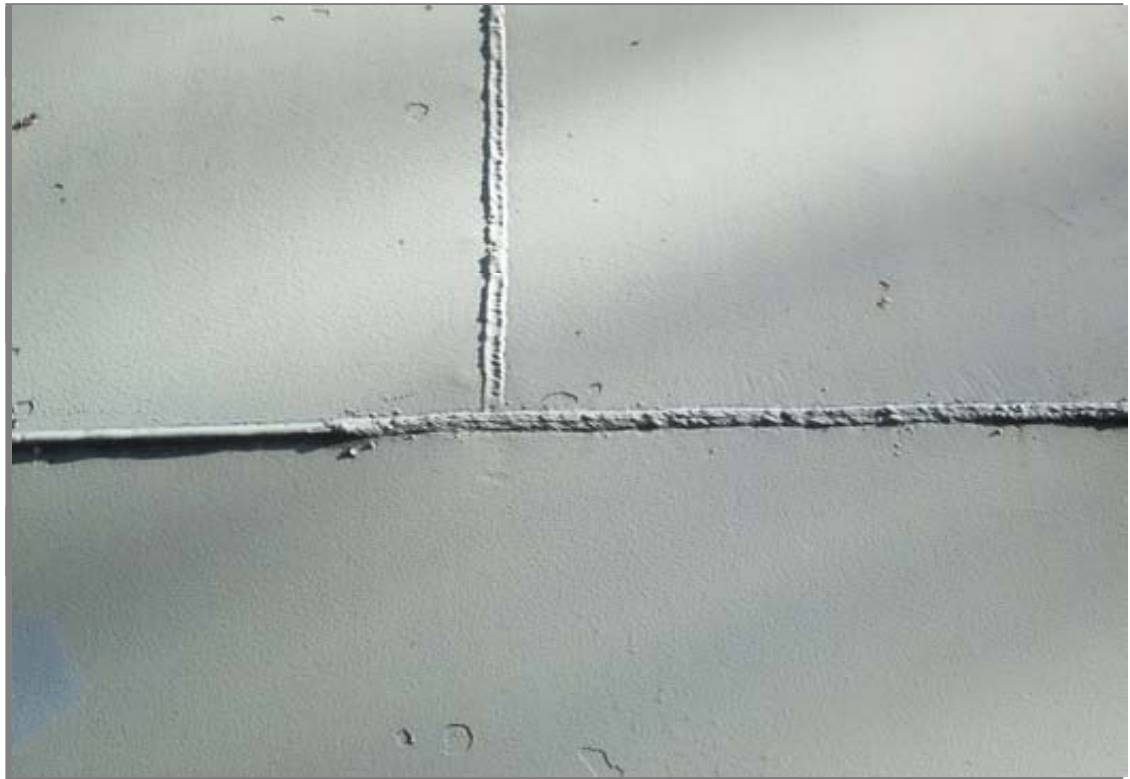
Scattered areas of spatter are present on the shell and roof welds. The area shown above is a repair completed manually. The weld on the left is by a mechanized system.
