## **APPENDIX D**

### **PROJECT LOCATION & EXISTING CONDITIONS**

**TITLE: PROJECT SITE LOCATION**

**PROJECT: MG#2 WATER TANK RECOATING AND UPGRADE PROJECT**

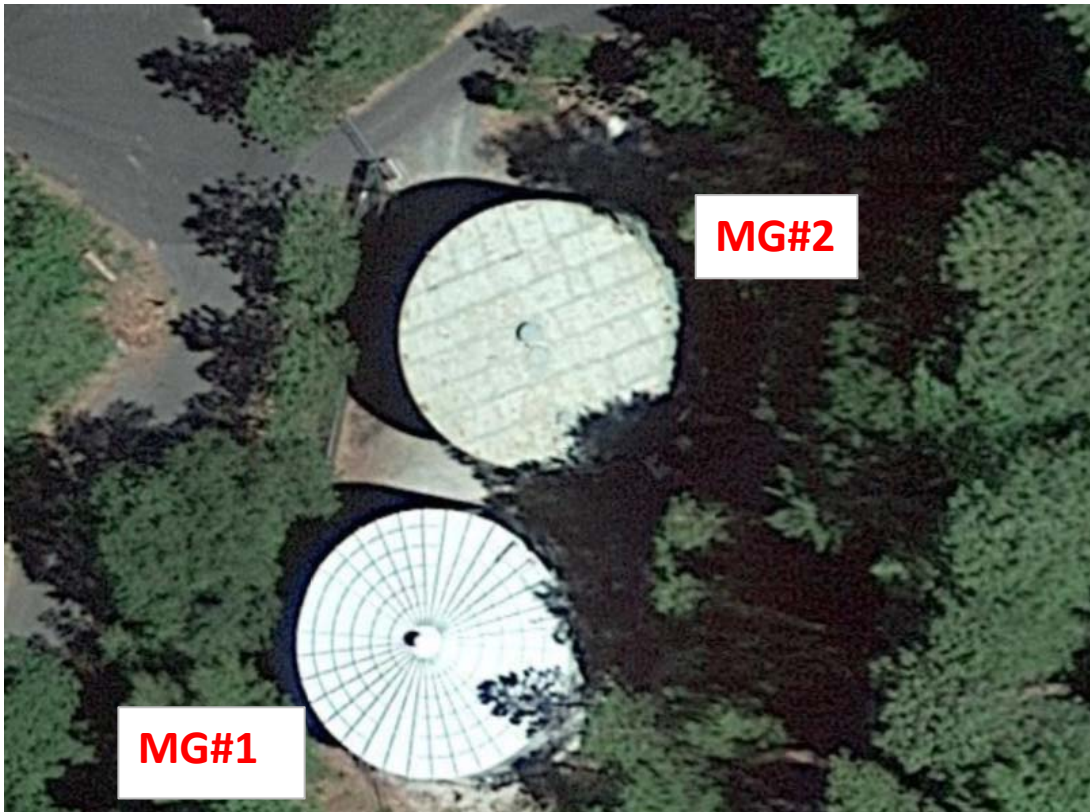
Plan view of site. MG#2 is the tank being rehabilitated in this project. MG#1 was previously rehabilitated.

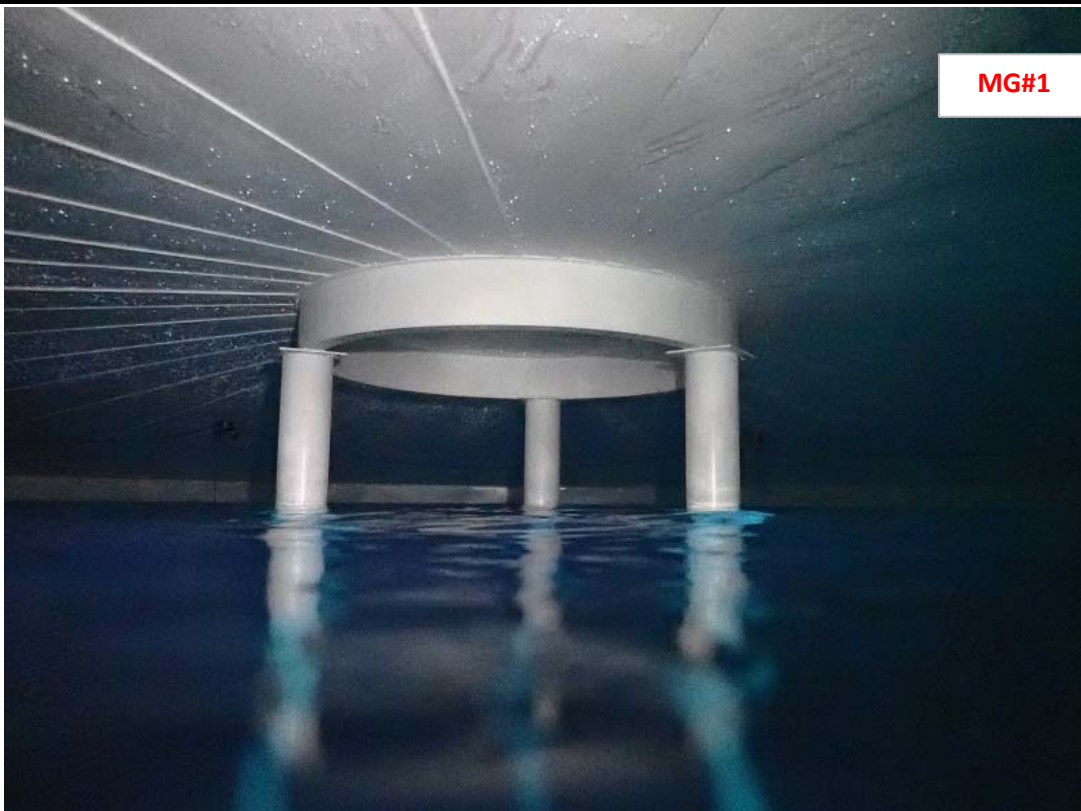
View of interior roof of previously rehabilitated MG#1 showing the desired style of structure on the MG#2 replacement roof.

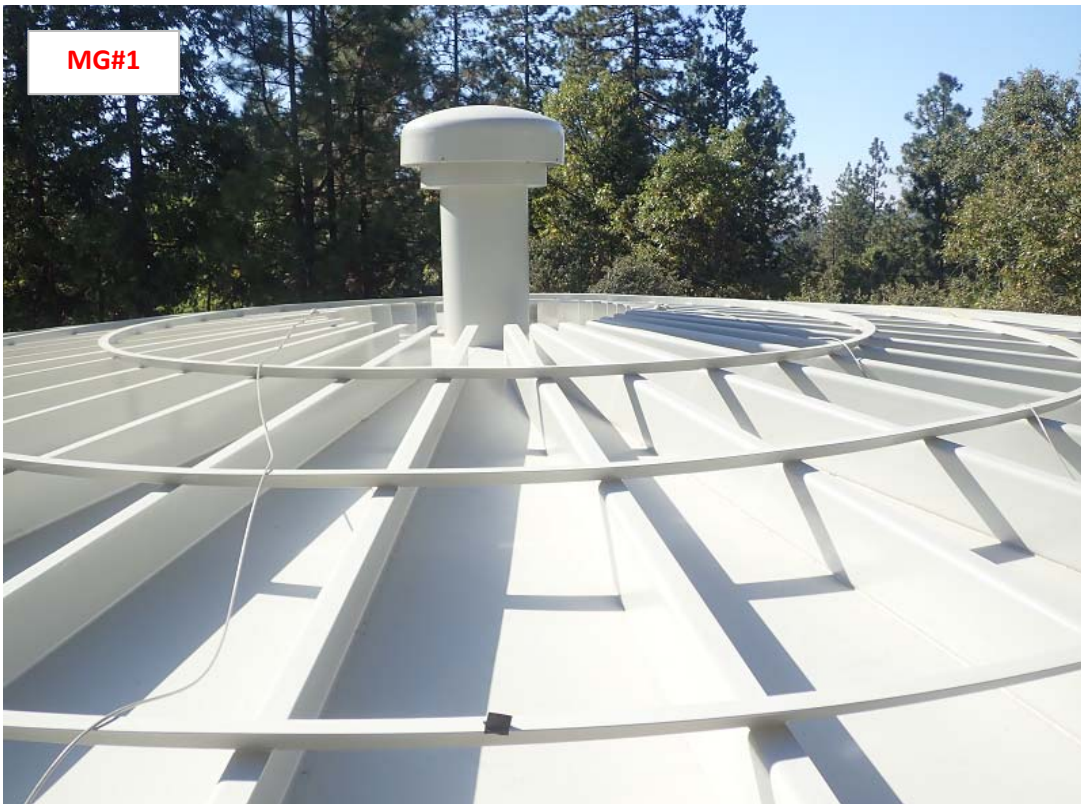
View of exterior roof of previously rehabilitated MG#1. The new roof, vent and guardrail on this MG#2 Rehabilitation project is to be similar.

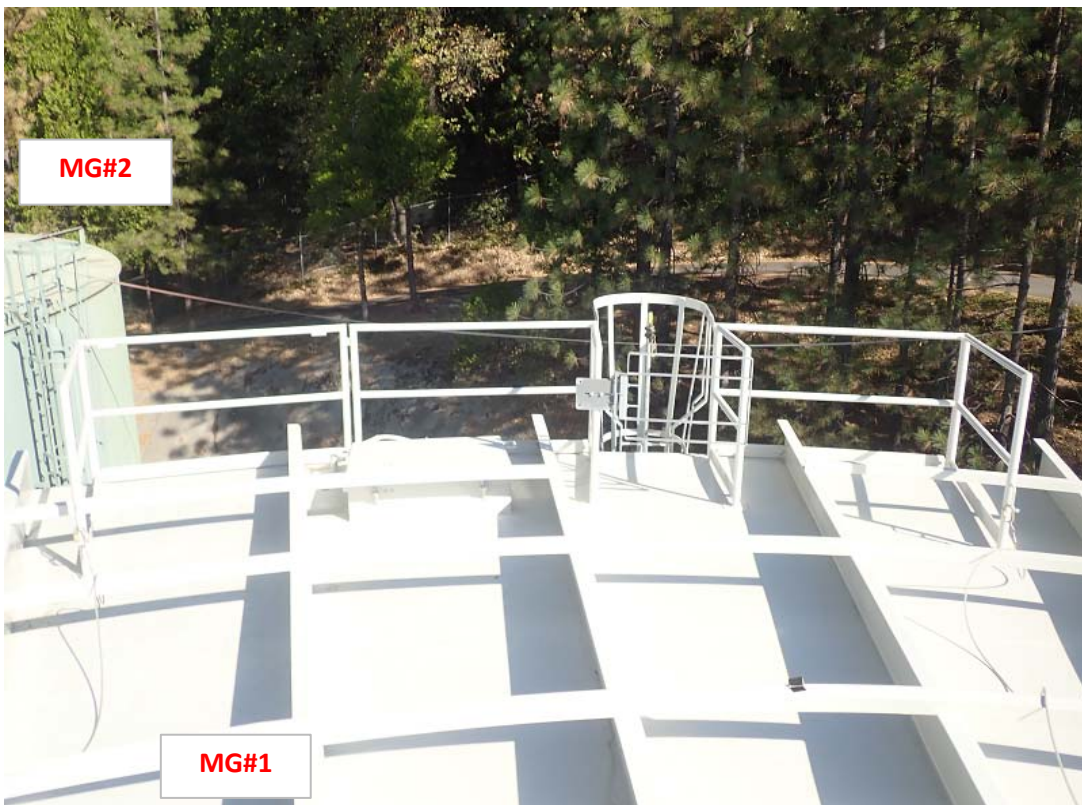
Desired roof configuration of new guardrail, and hatch at existing exterior ladder as seen on previously rehabilitated Tank #1.

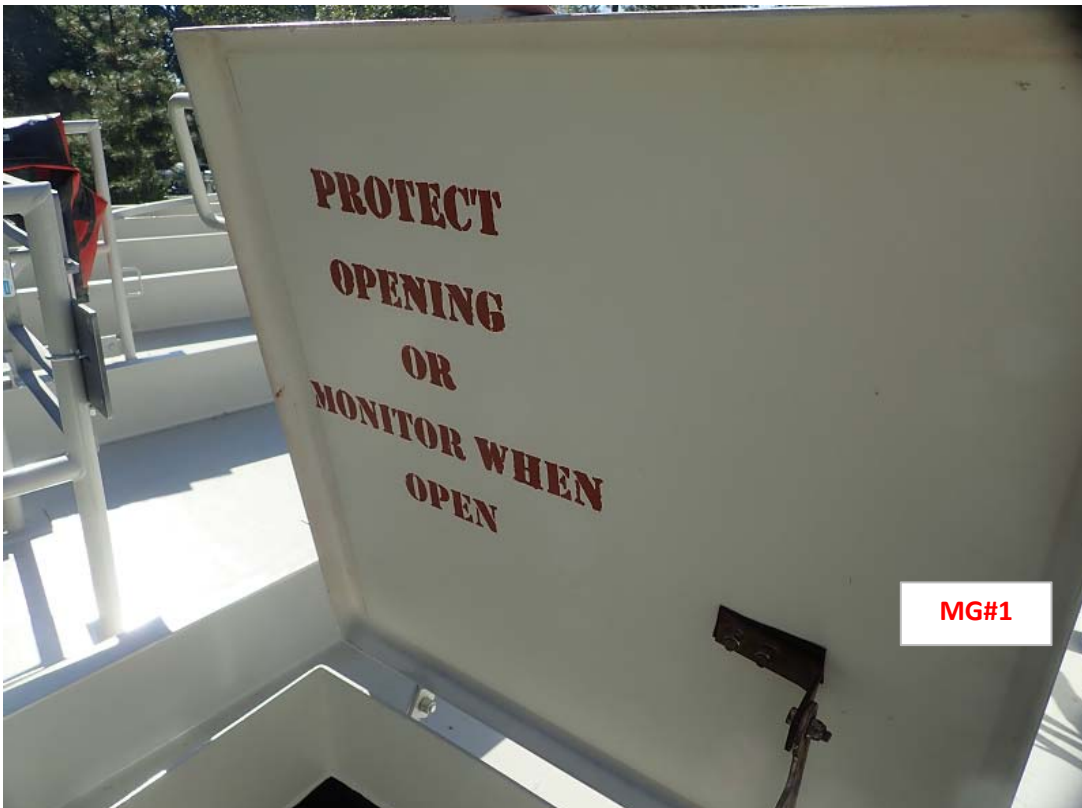
Signage required on new roof hatch.

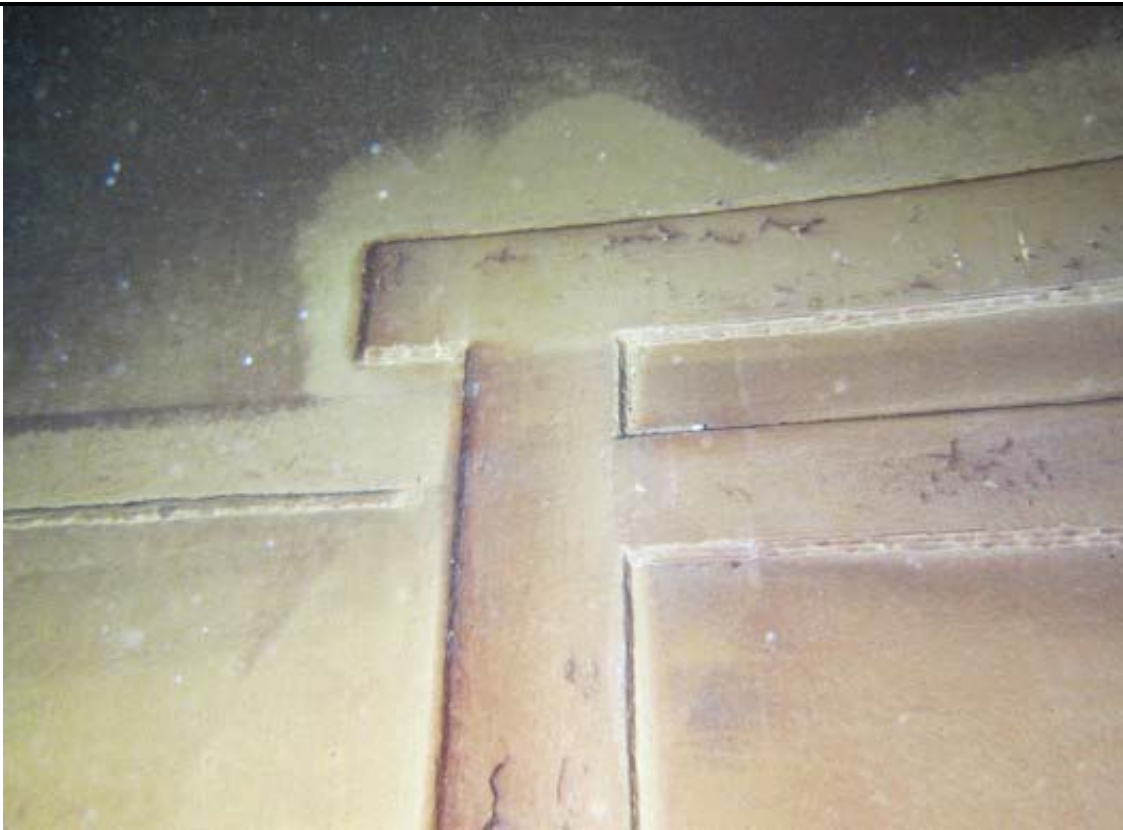
Interior shell at top corner of previous temporary shell opening ("door sheet").

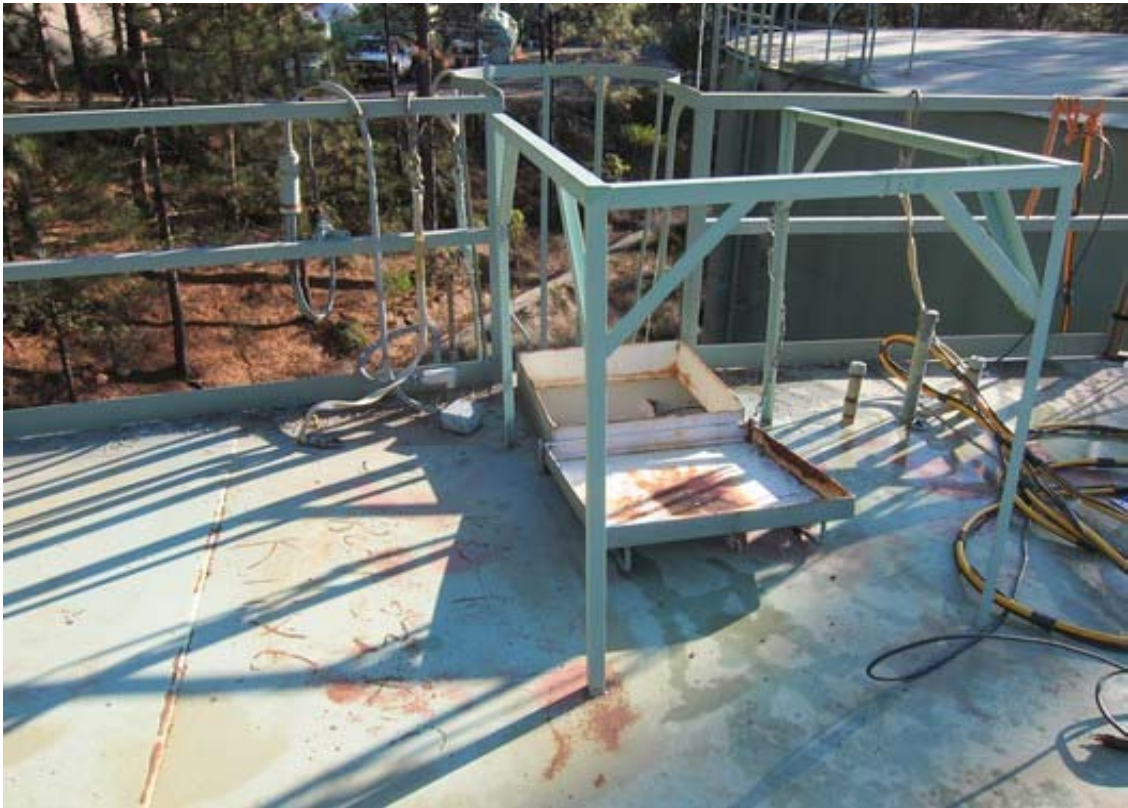
MG#2 Existing roof hatch, guardrail and appurtenances.

Modify guardrail as appropriate for attachment of the new lower ladder and cage.

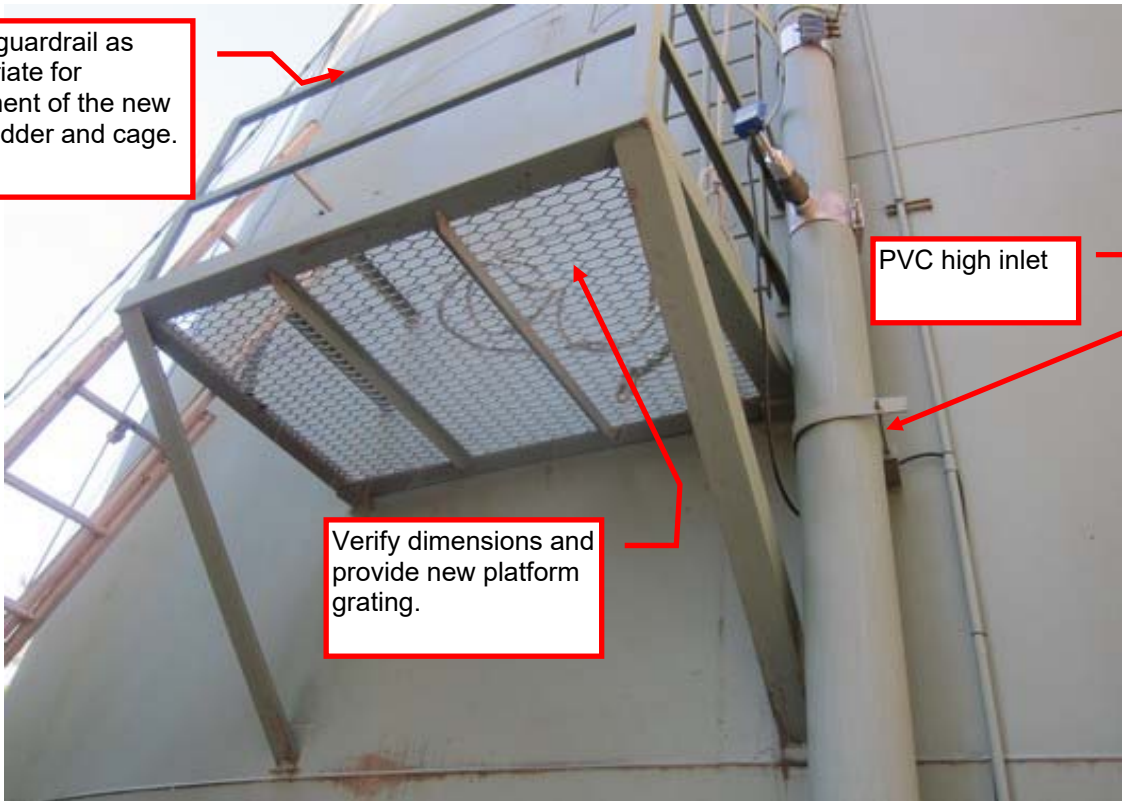
PVC high inlet

MG#2 Existing ladder platform. A new low section of ladder to the platform and appropriate additional guardrail and new grating on the platform are part of the scope of work.

Verify dimensions and provide new platform grating.

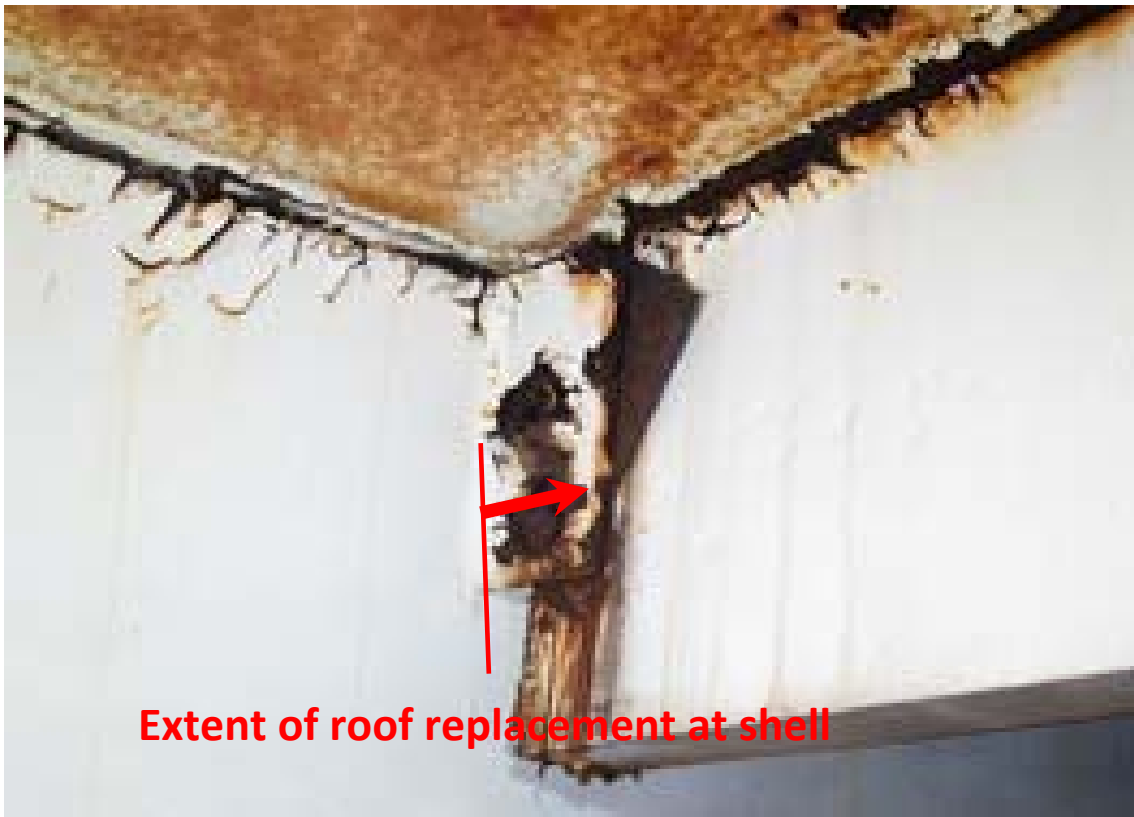
**Extent of roof replacement at shell**

MG#2 existing rafter and shell clip and extent of roof replacement at the shell.

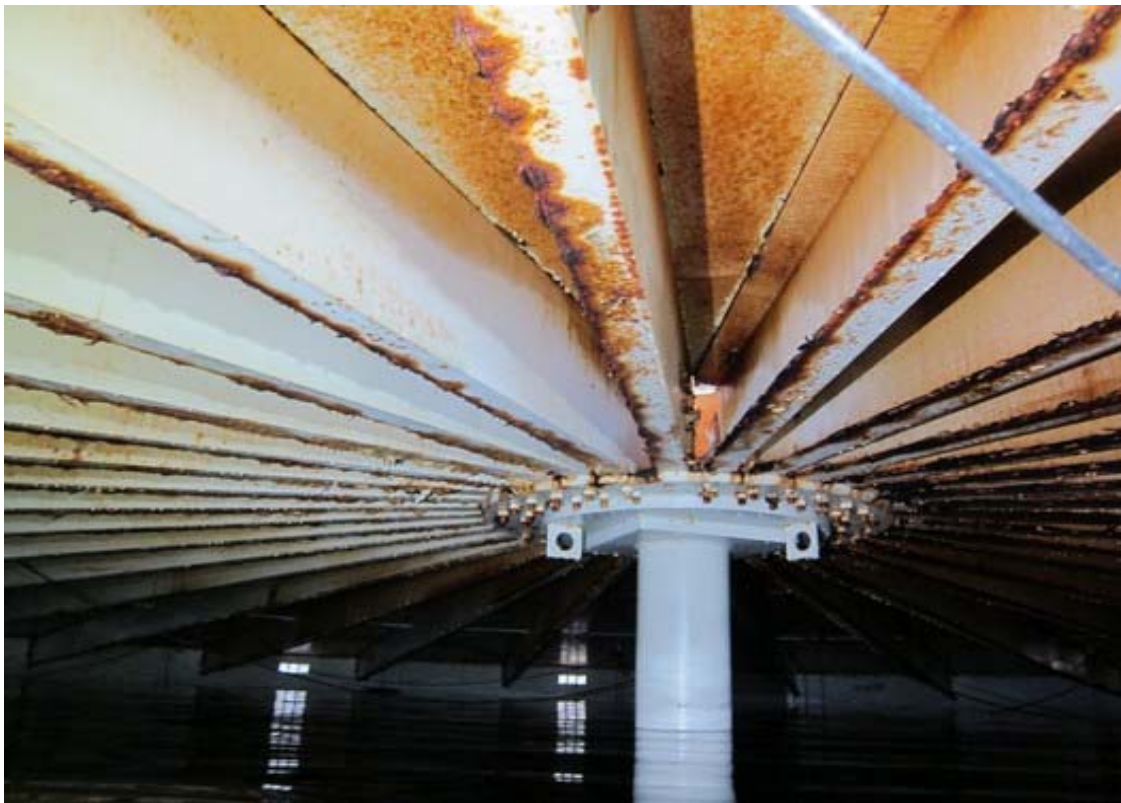
MG #2 existing roof plate, interior center support and rafters to be replaced.

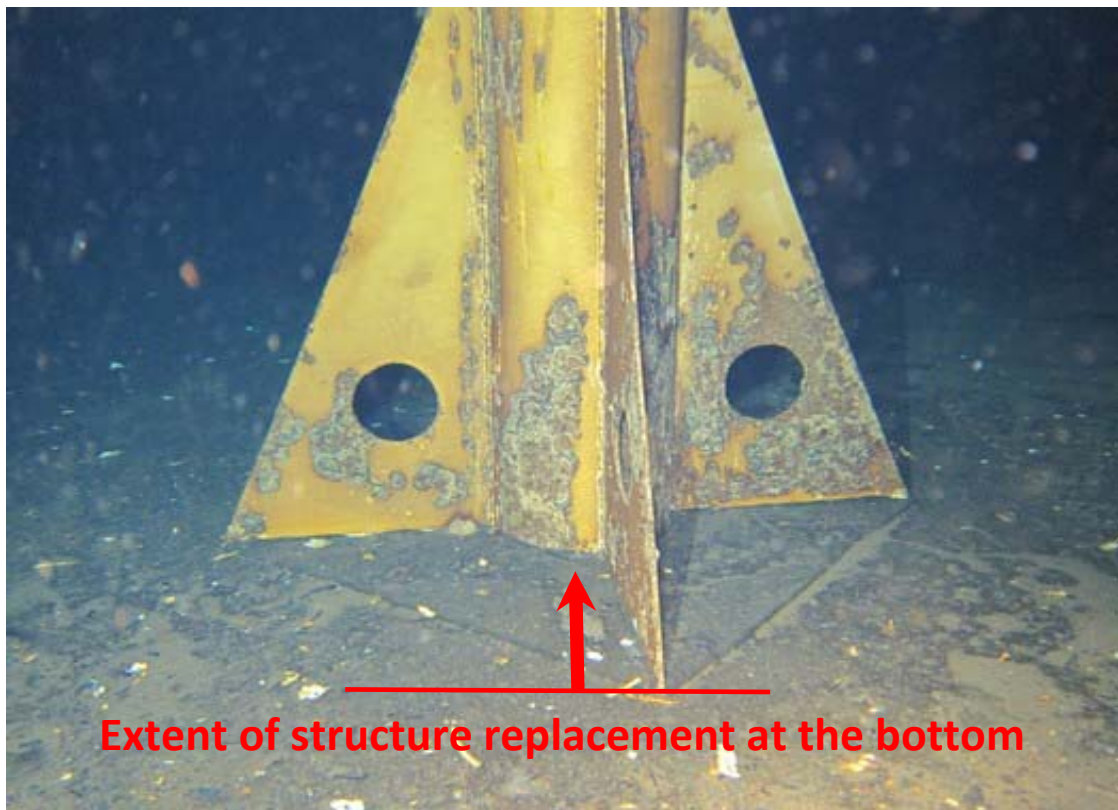
Existing MG#2 center column base plate and extent of roof structure replacement at the bottom.

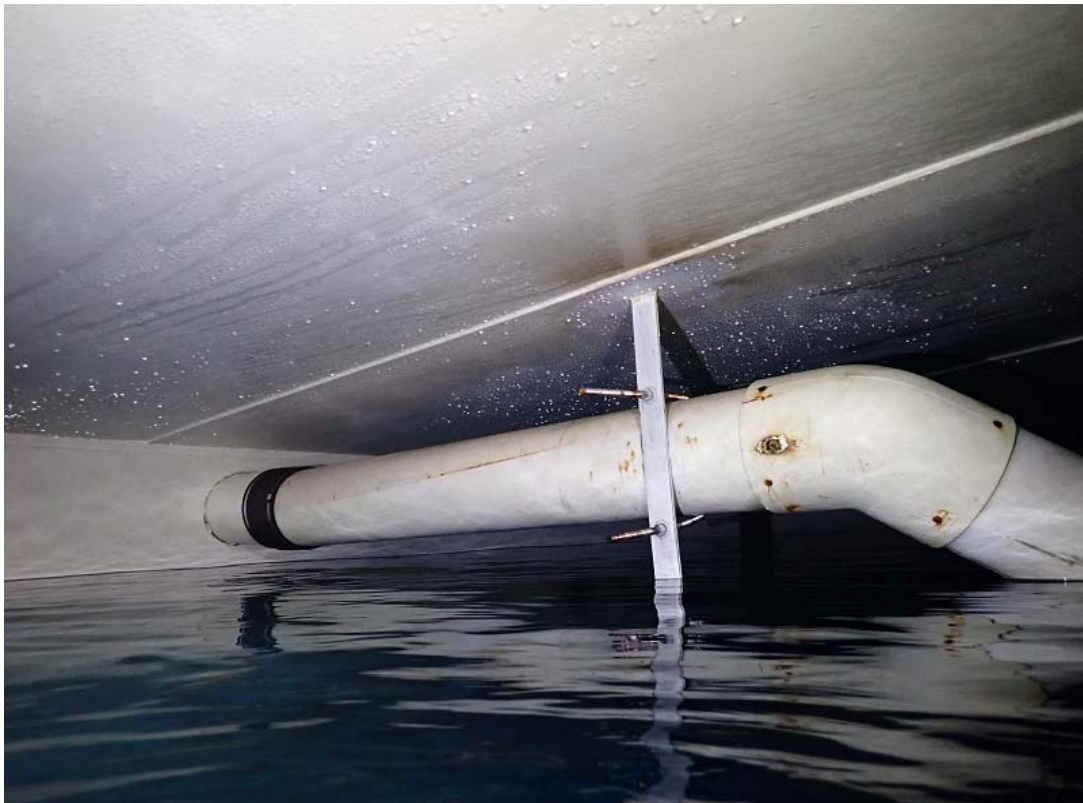
Acceptable support for PVC high inlet as shown on MG tank #1.

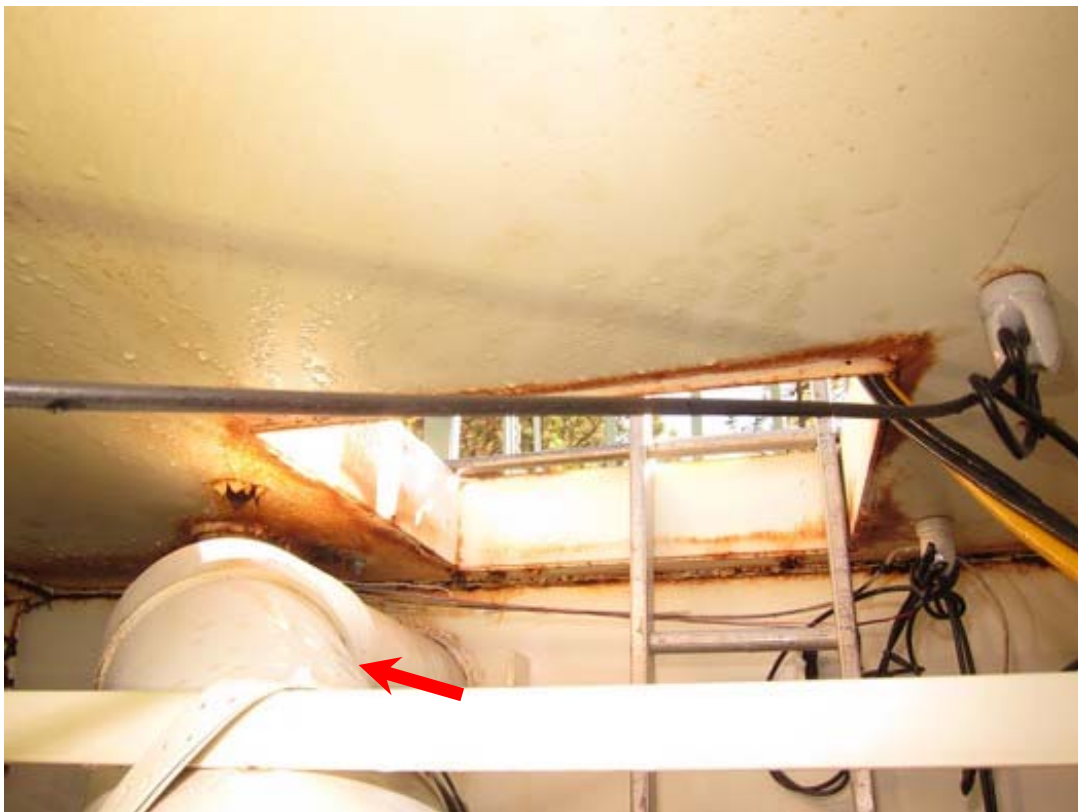
Existing PVC in high inlet pipe on MG#2 that will require protection during work and support from the new roof.

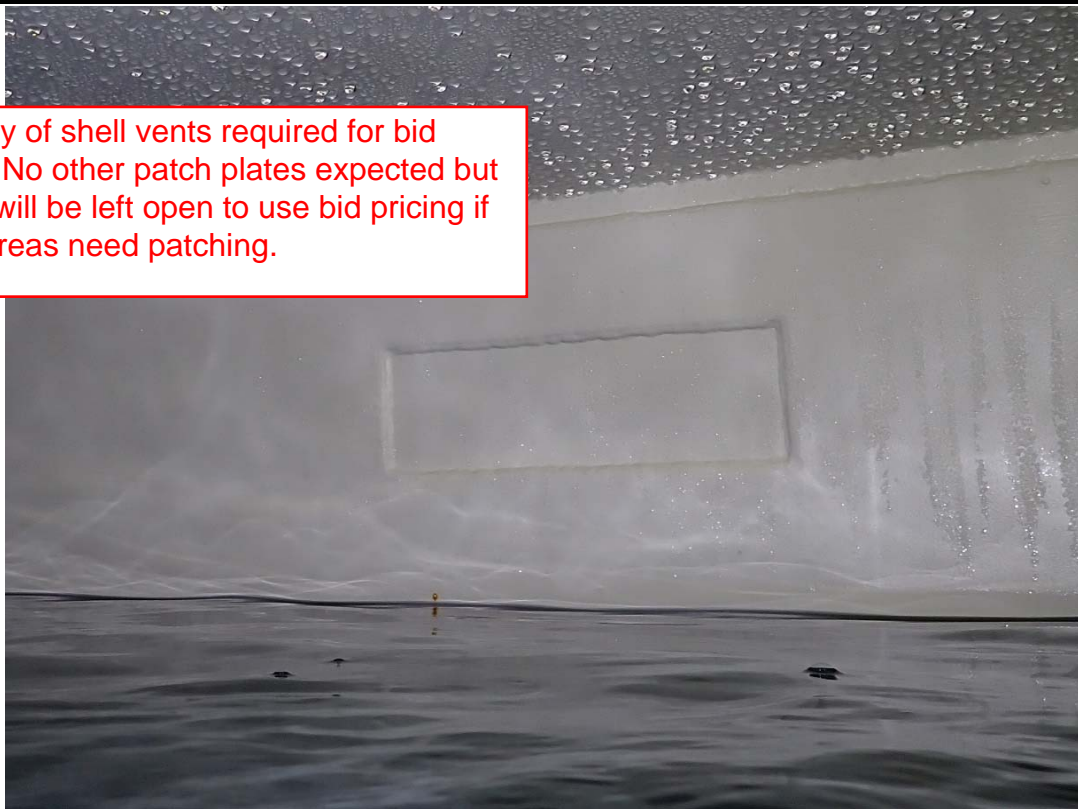
View of acceptable shell vent closure.

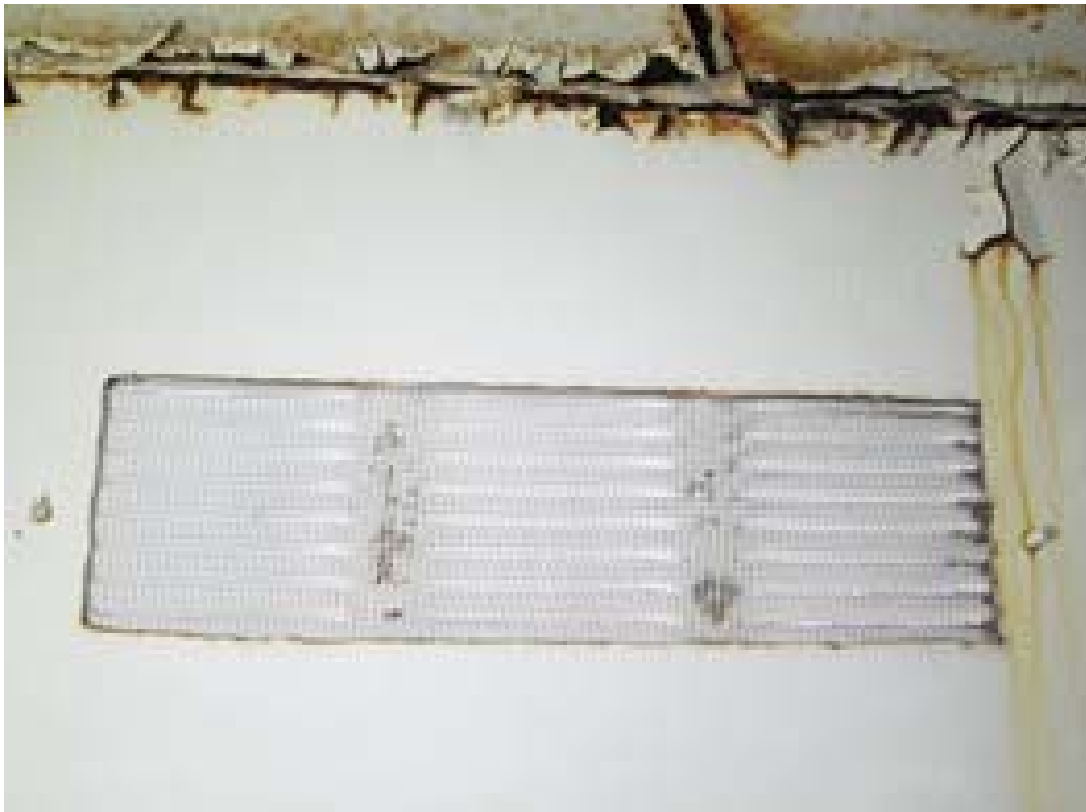
View of typical existing shell vent. Cover plates are to be installed as part of the Work.
