APPENDIX C
Dive Inspection Reports – Existing Welded Tanks

**INSPECTION REPORT FOR THE
TWIN HARTE COMMUNITY SERVICE DISTRICT'S
MILLION GALLON TANK #1
DECEMBER 29TH, 2017**

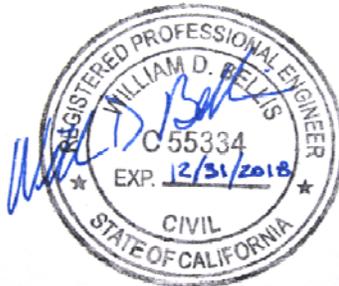
Registered Civil Engineer, CA C55334

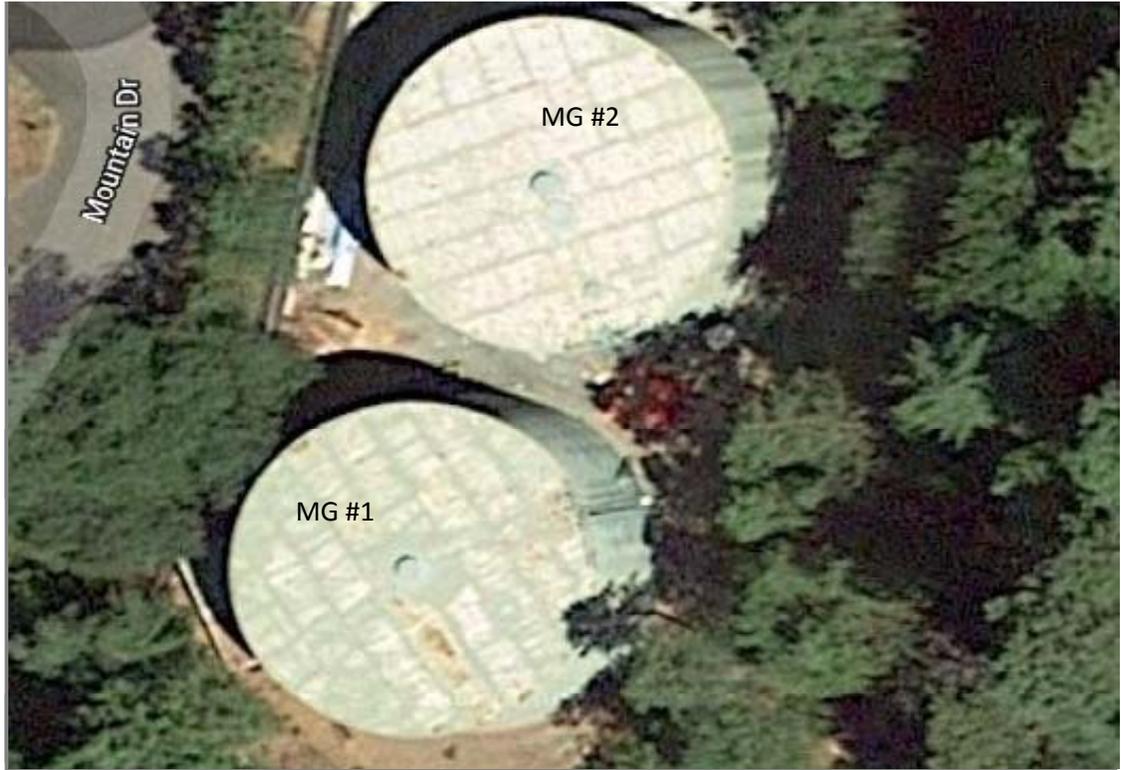
Plan view of the tank site.

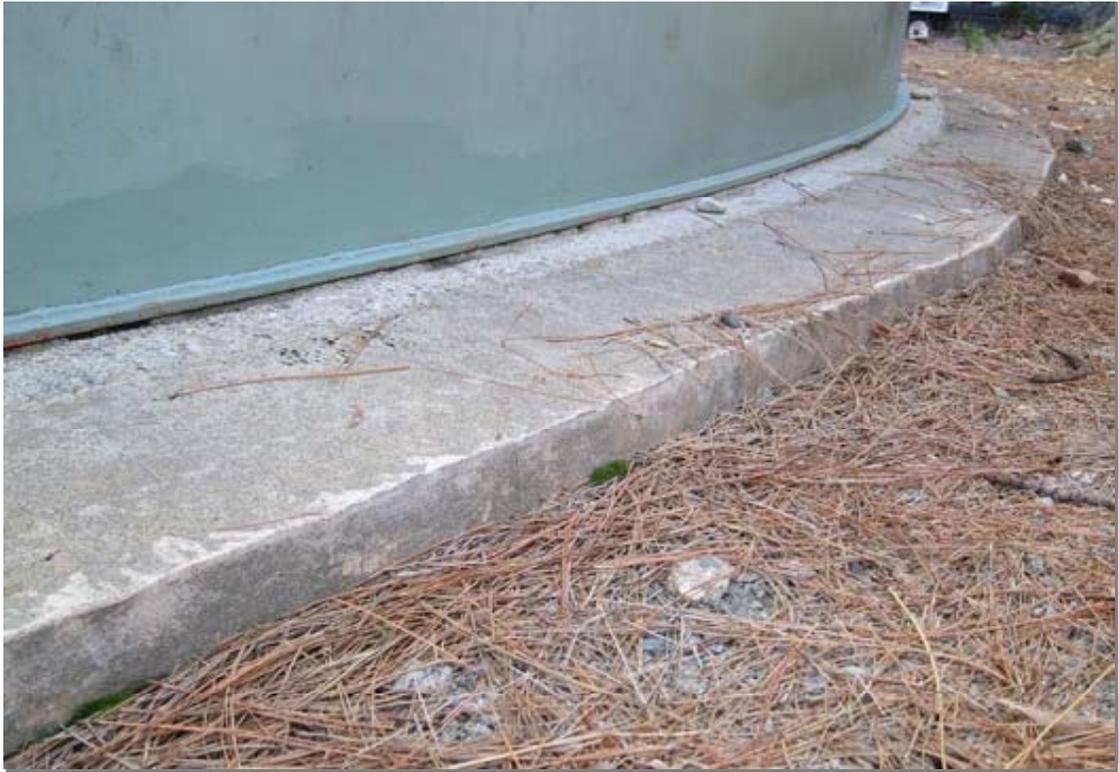
Lower shell and concrete footing. No significant corrosion points were identified. Some significant cracks and concrete corrosion are present in the concrete.

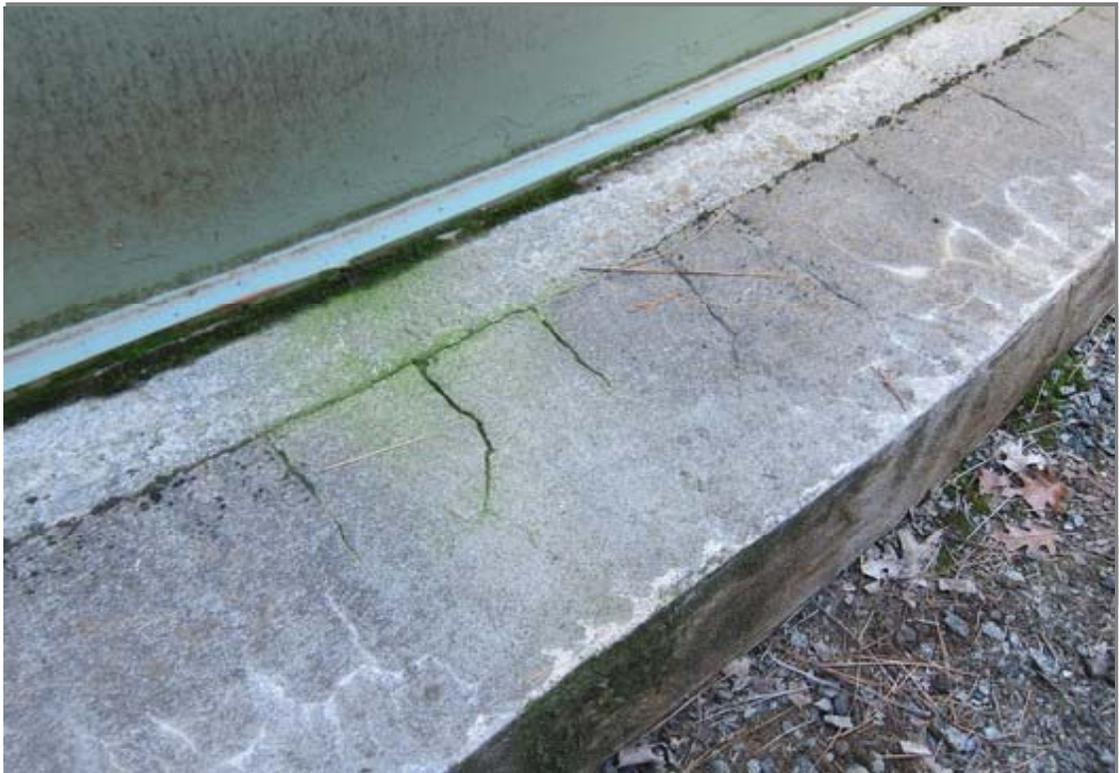
This photo is a closer view of the area shown in the top photo of this page.

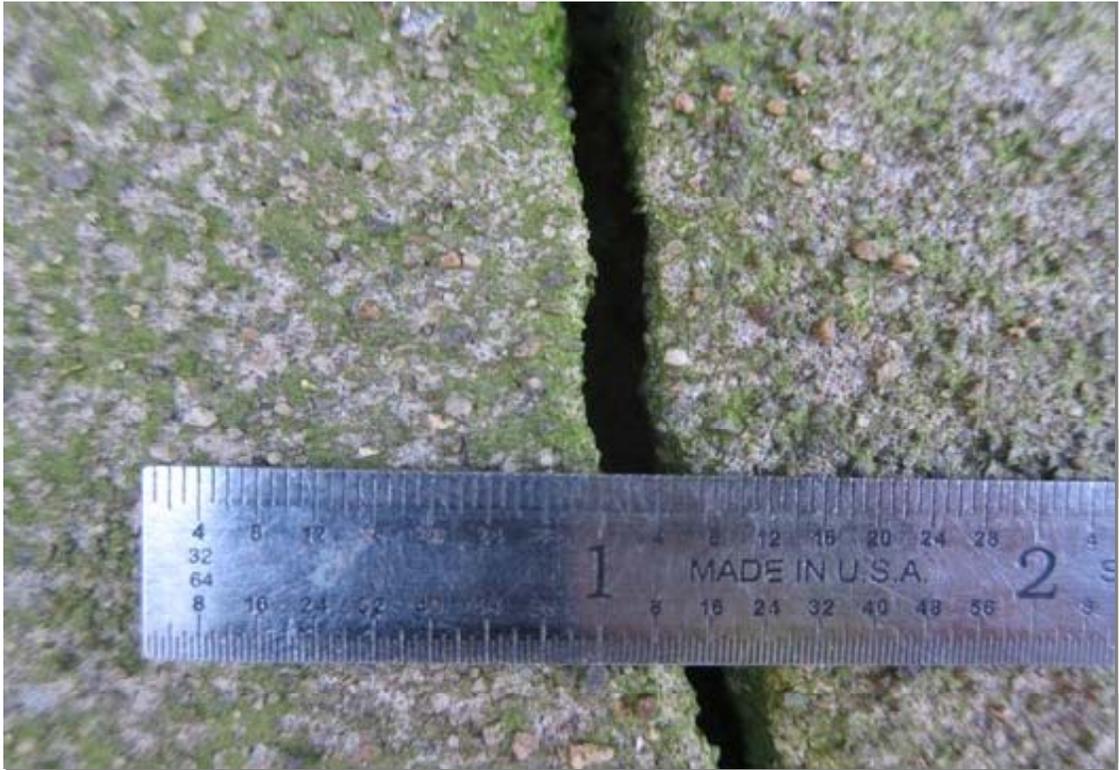
This view of a typical crack in the concrete footing shows approximately 3/16 width"

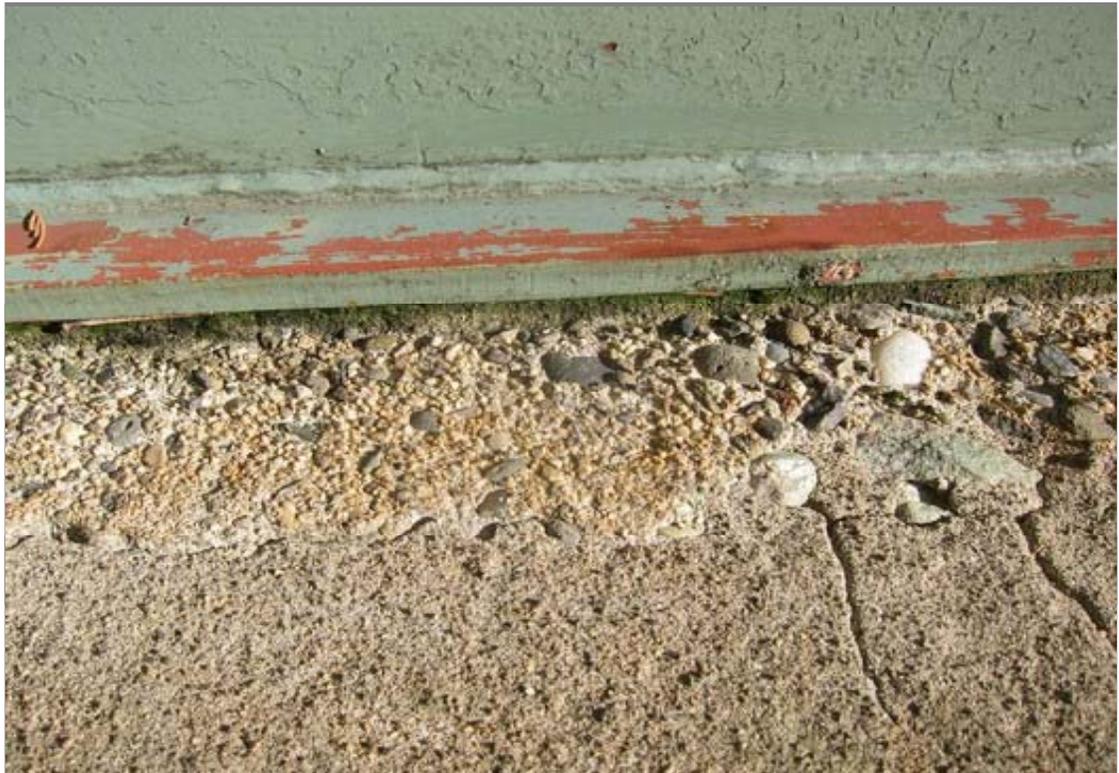
Corrosion of the concrete on the southern side of the tank. Cementitious material is lost but not aggregate. The 5/8" annular ring is visible extending outward from the bottom.

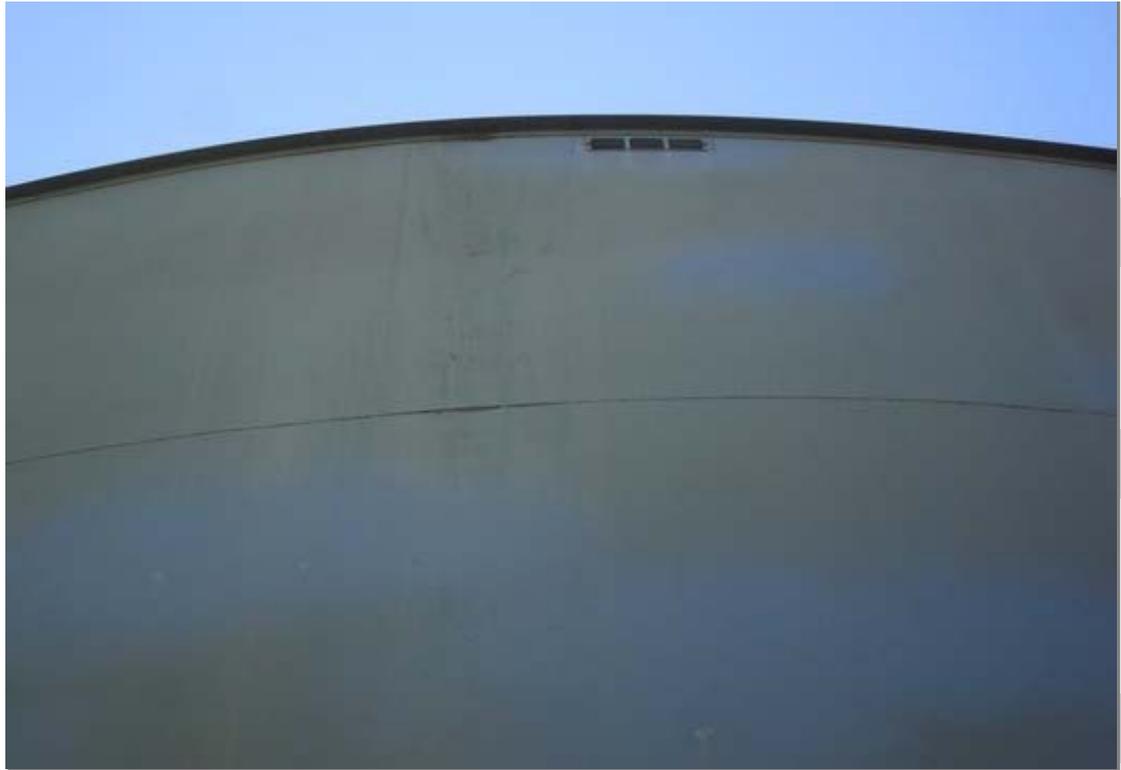
This view represents the typical conditions on the upper shell and shell to roof joint. The upper shell is in good condition with only minor corrosion points noted.

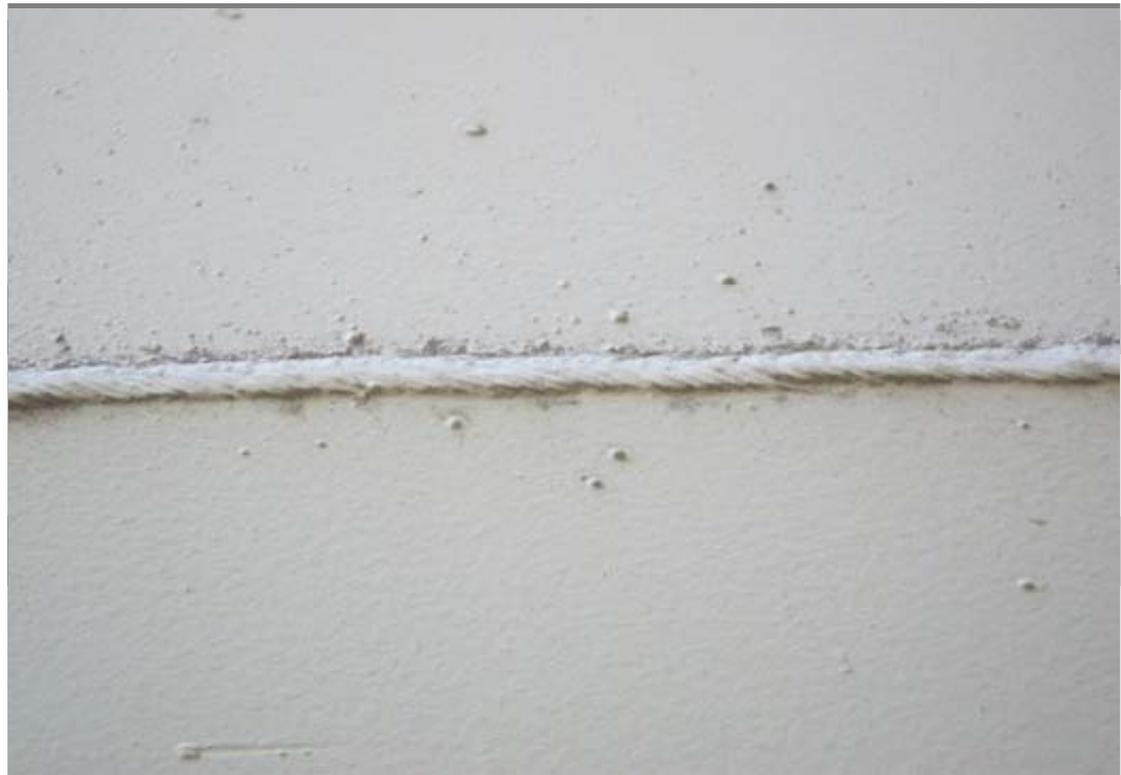
Welds on the exterior shell are rough and spatter is present in many locations. This is common with older tanks where cellulosic "stick" electrodes were used.

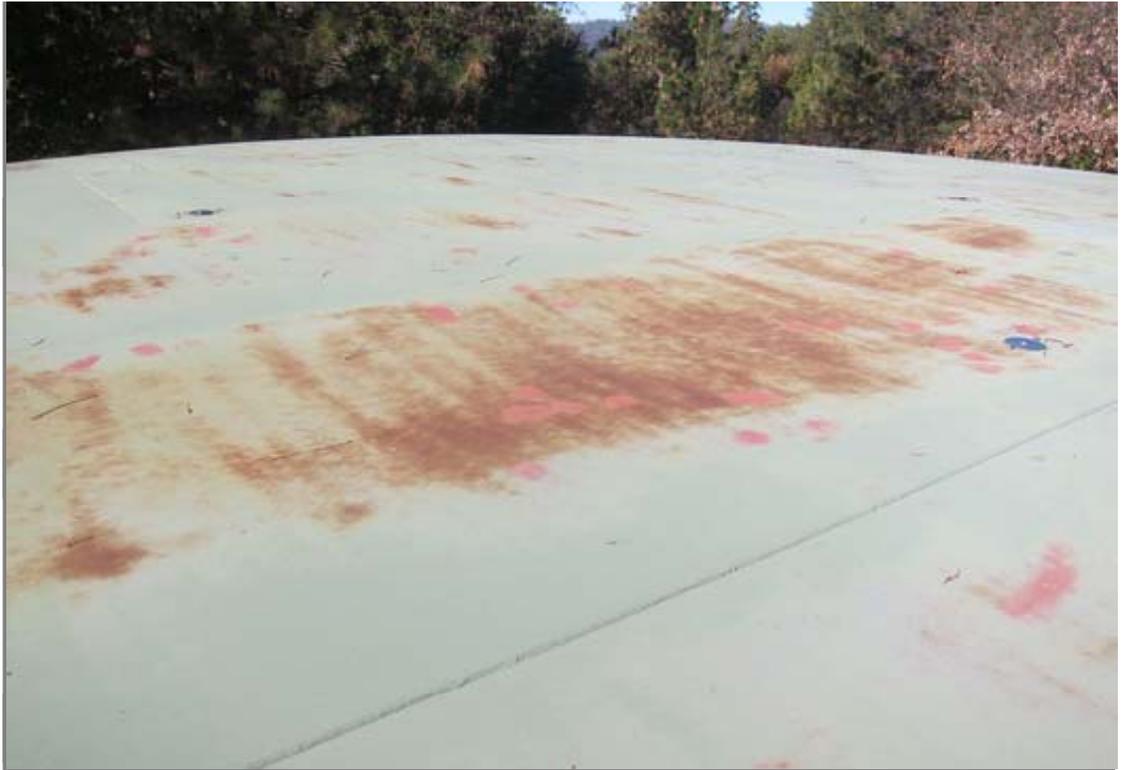
This view indicates the overall condition of the roof. The roof plate (steel) is in good condition but coatings are failing as indicated by the presence of general corrosion.

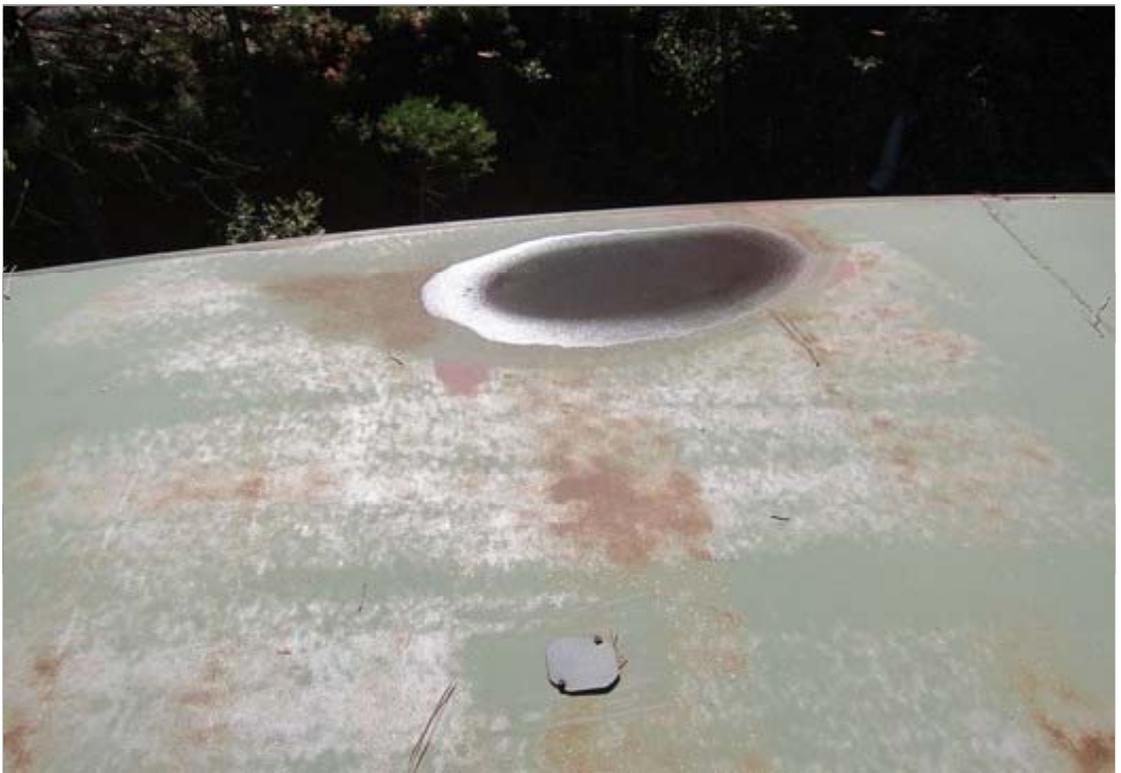
Close view of a ponding area with corrosion. Submersed exterior coatings pose a maintenance challenge.

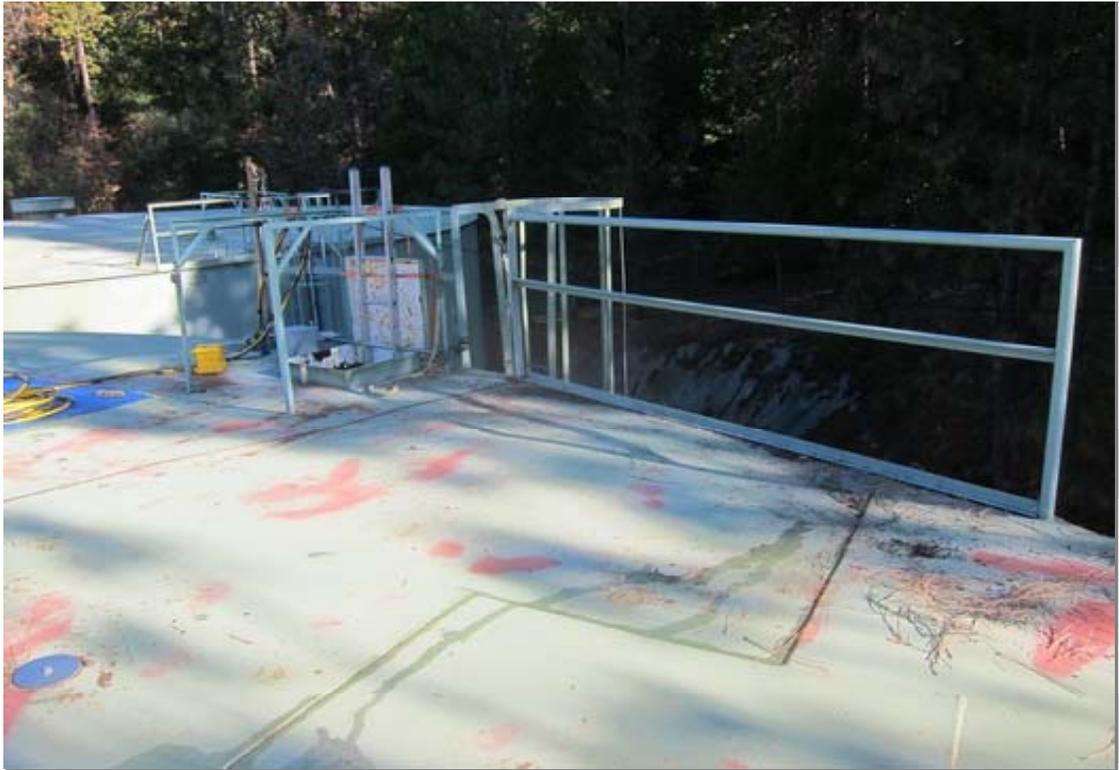
The photo above shows the roof hatch area with guardrail.

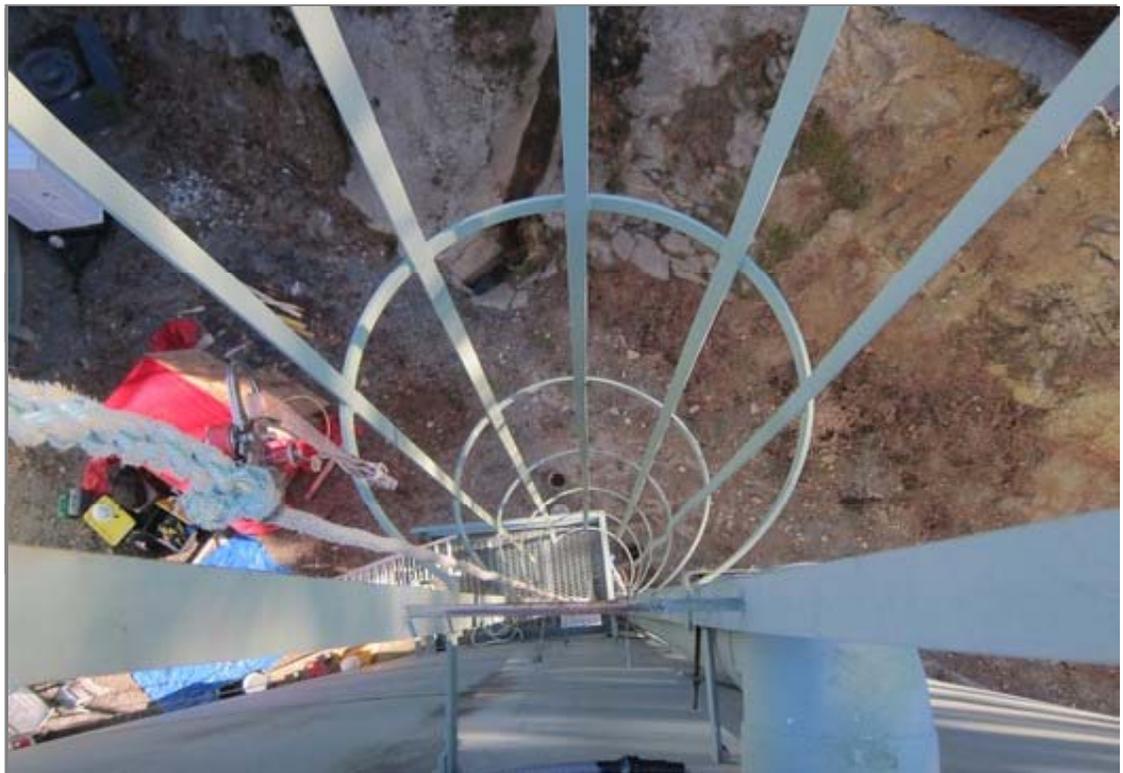
This view from the top of the exterior ladder and cage.
No significant corrosion is present. The rung width is 15".

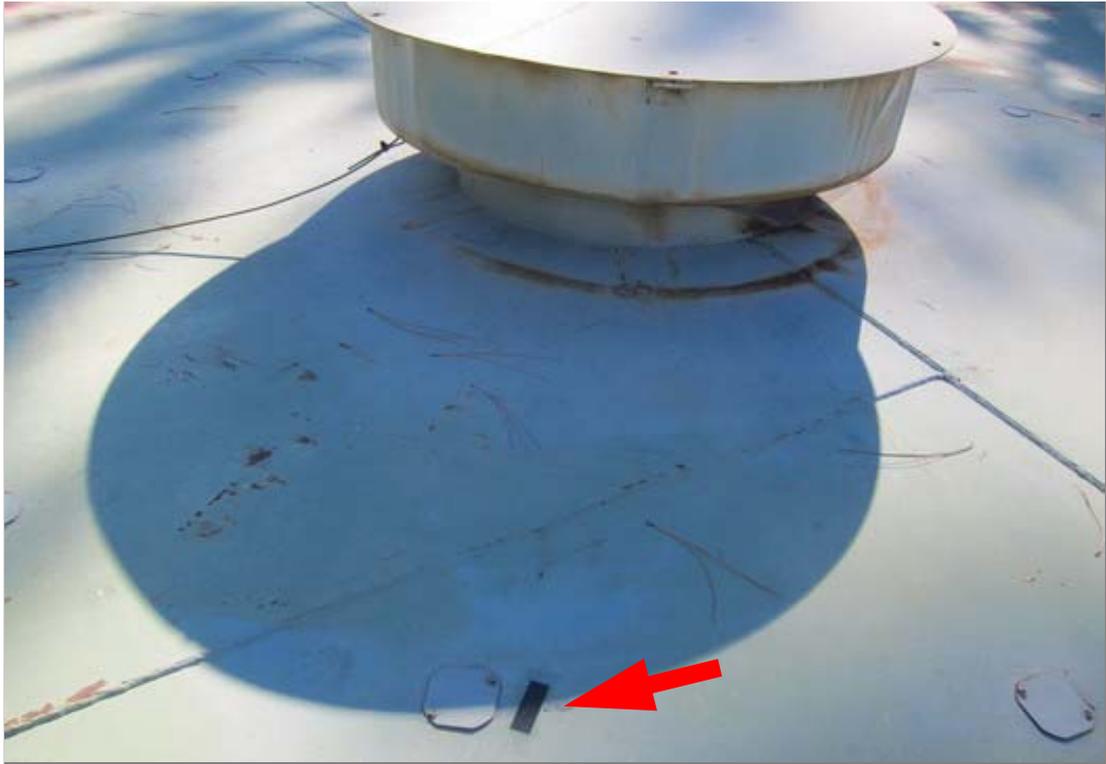
The roof vent consists of a steel cover over a steel riser pipe. The location identified by the arrow is a drilled hole that was temporarily sealed with tape by ATS, Inc.

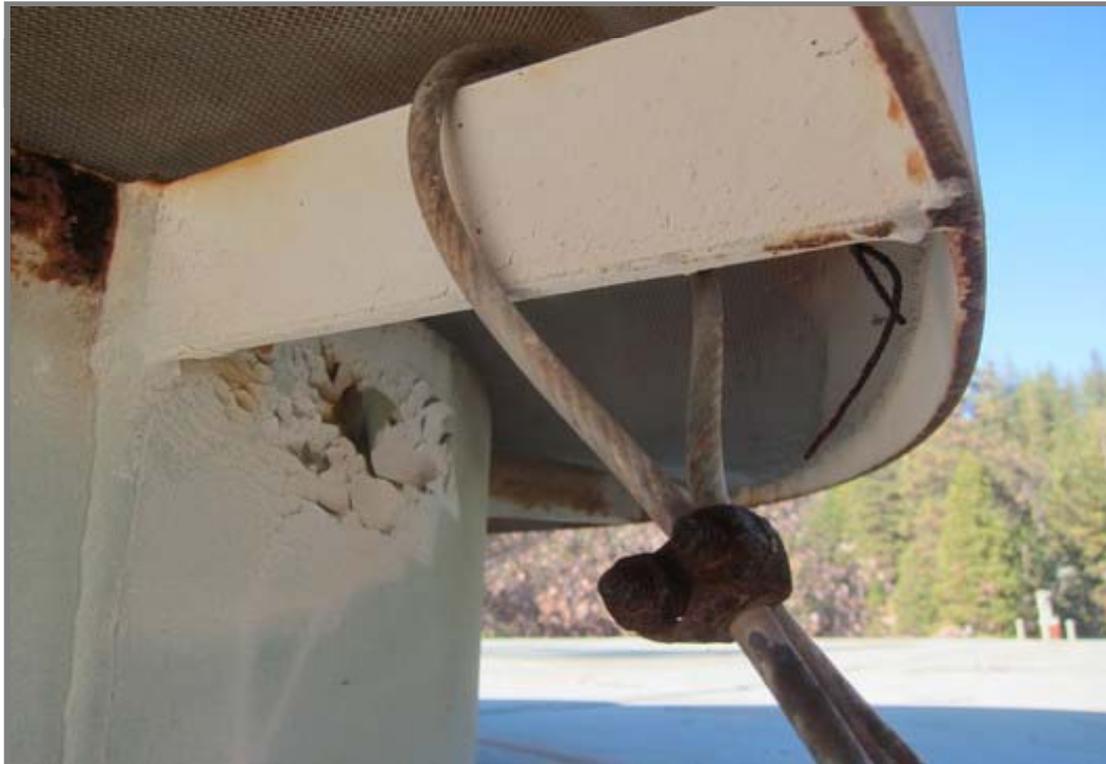
This view of the underside of the vent hood shows that the screen is in good condition. Corrosion is present on the riser but the screen appeared to be bug proof. It appears that this cable may be intended for fall protection but it appears to be inadequate.

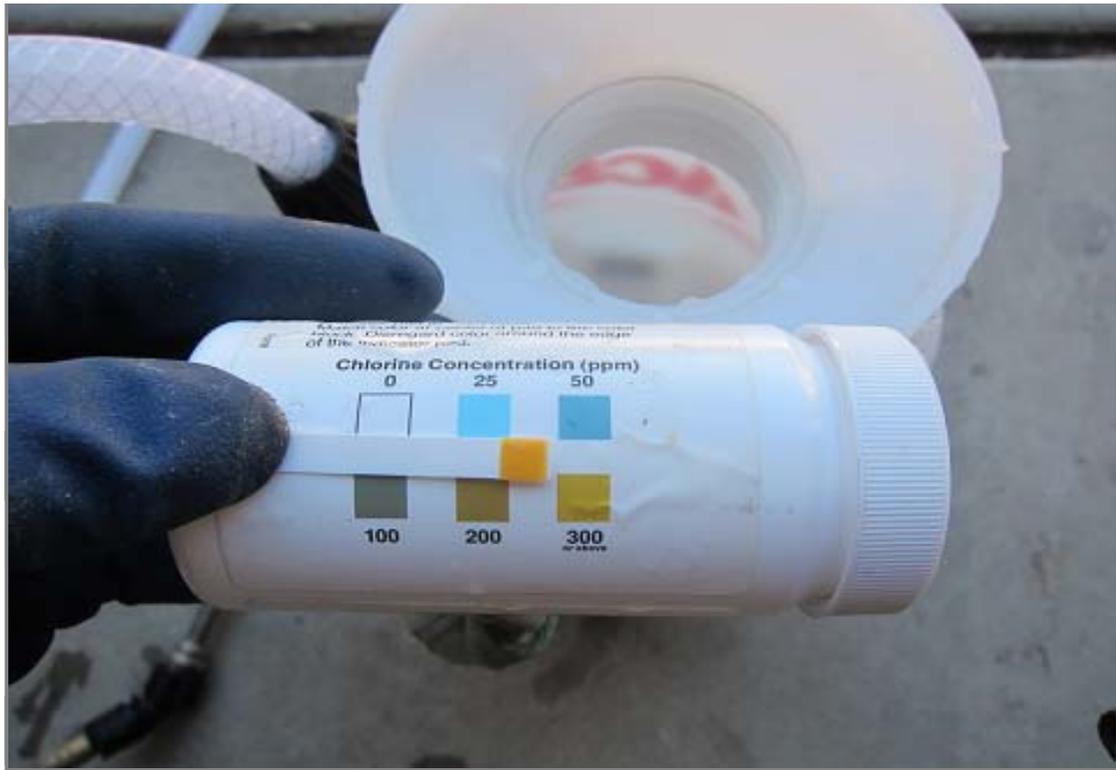
The disinfecting solution is tested to verify that it exceeds the 200 ppm free chlorine concentration level.

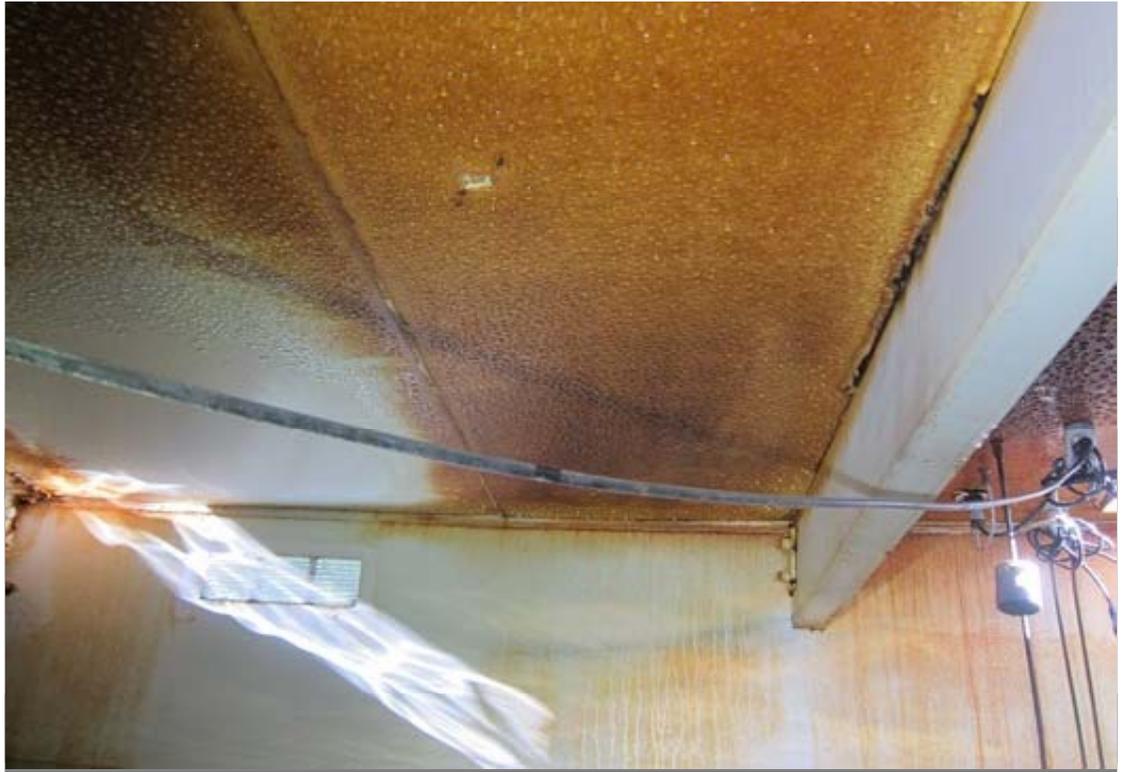
Upper shell and adjacent roof. Staining and general corrosion is present on most surfaces.

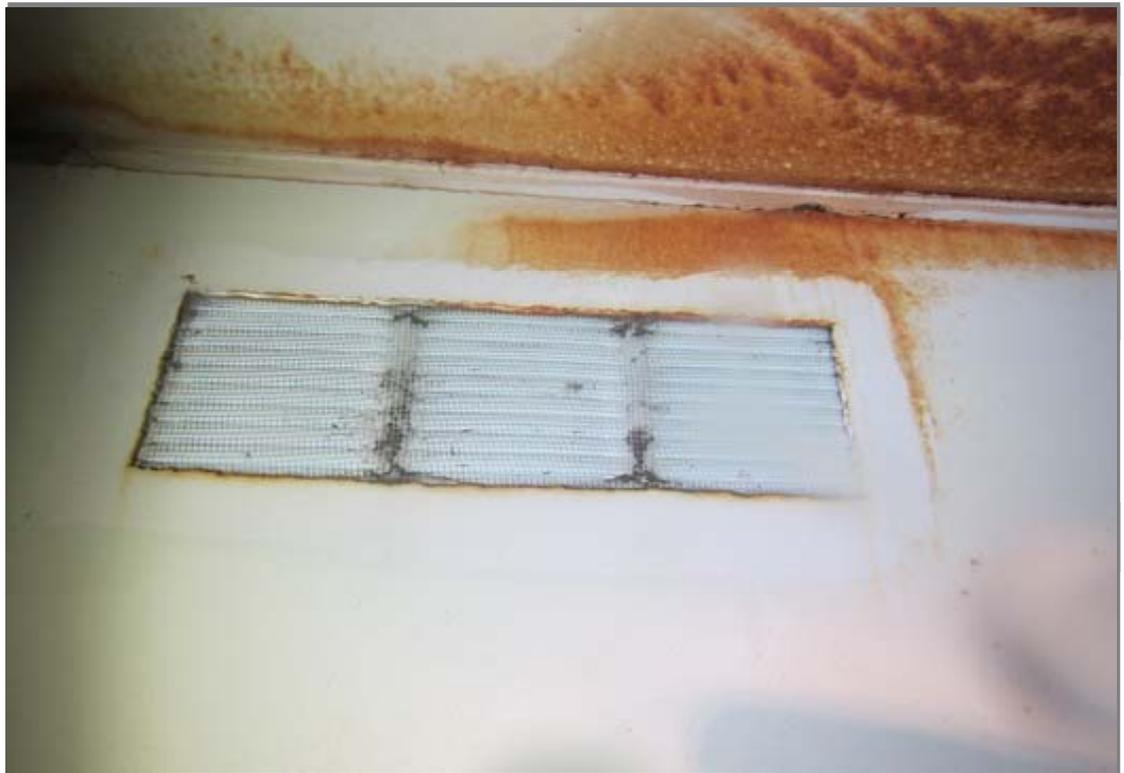
This is a close view of the upper shell showing one of the numerous shell vents.

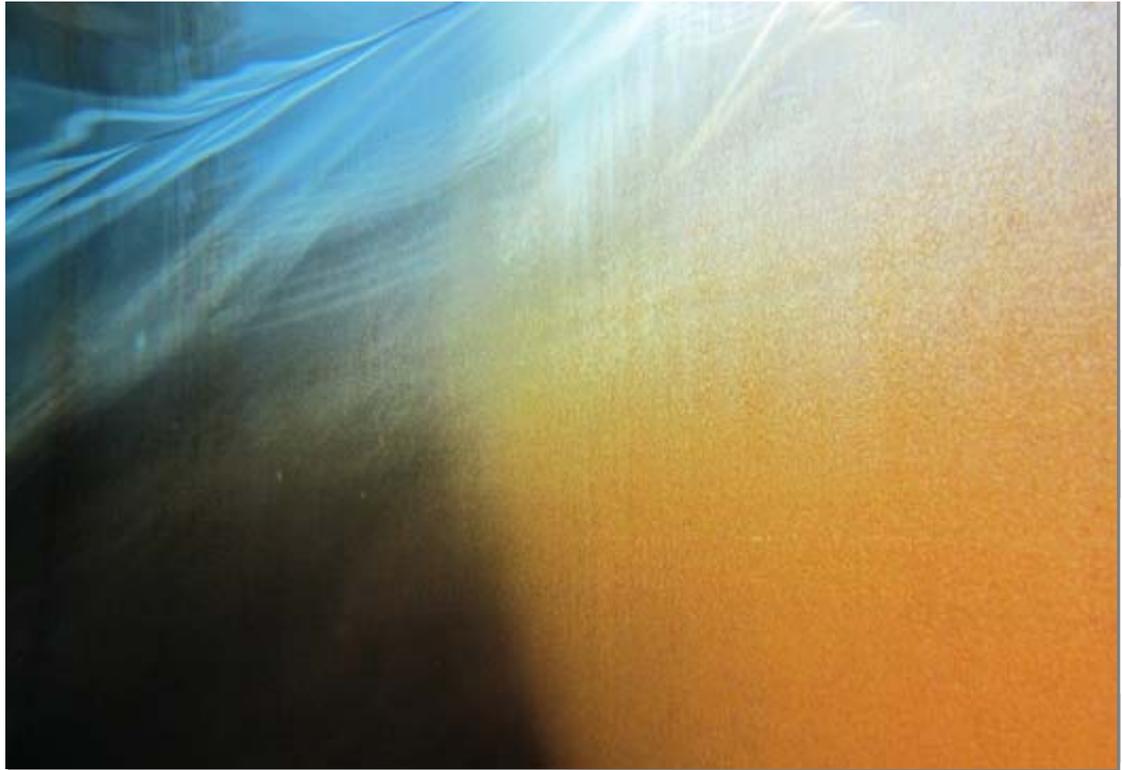
The photo above shows the interior shell just below the water surface (submersion zone). The rust color on the shell is staining.

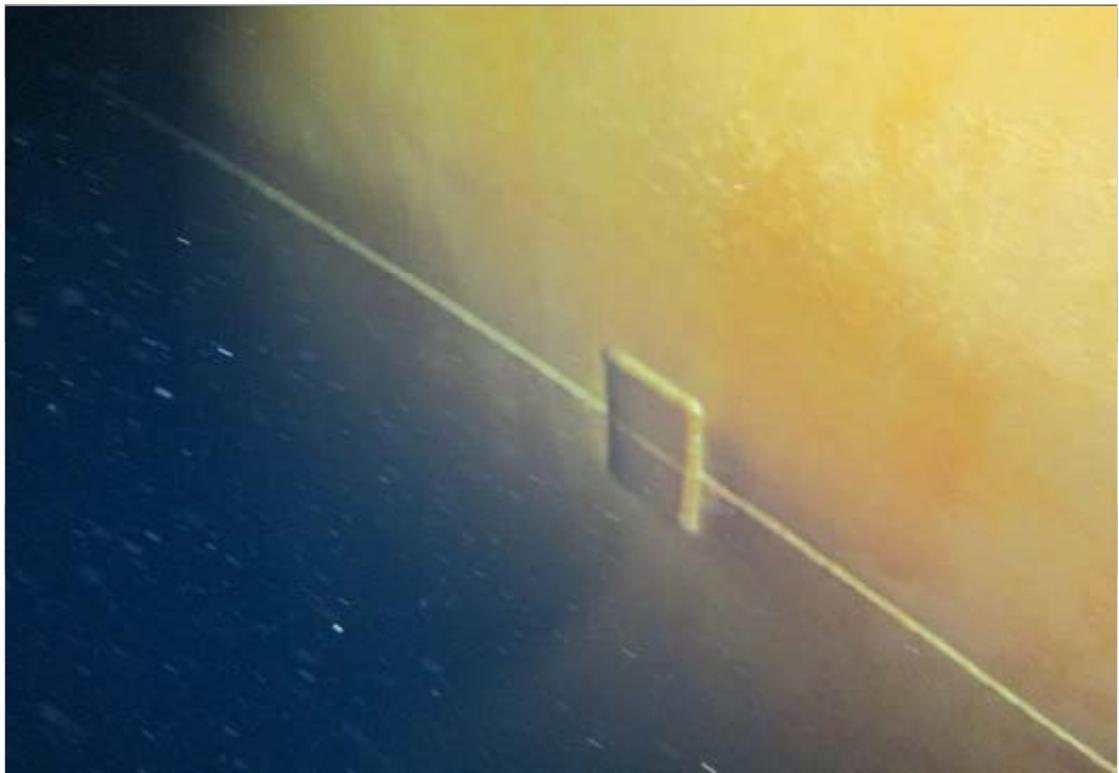
Interior shell in the submersion zone. This view shows a horizontal shell joint and a patch plate. The interior shell appears to be in good condition overall.

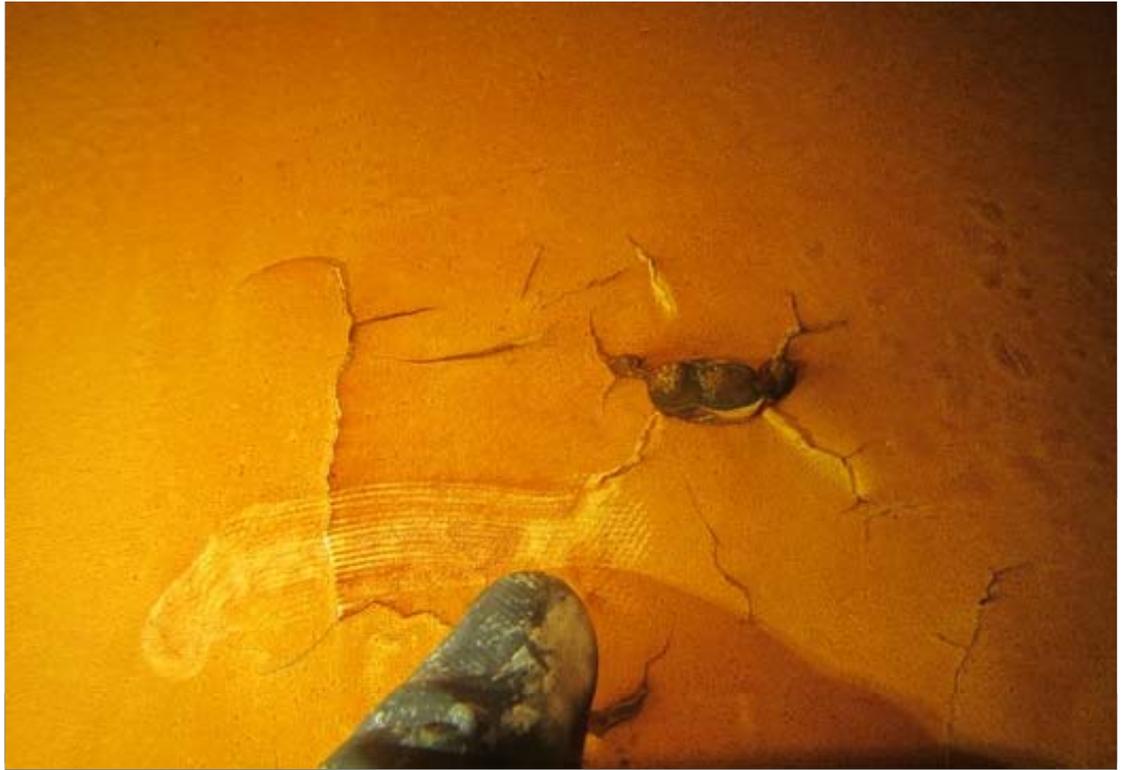
Interior shell in the submersion zone. This view shows one of approximately 20 areas of damaged coating in the lower shell. The coatings have cracked and corrosion is present.

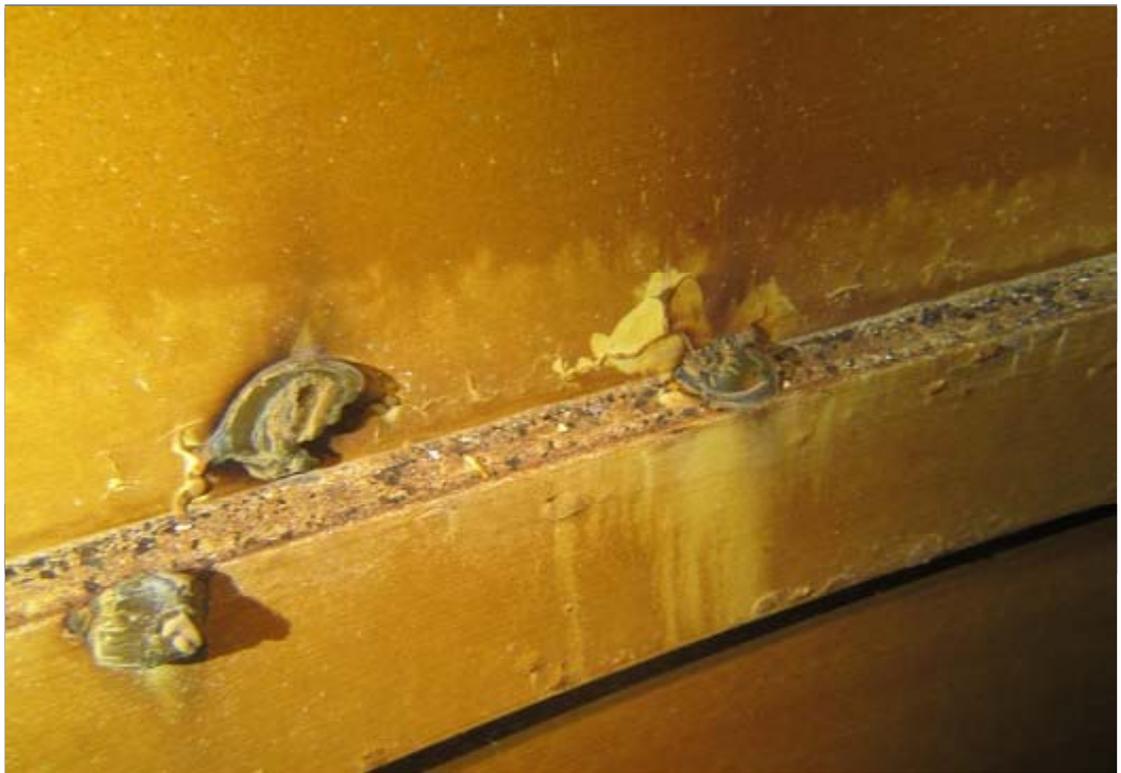
An additional view of corrosion nodules on the interior shell. The area shown is where a shell opening (door sheet) was cut and rewelded upon completion of the work. This area has a particularly high concentration of coating failures.

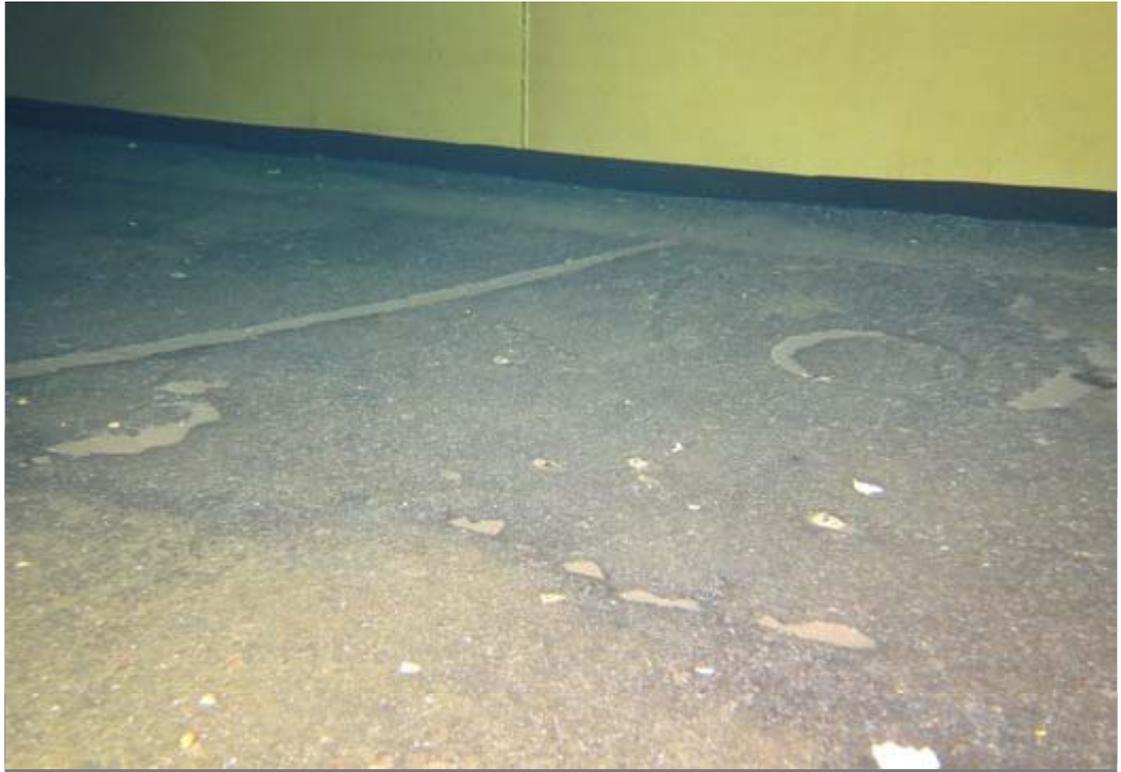
Lower shell and tank bottom. Coatings are in good condition overall in this zone.

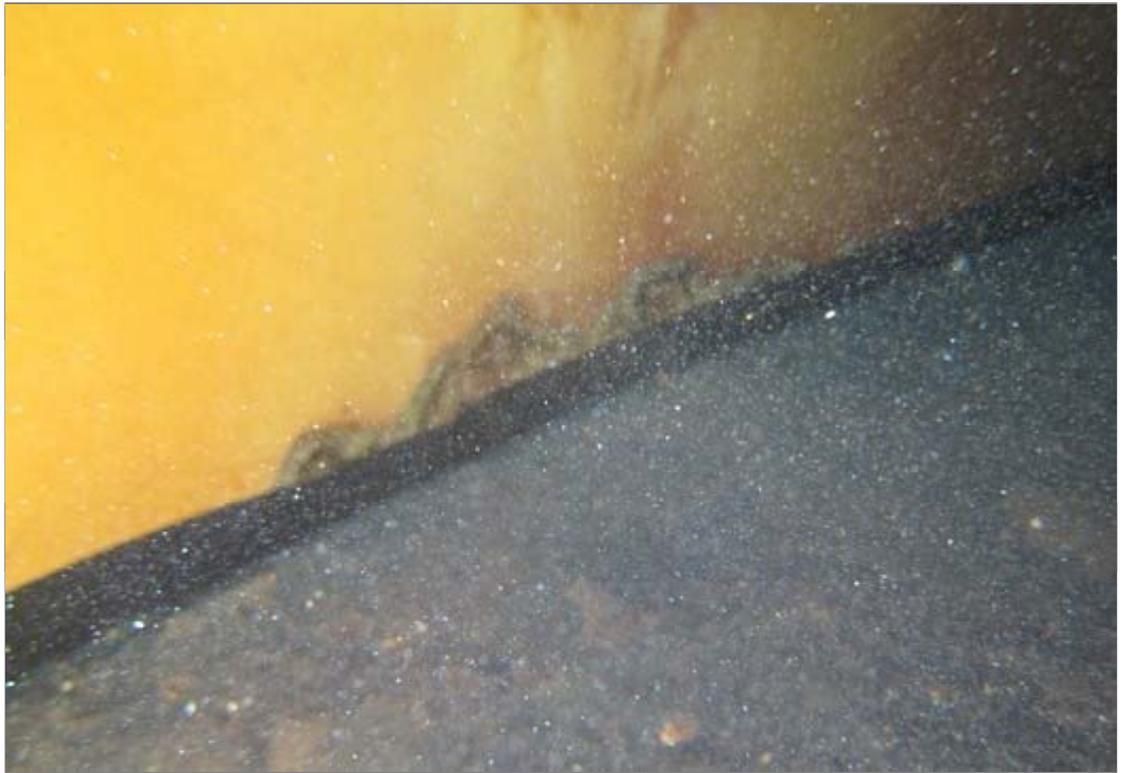
This photo shows an area of the lower shell where coatings are failing. This is an example of the worst condition in this zone.

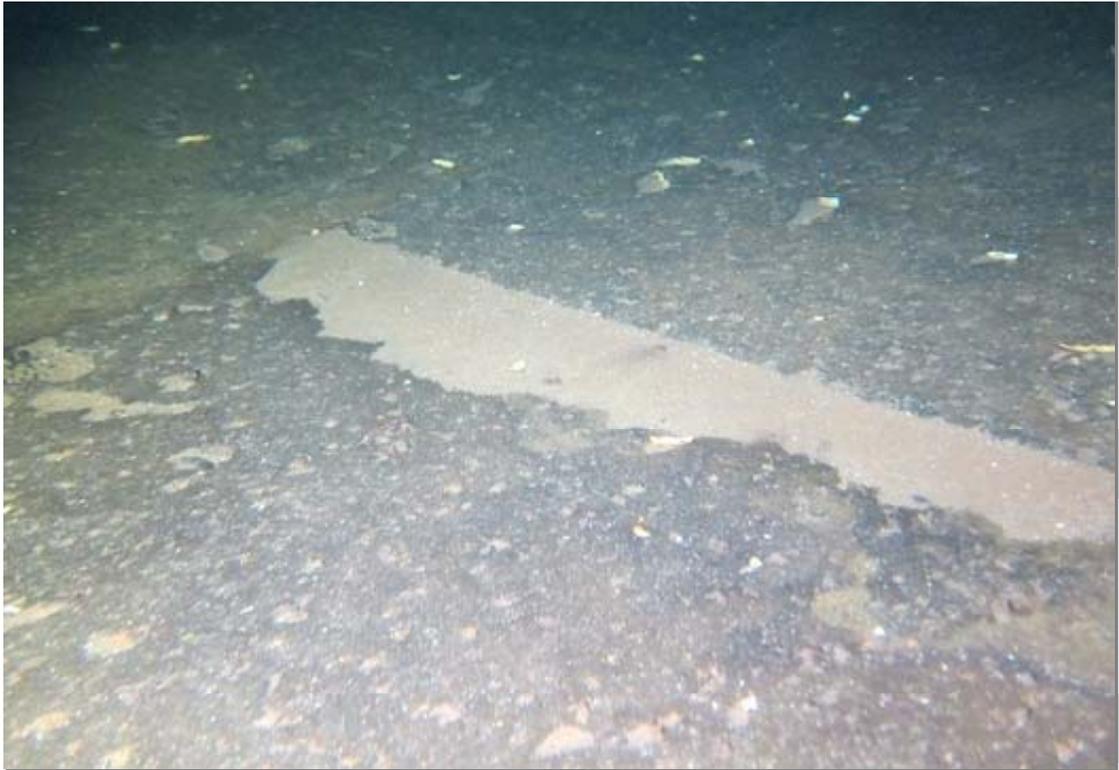
This photo shows the typical condition of the bottom. Sediment removal was not completed with this inspection.

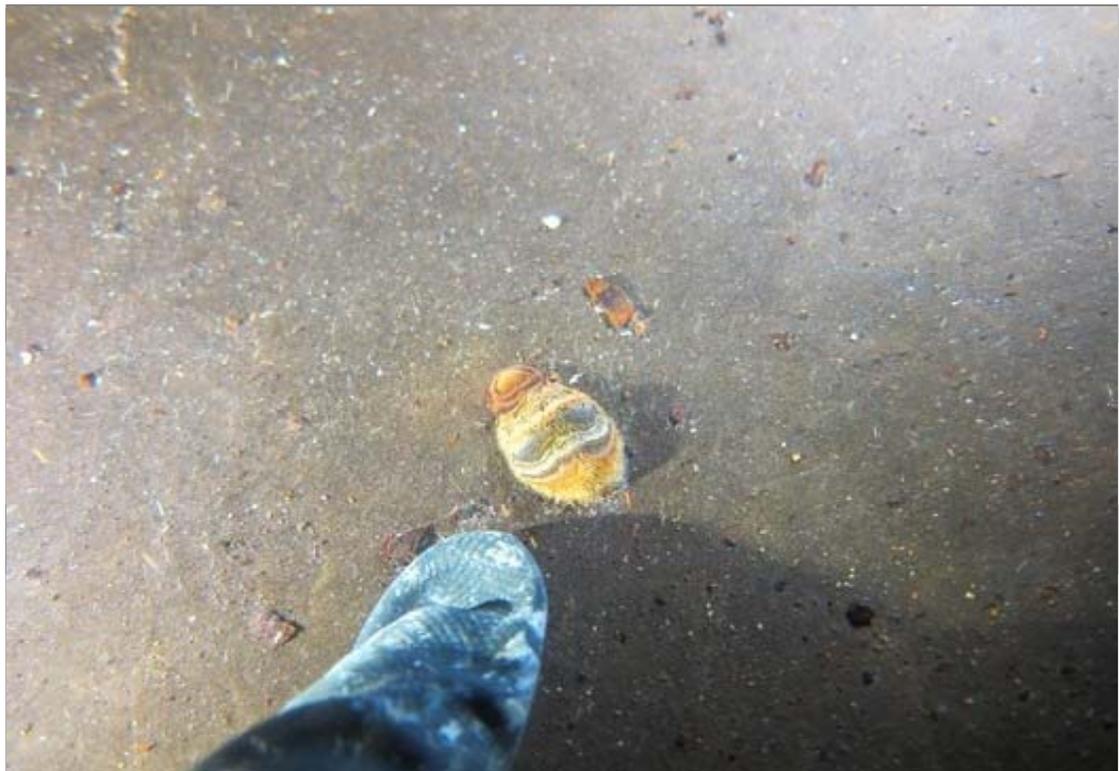
This view shows a rust nodule on the bottom with the diver's finger also visible. This nodule is representative of the scattered corrosion points found on the bottom.

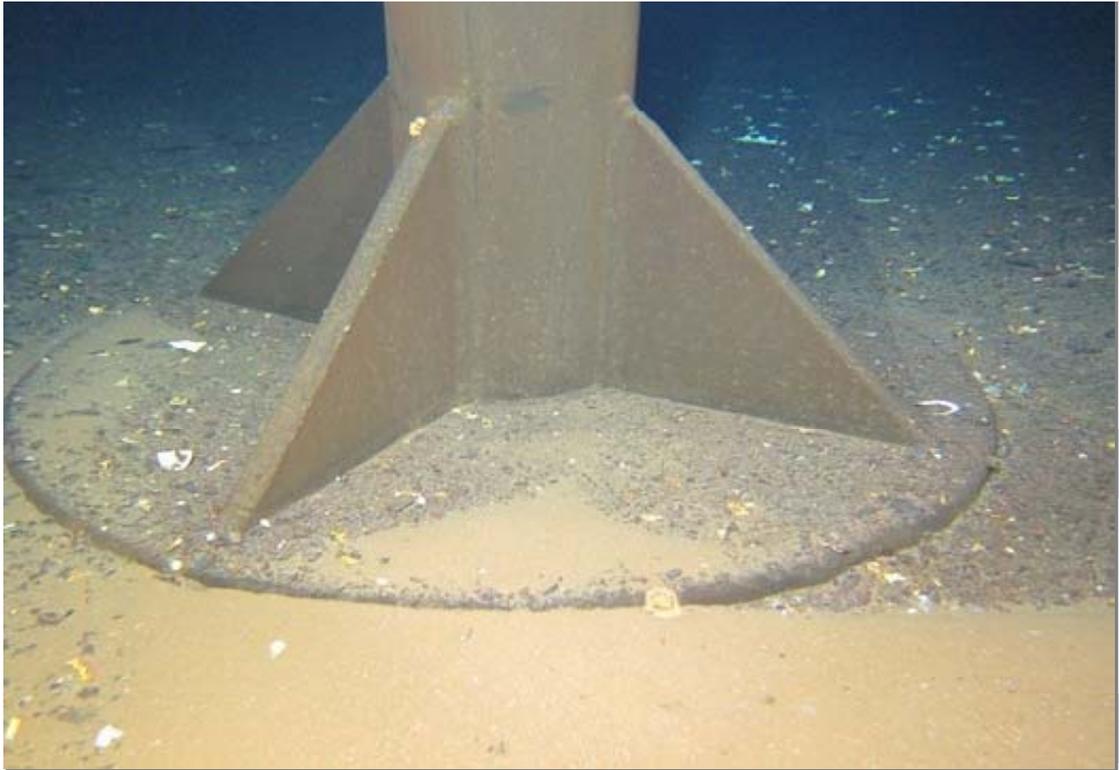
This view shows the column base plate and adjacent bottom plate. Coatings are in good condition overall on the column and base plate. Approximately 10 corrosion points are present along with some associated metal loss.
