APPENDIX C
Dive Inspection Reports – Existing Welded Tanks

**INSPECTION REPORT FOR THE
TWIN HARTE COMMUNITY SERVICE DISTRICT'S
MILLION GALLON TANK #1
DECEMBER 29TH, 2017**

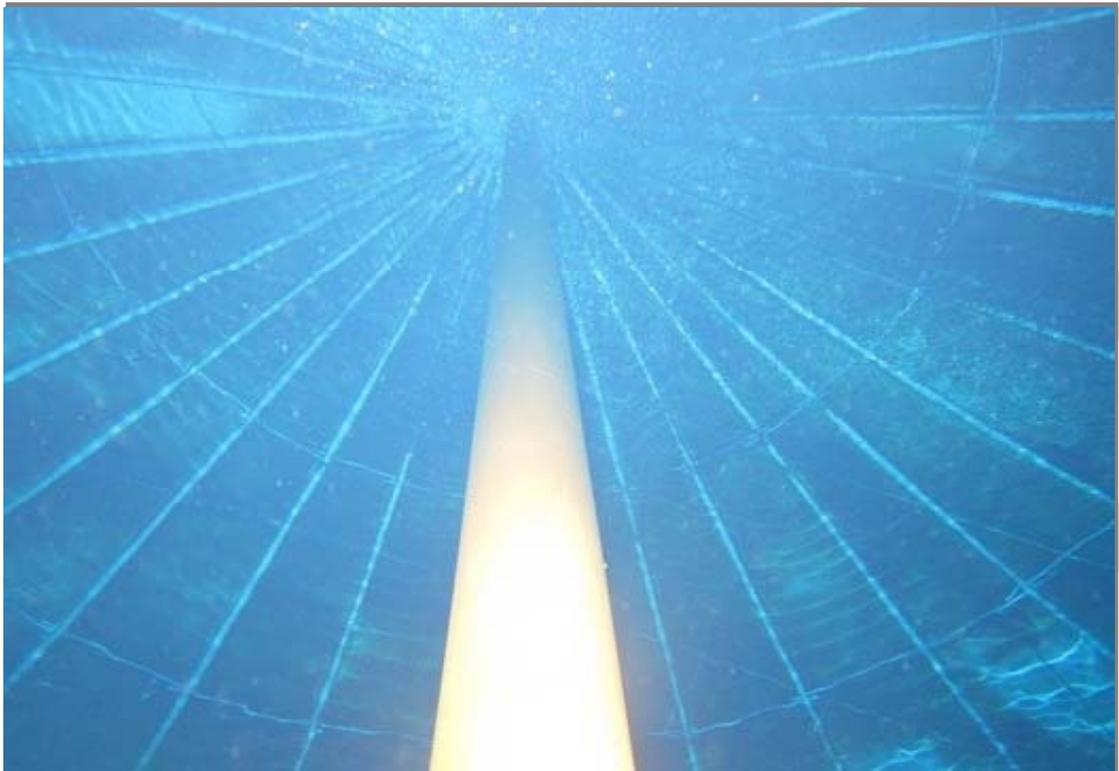
This shot was taken looking upward at the center column. The column is in good condition overall.

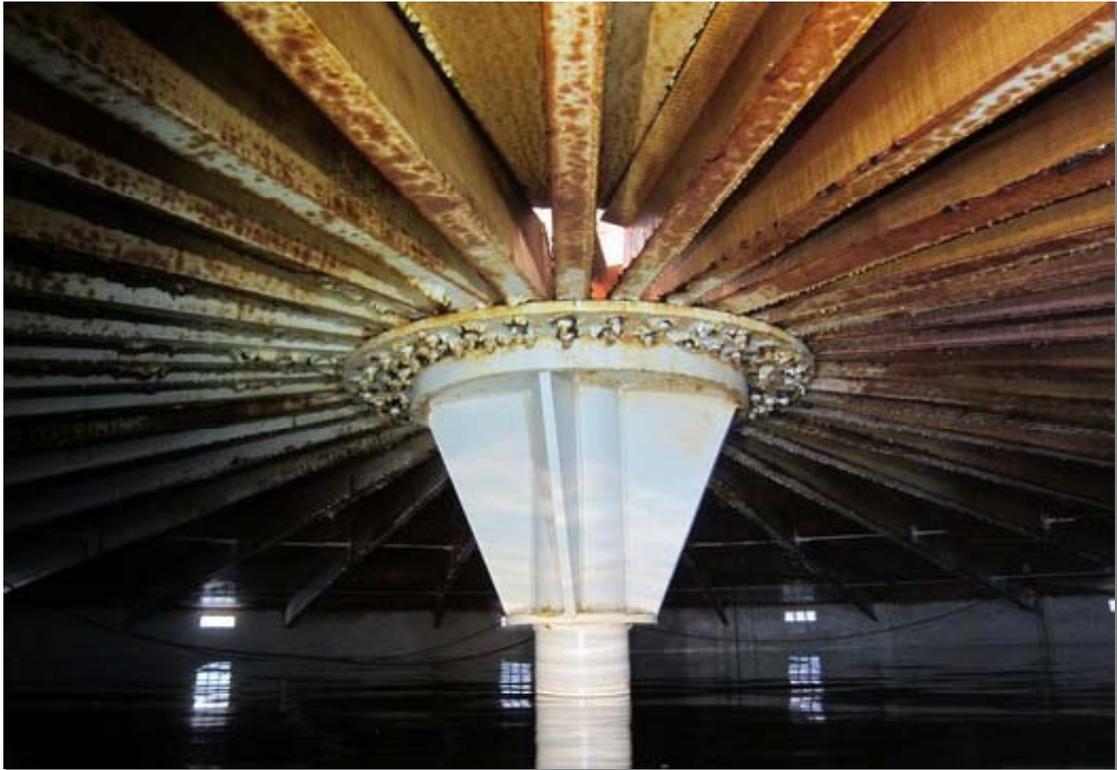
Upper center column, rafters and roof plate. Significant corrosion and associated metal loss are present.

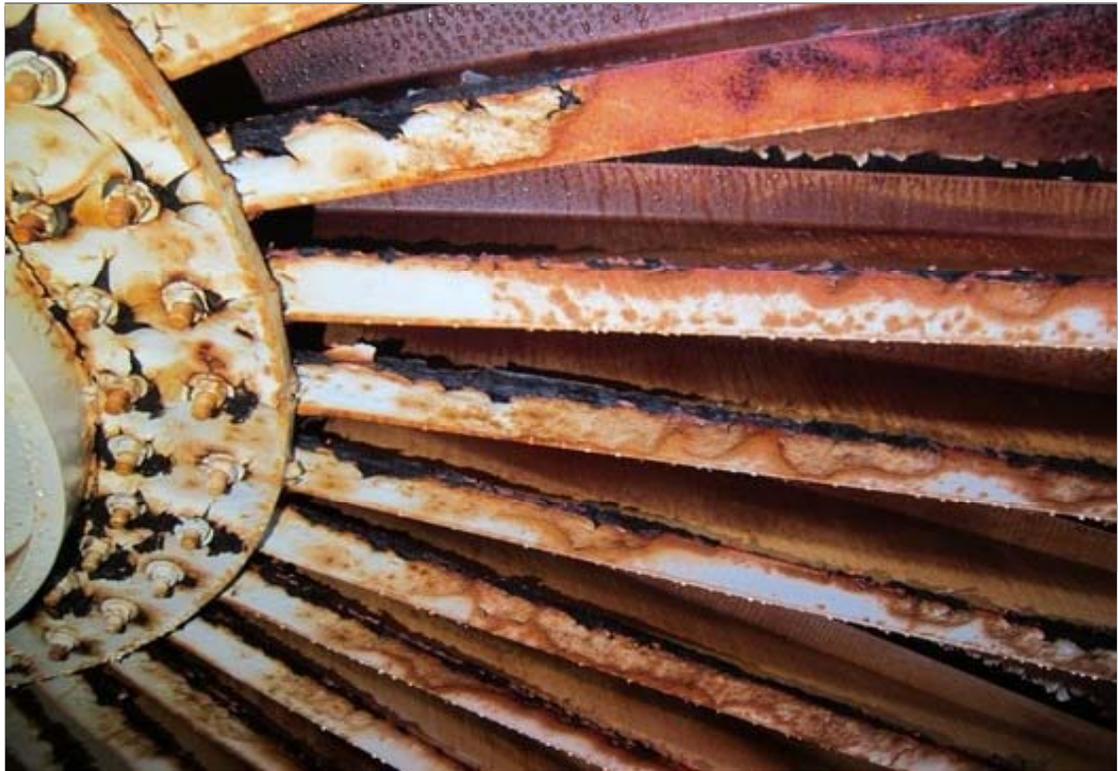
Close view of the center support and rafters. Coating failure and associated corrosion are visible.

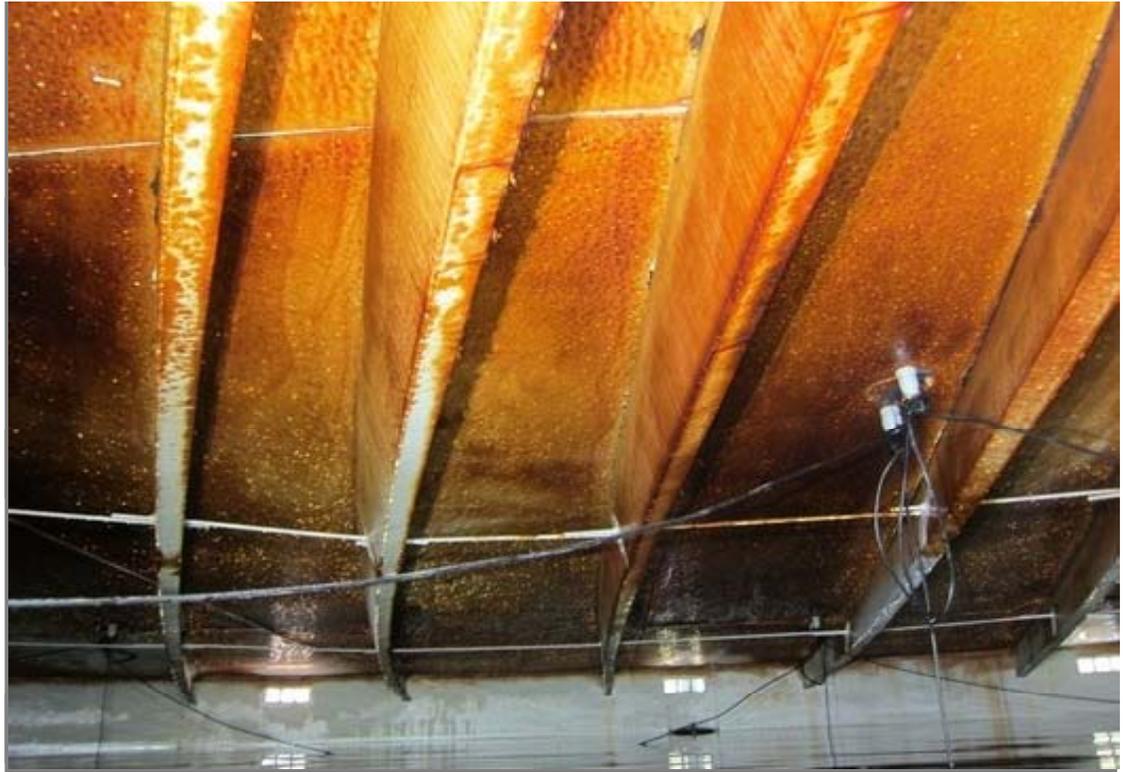
Interior roof plate, rafters and bracing. Typical broad view. Approximately 20 of the rafters have "rolled" which could be due to a past over-stress condition such as lateral loads from seismic sloshing or heavy snow load or other types.

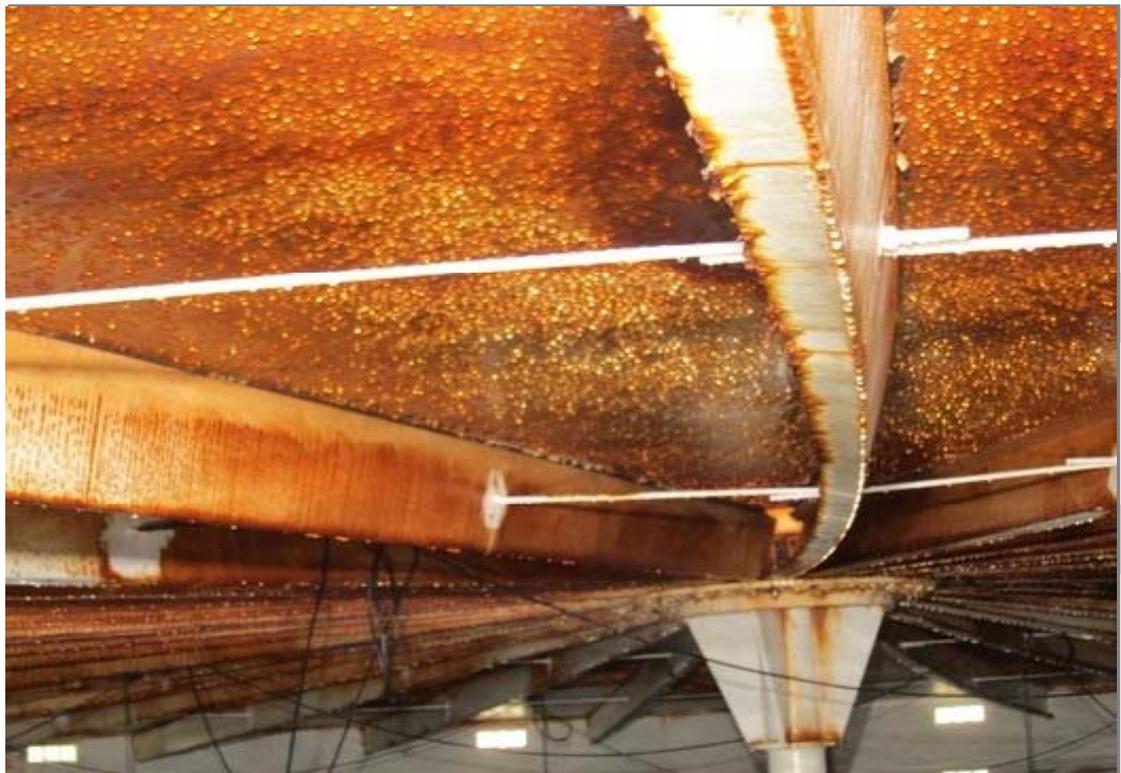
Additional view of the interior roof and a bowed rafter.

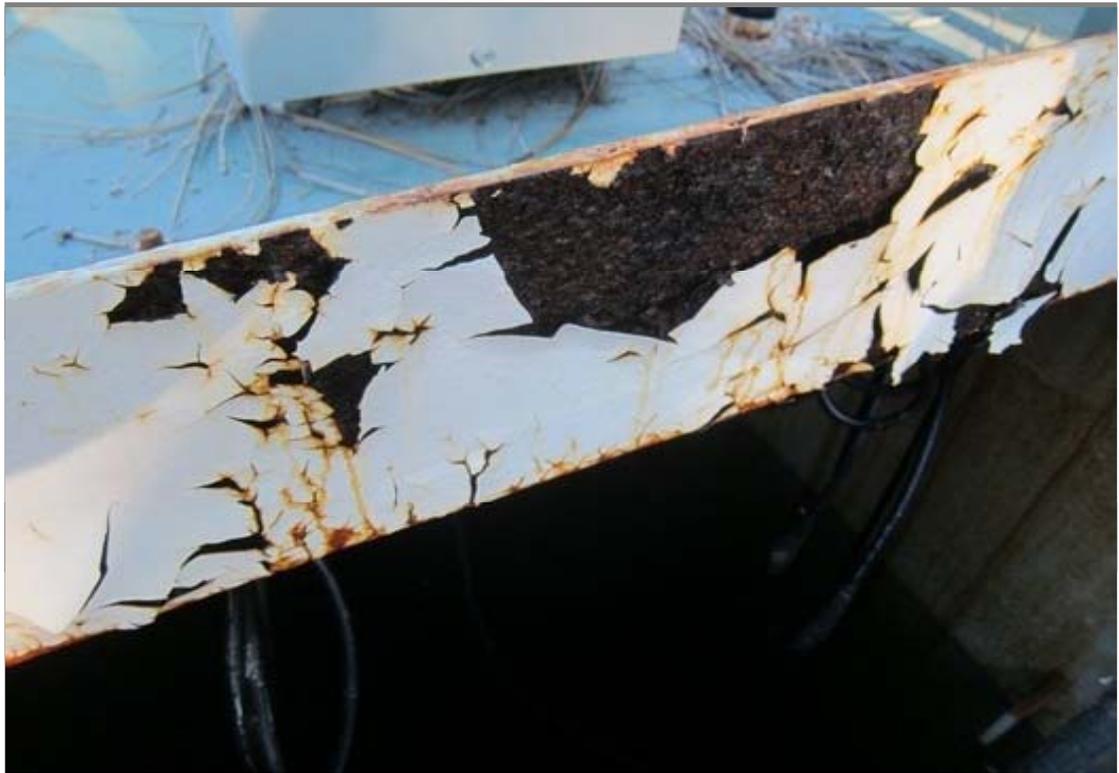
Corrosion and roughening on the interior side of the roof hatch.

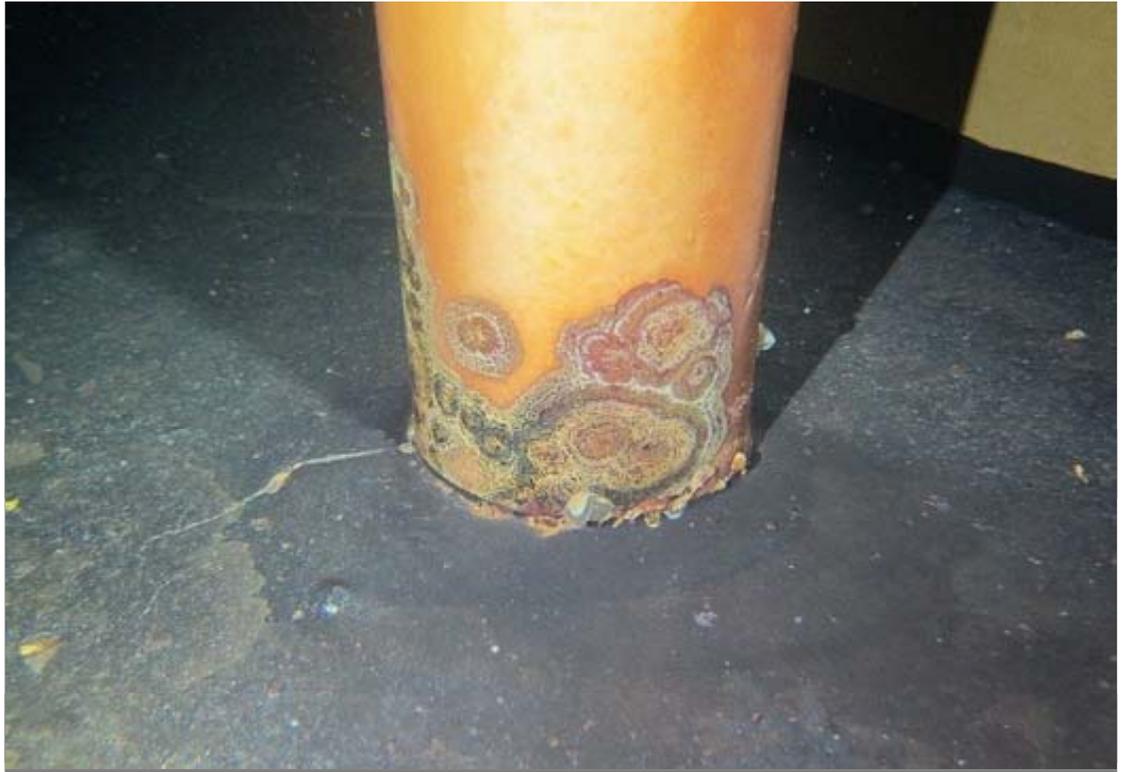
Overflow riser pipe with corrosion near the bottom.

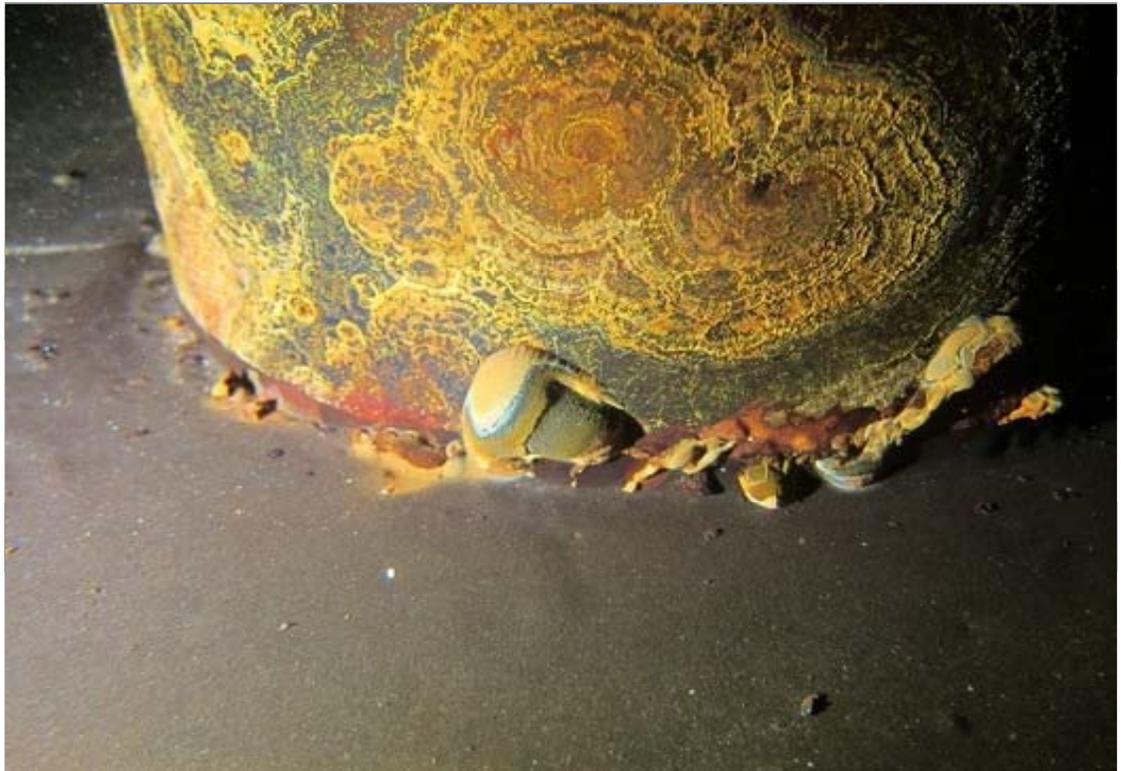
Close view of the area shown at the top of this page.

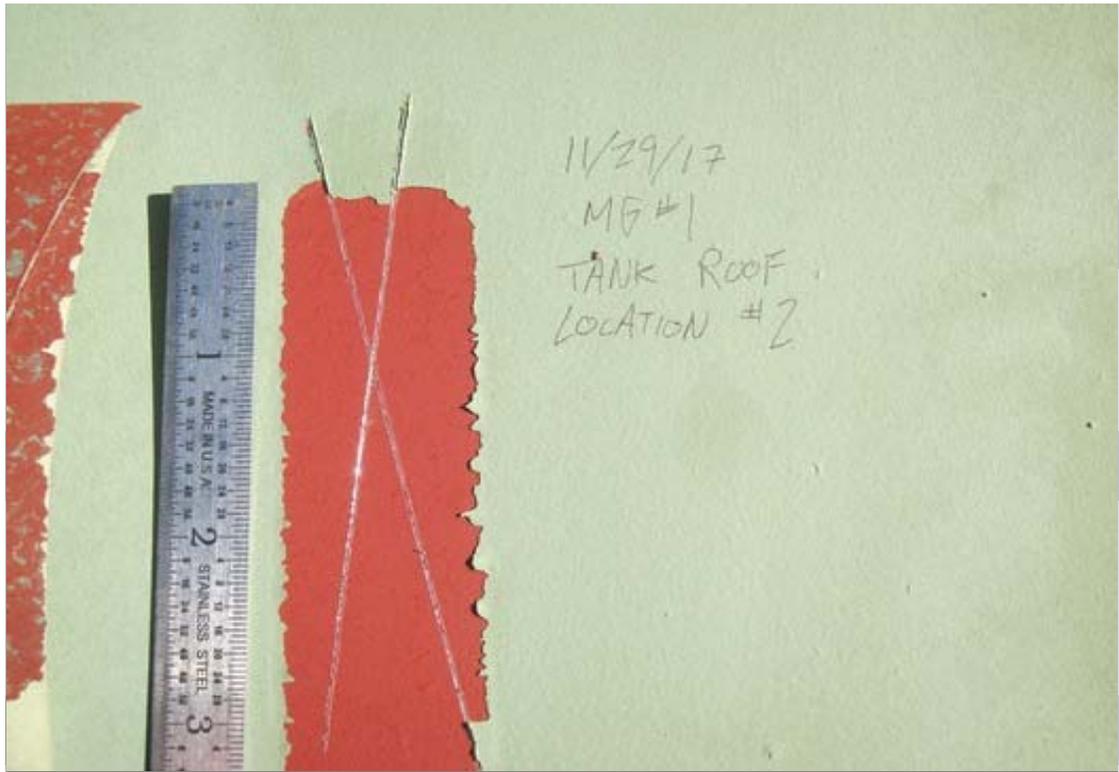
Adhesion was evaluated with a cross cut tape test and found to be poor.
This test location was on the roof.

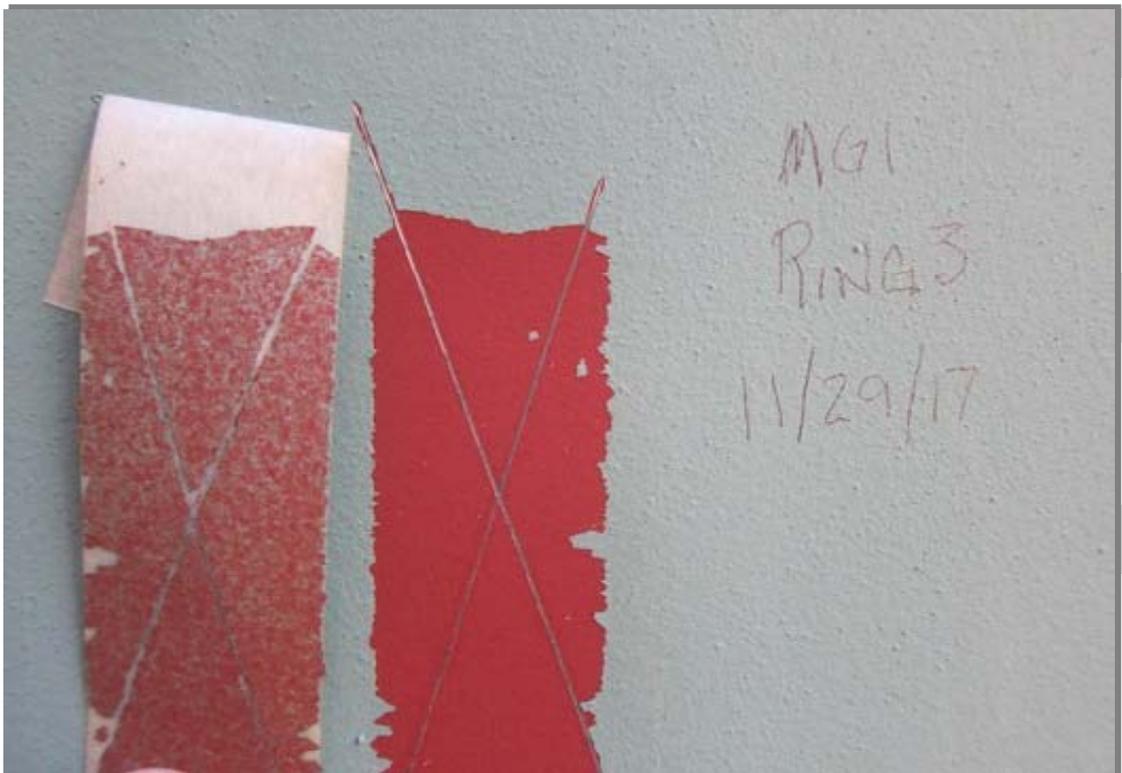
Adhesion was evaluated with a cross cut tape test and found to be poor.
This test location was on shell ring number 3.

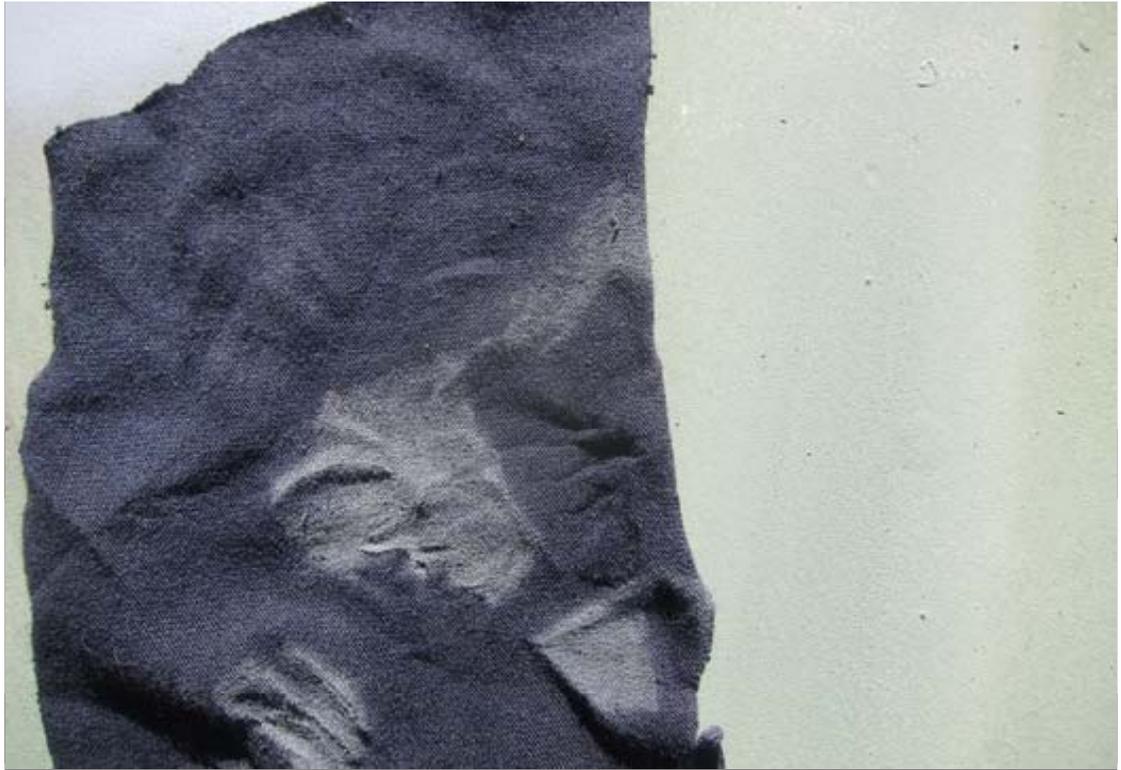
Chalking was evaluated pursuant to ASTM D4214, test method A. Chalking is approximately a No. 7 valuation as compared to photographic reference standard No. 1

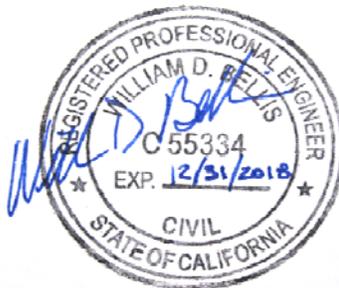
Registered Civil Engineer, CA C55334

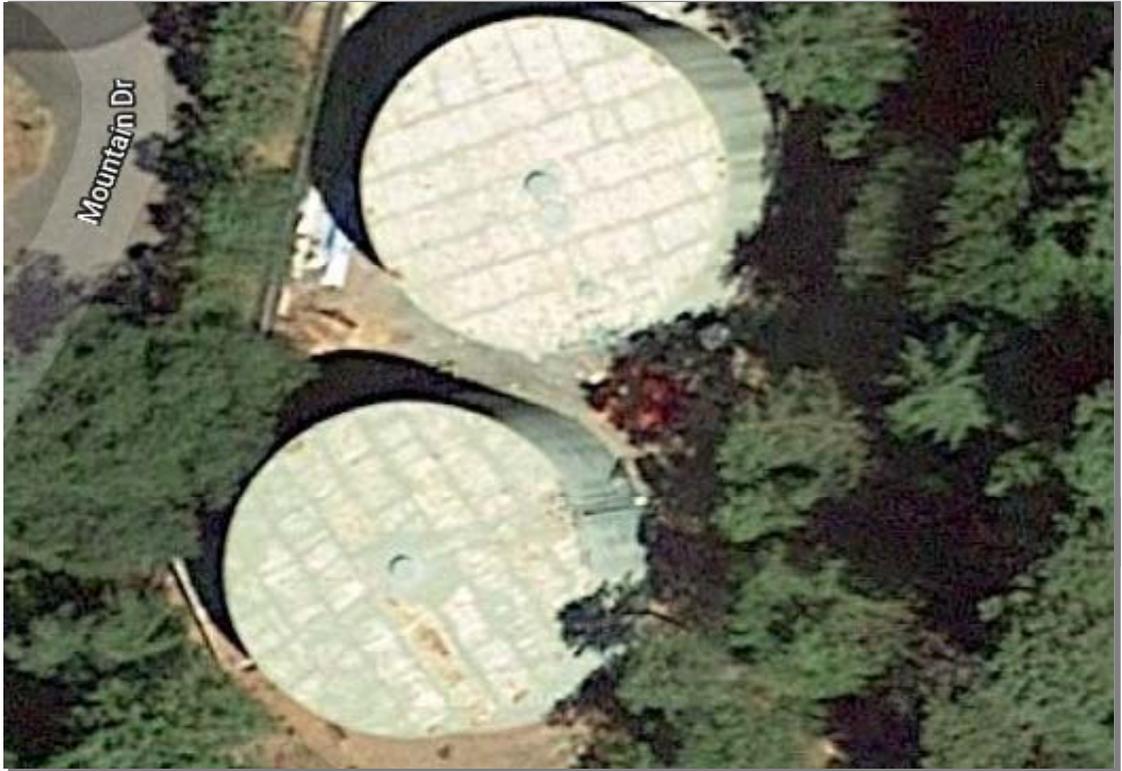
Plan view of tanks and site (courtesy of Google).

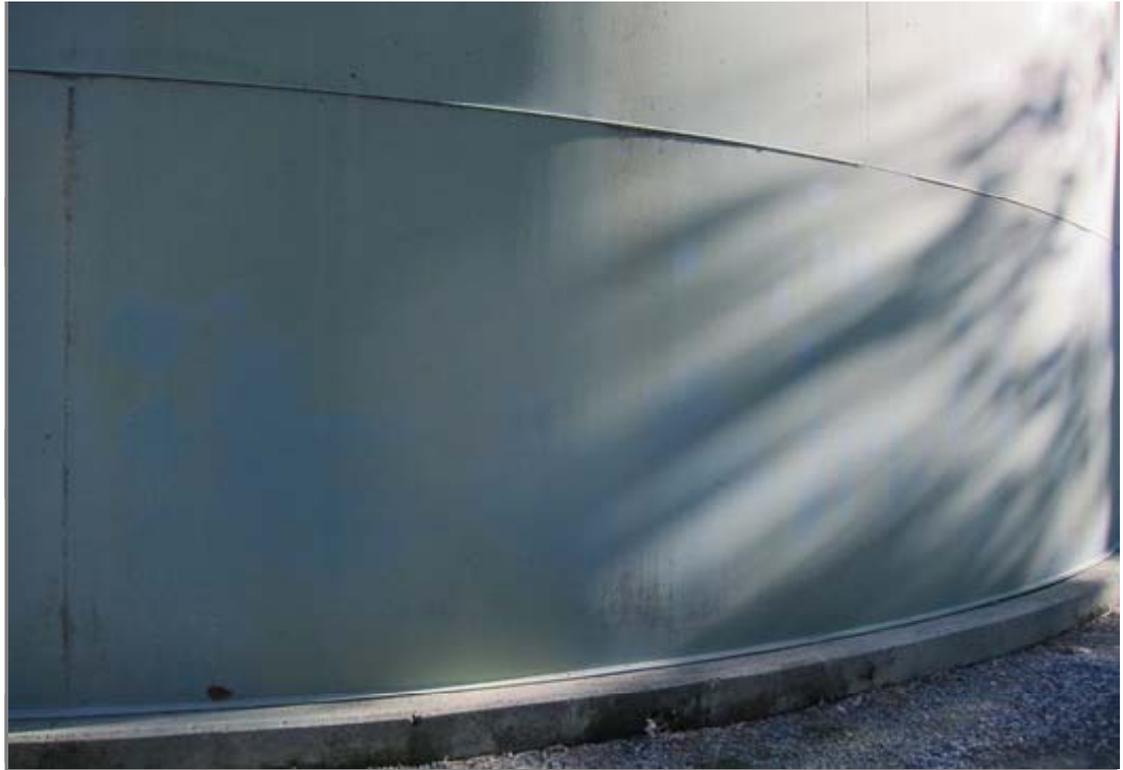
Lower shell and concrete footing. No significant corrosion points were identified.

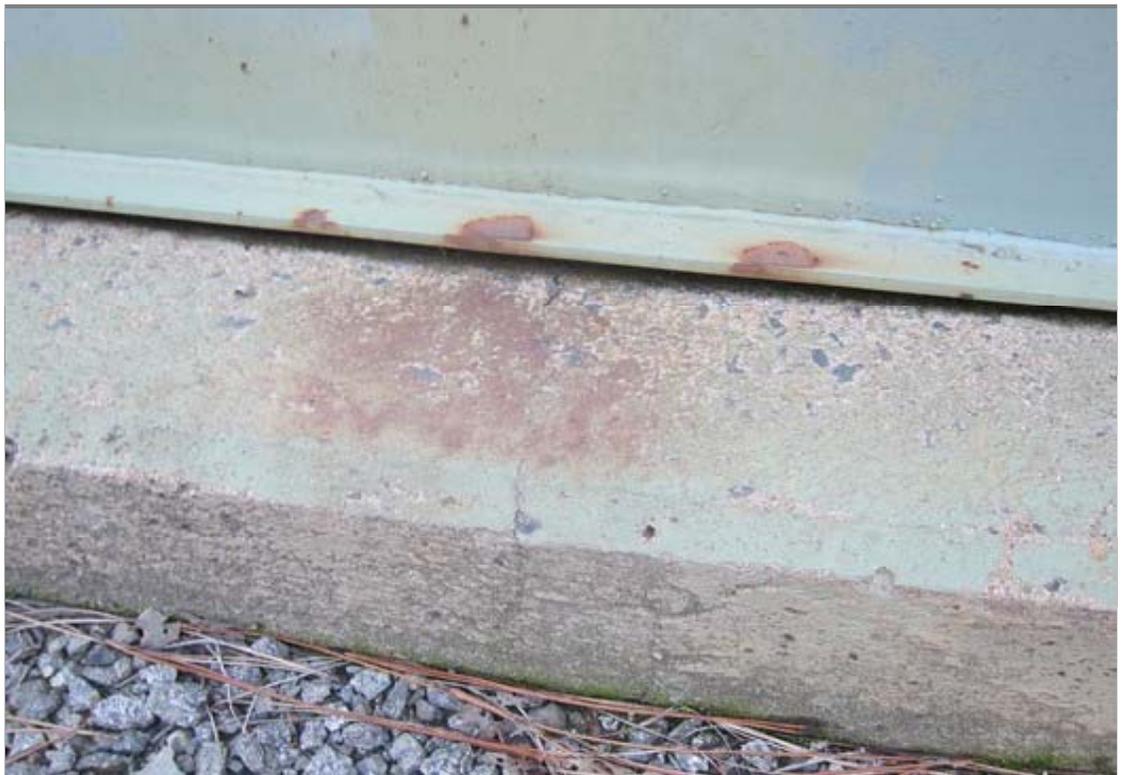
This view of the concrete footing and lower shell shows the typical condition found.

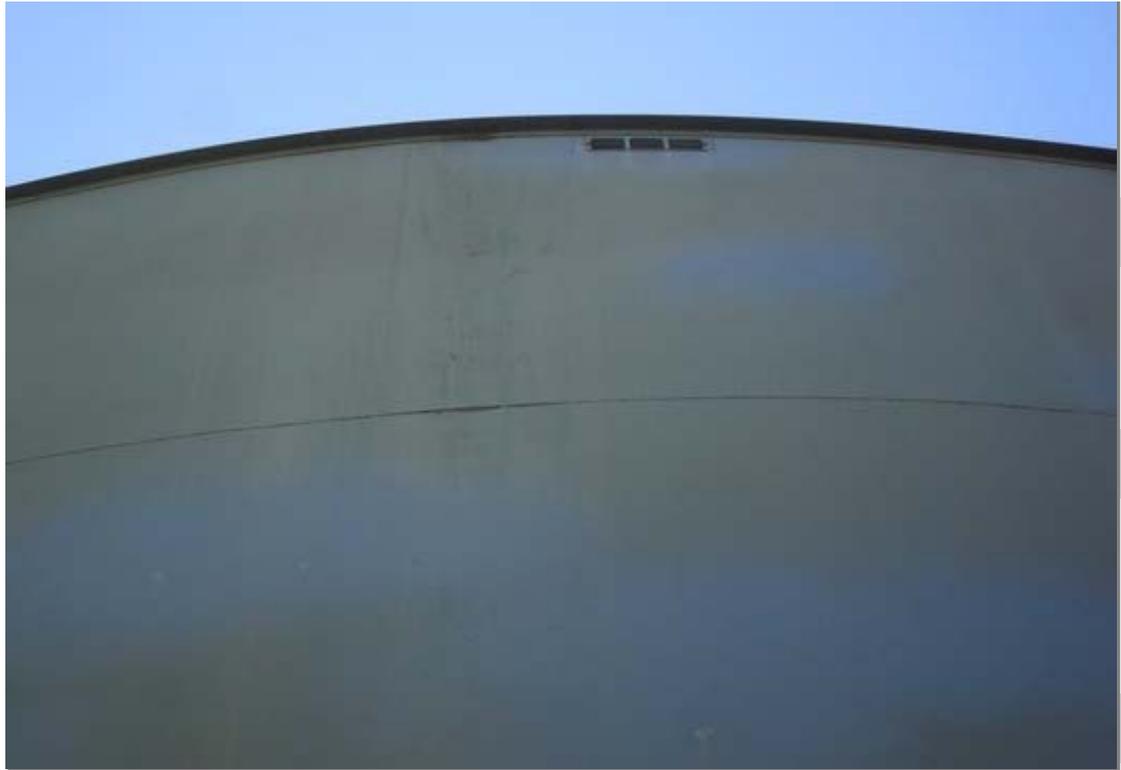
This view represents the typical conditions on the upper shell and shell to roof joint. The upper shell is in good condition with only minor corrosion points noted.

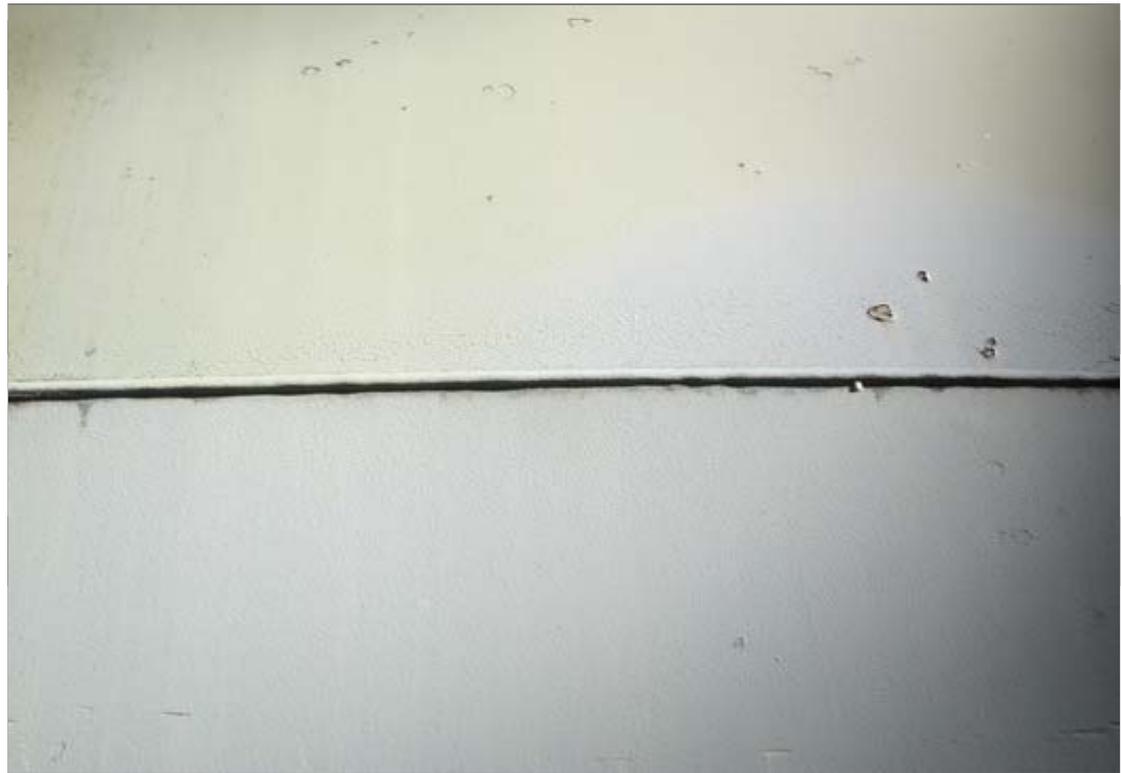
Welds on the exterior shell are generally smoother than the older tank #1 because the welds on this tank are mostly by a mechanized system. Some scattered spatter is present particularly in the areas of welded repairs completed manually.

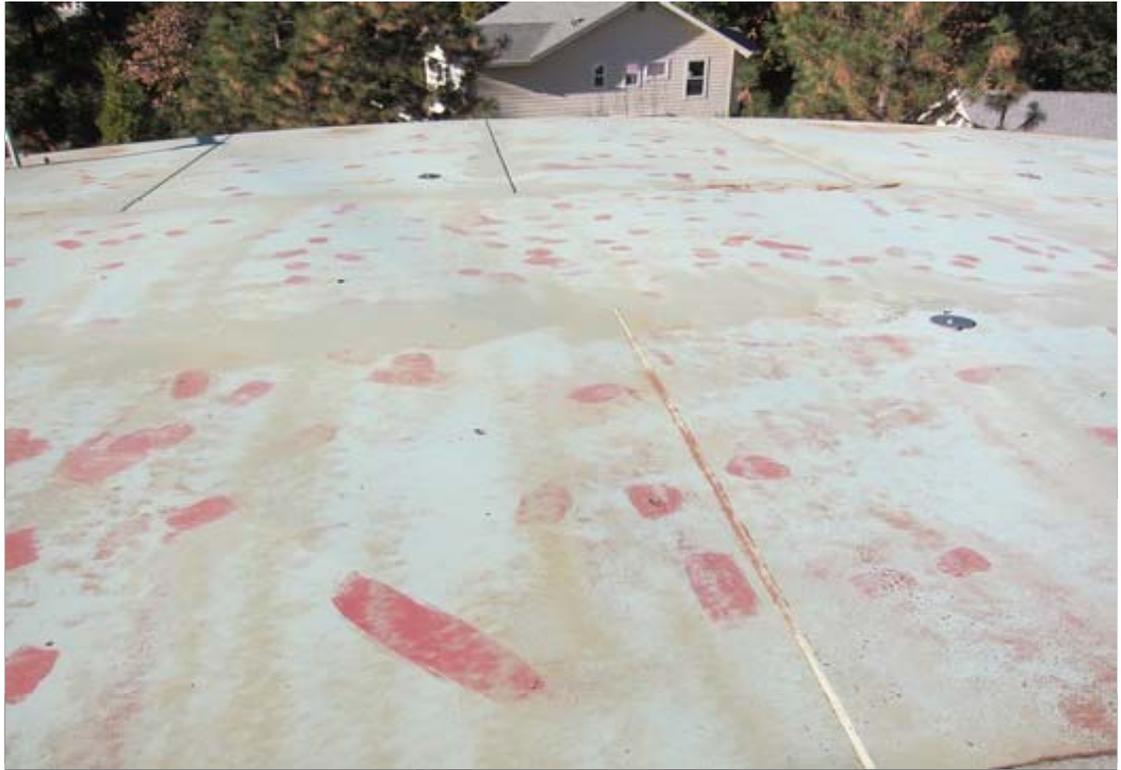
This view indicates the overall condition of the roof. The roof plate (steel) is in good condition but coatings are in poor condition.

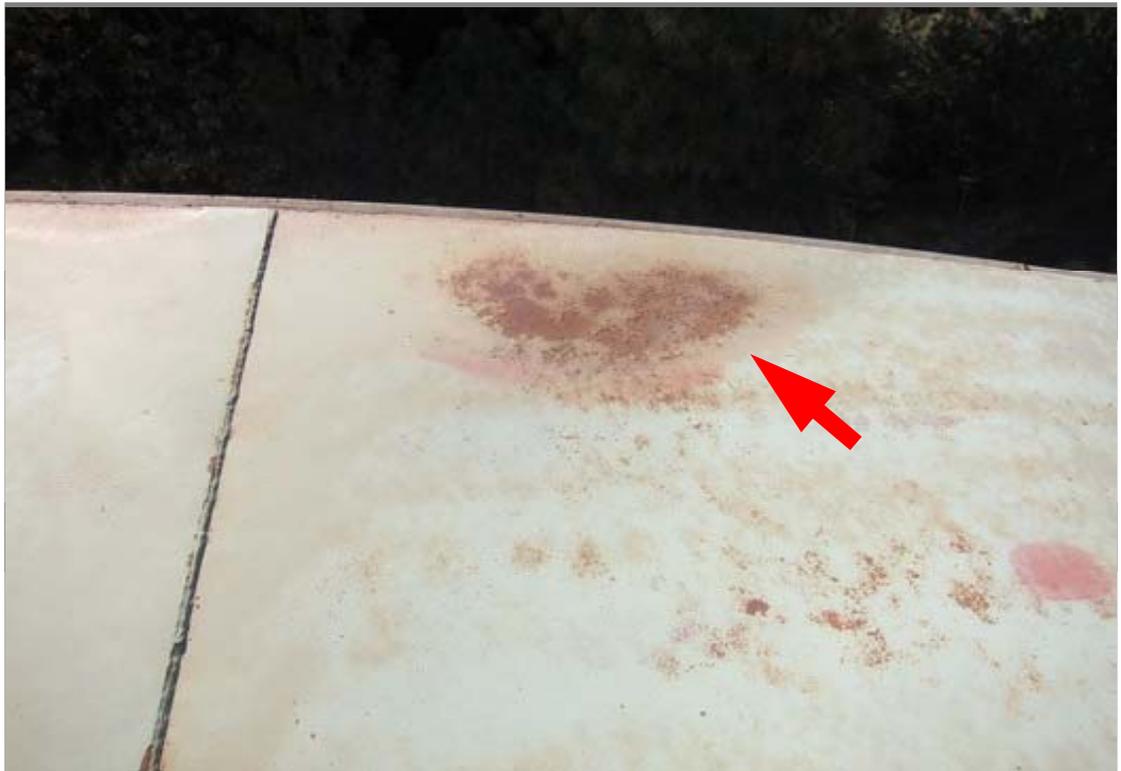
Close view of a ponding area with corrosion. Submersed exterior coatings pose a maintenance challenge.

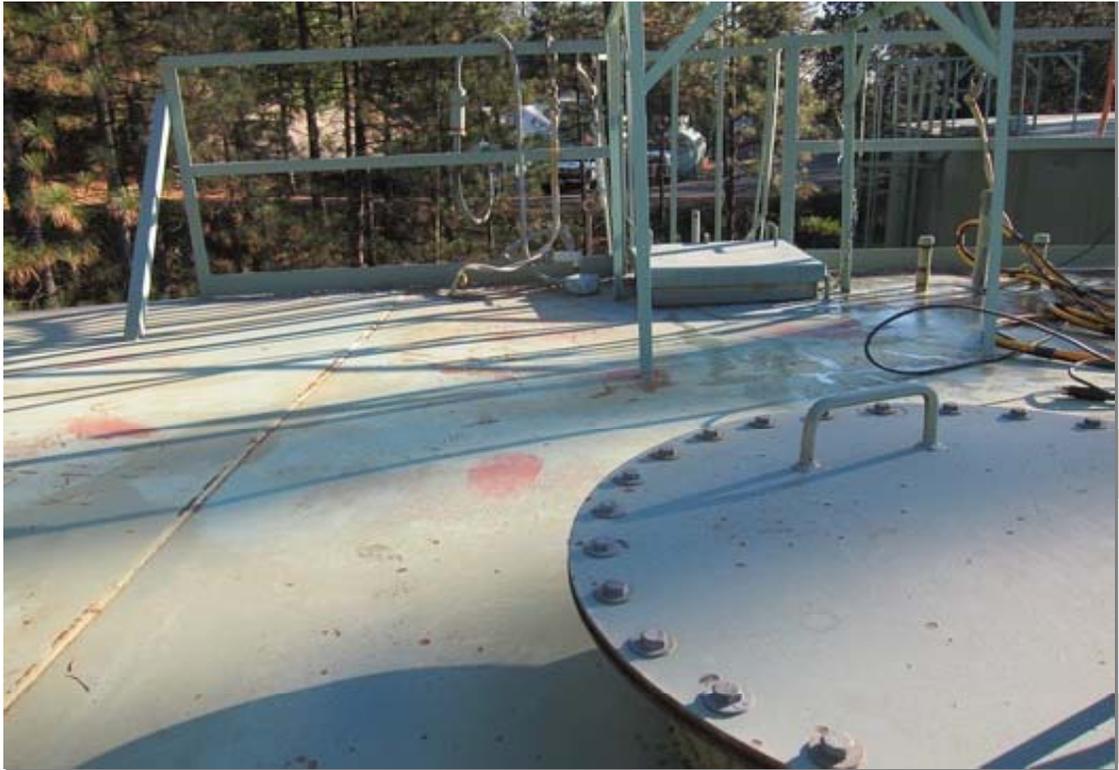
The photo above shows the roof hatch area with guardrail. A second hatch is visible in the foreground.

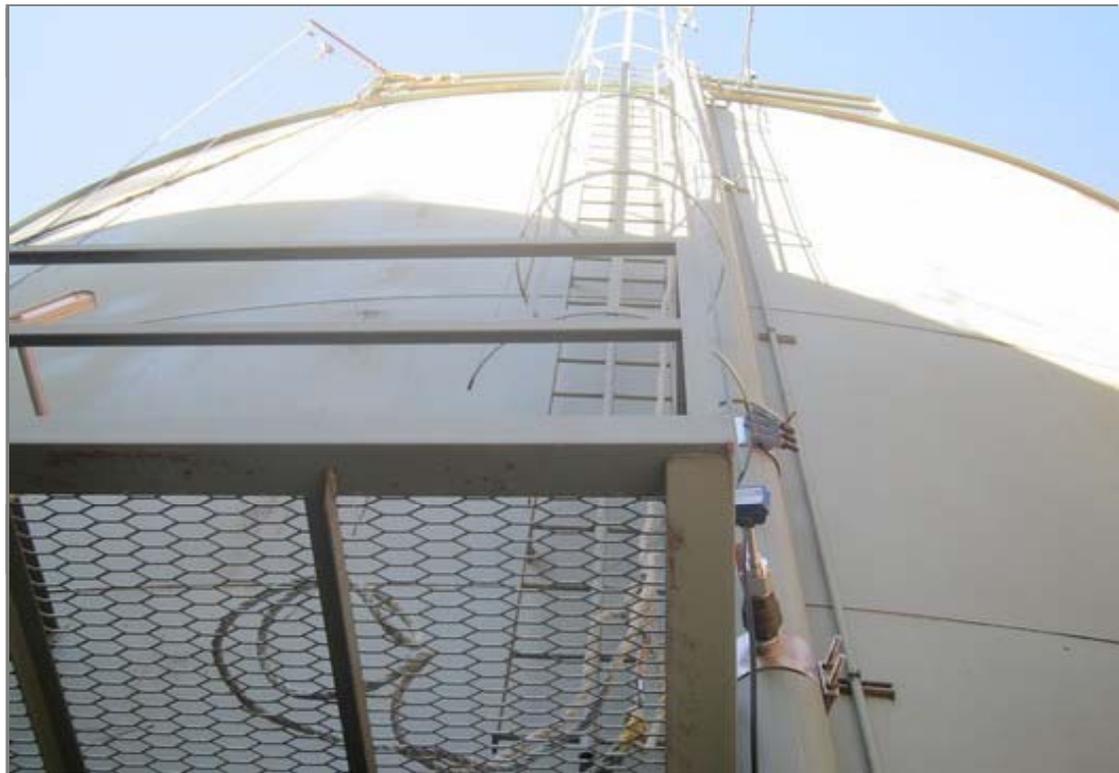
This view from the ground shows the platform, exterior ladder and cage. No significant corrosion is present. The climber safety rail has been painted.

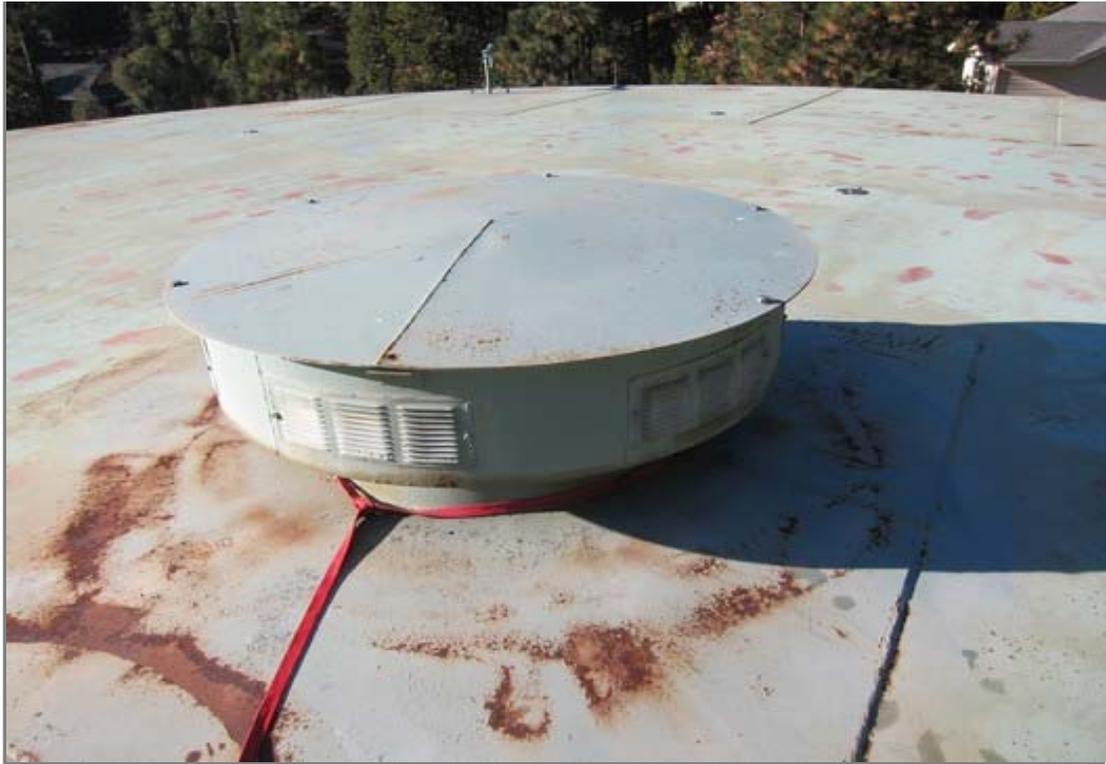
The roof vent consists of a steel cover over a steel riser pipe.

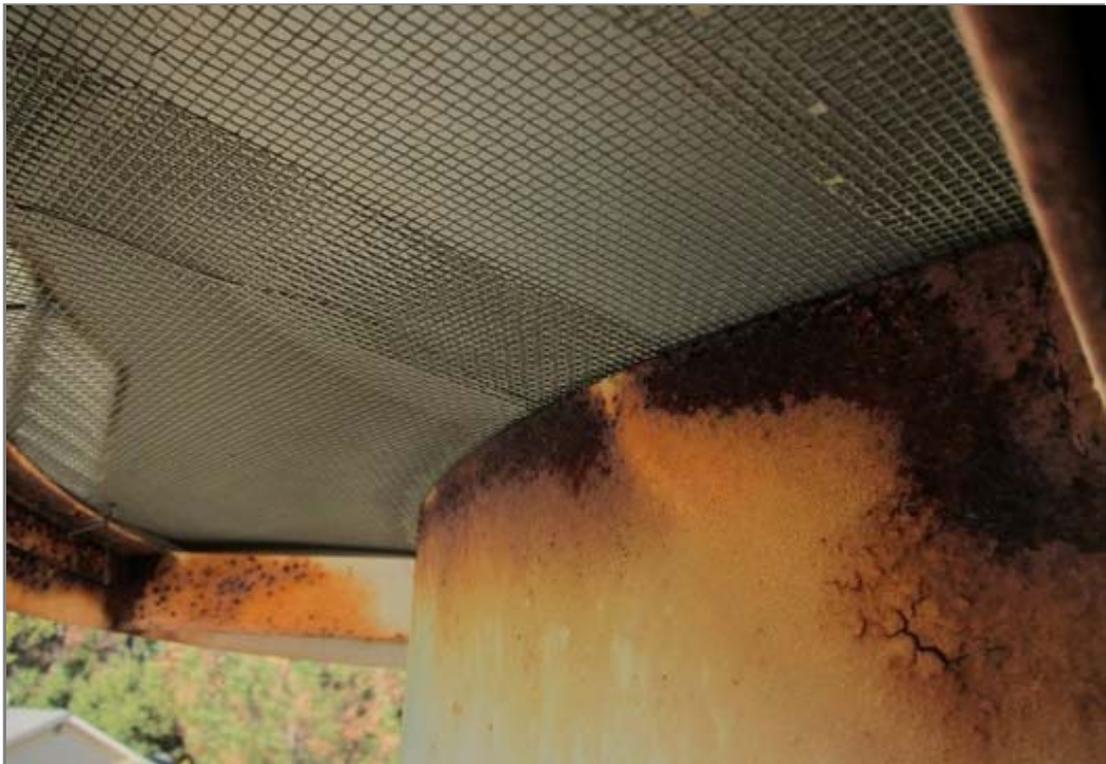
This view of the underside of the vent hood shows that the screen is in good condition. Corrosion is present on the riser but the screen appeared to be bug proof.

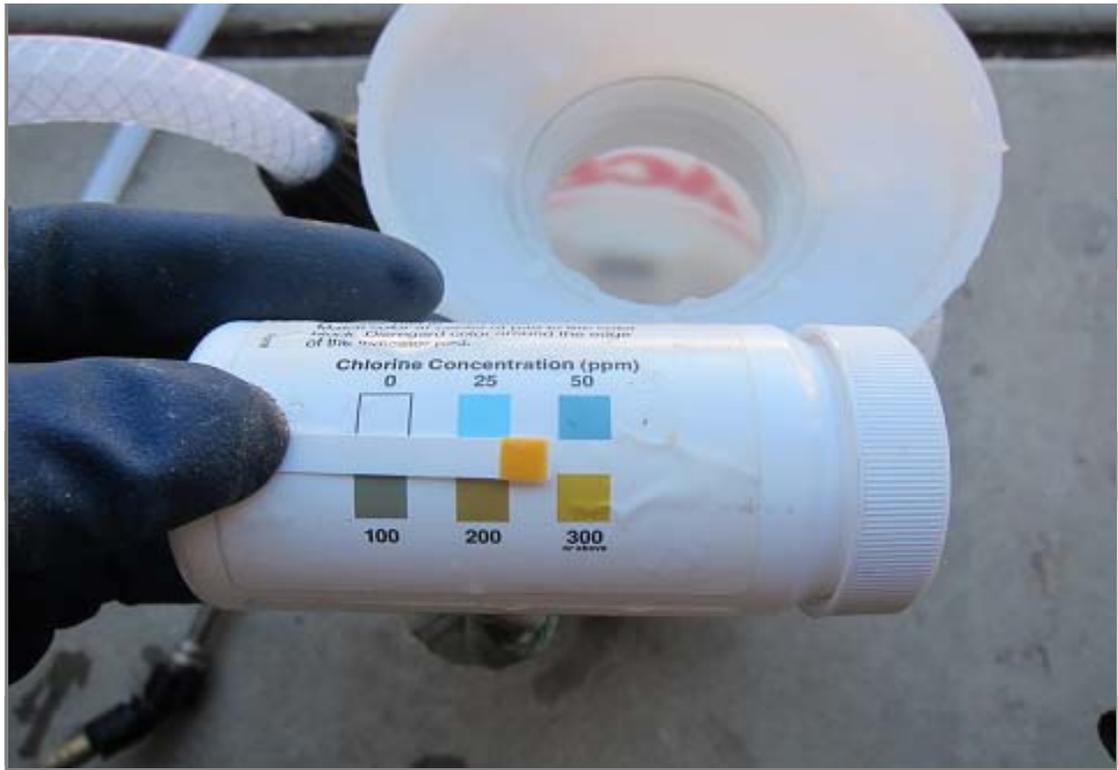
The disinfecting solution is tested to verify that it exceeds the 200 ppm free chlorine concentration level.

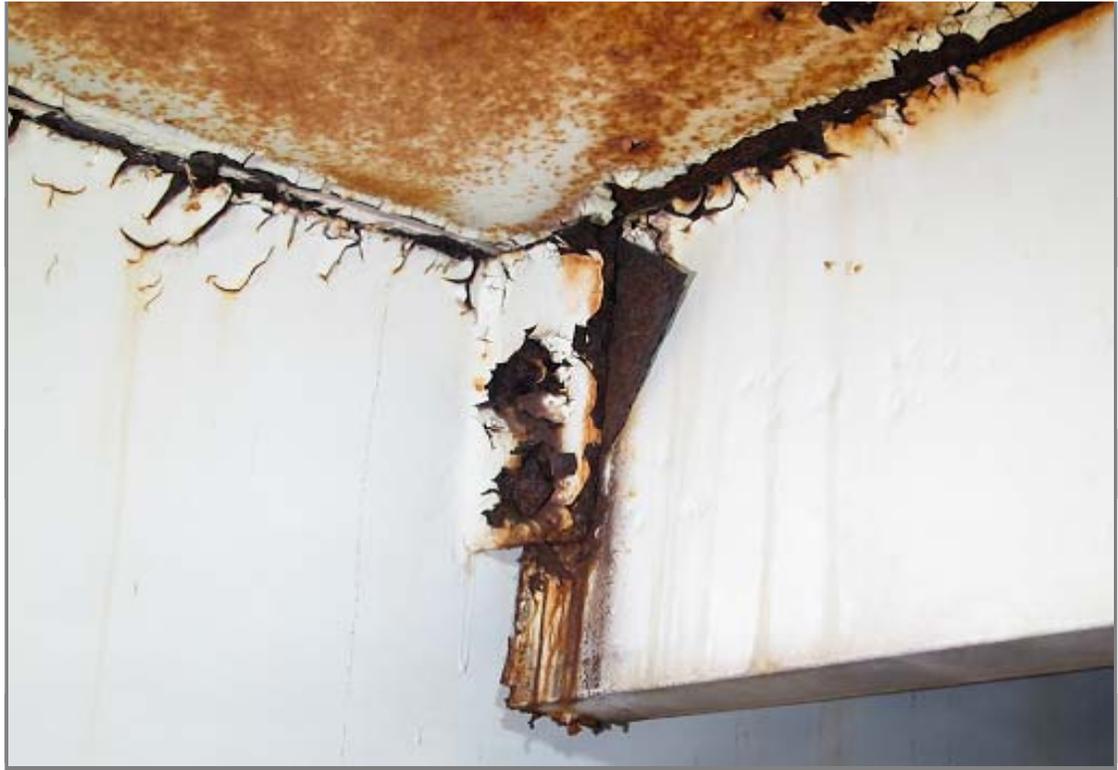
Upper shell, rafter and adjacent roof. Coatings are peeling and general corrosion is present on many surfaces.

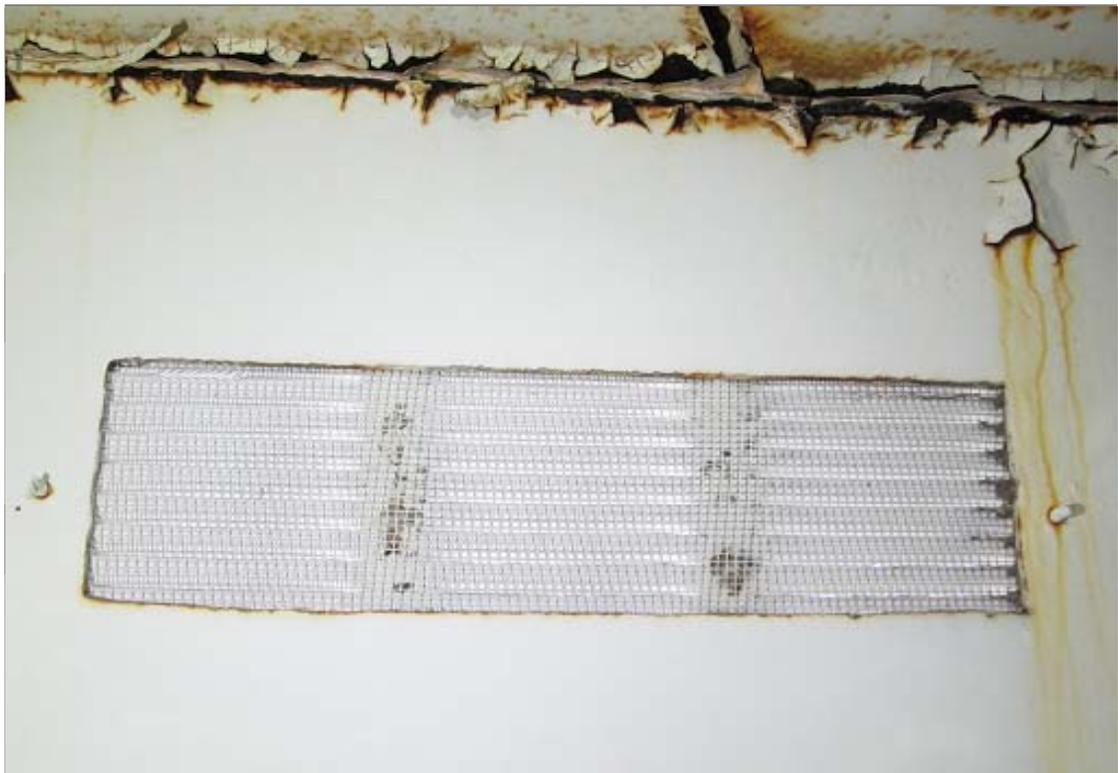
This is a close view of the upper shell showing one of the numerous shell vents.
