APPENDIX C
Dive Inspection Reports – Existing Welded Tanks

**INSPECTION REPORT FOR THE
TWIN HARTE COMMUNITY SERVICE DISTRICT'S
MILLION GALLON TANK #1
DECEMBER 29TH, 2017**

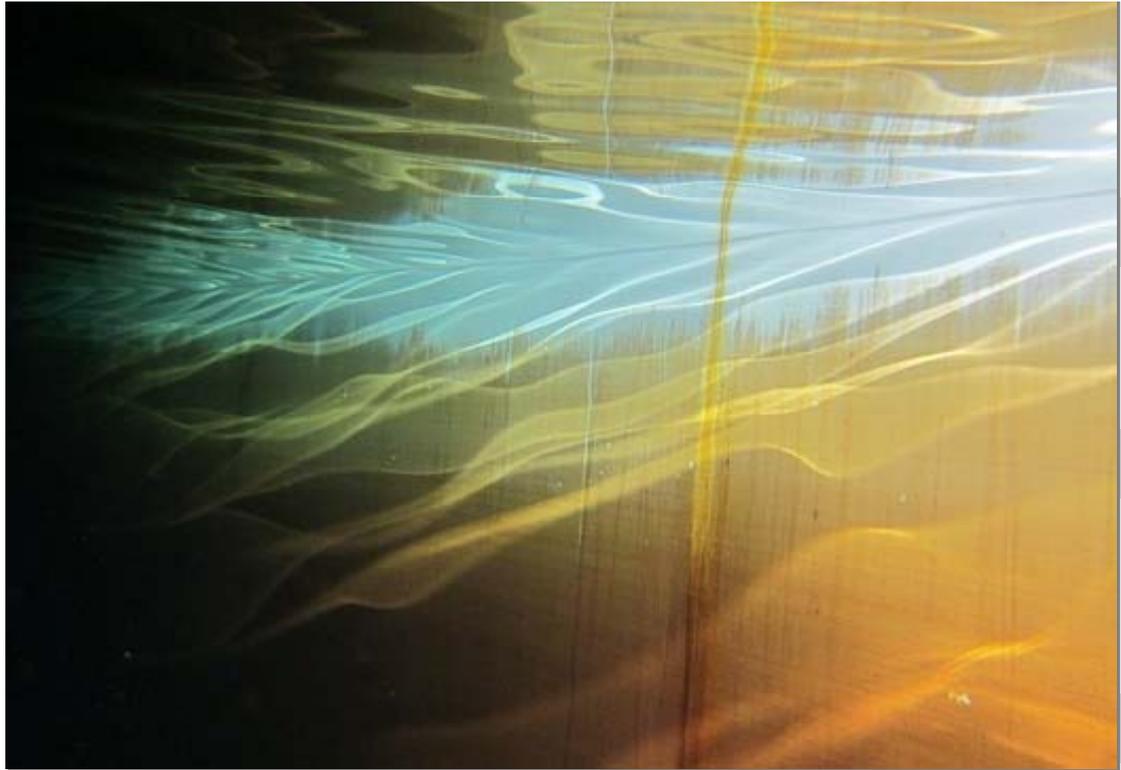
The photo above shows the interior shell just below the water surface (submersion zone). The rust color on the shell is staining.

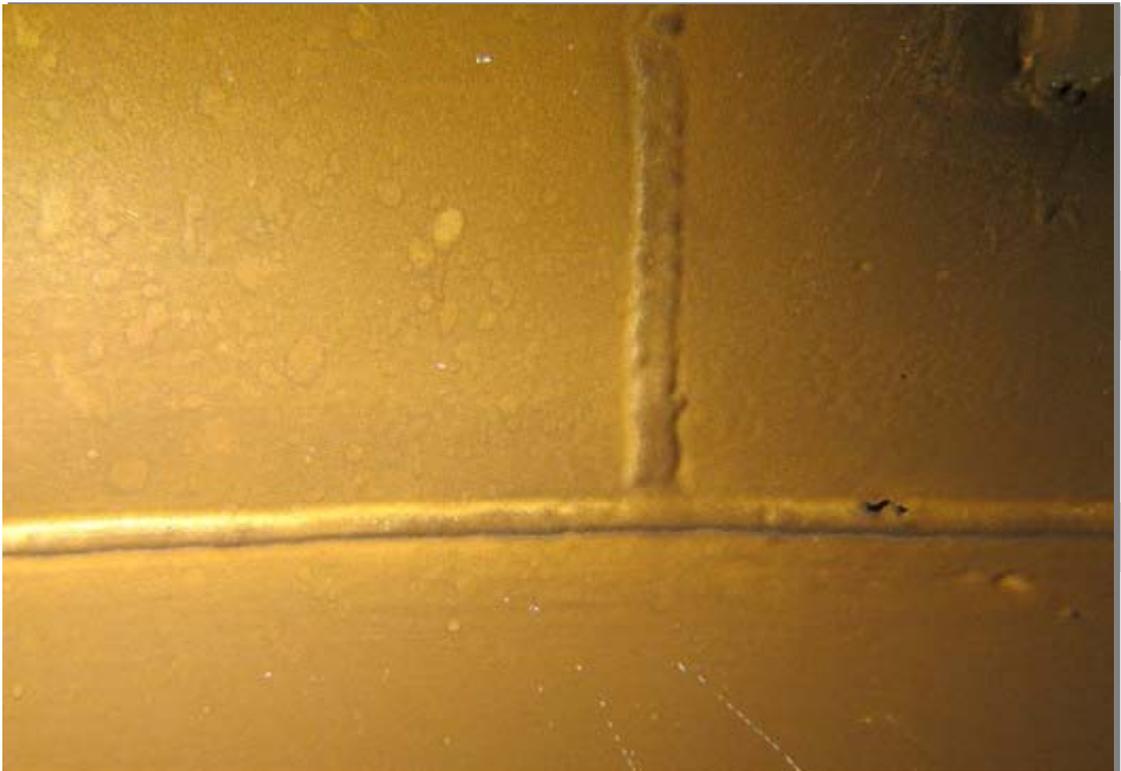
Interior shell in the submersion zone. This view shows a junction between a horizontal and vertical shell joint. The interior shell steel appears to be in good condition overall.

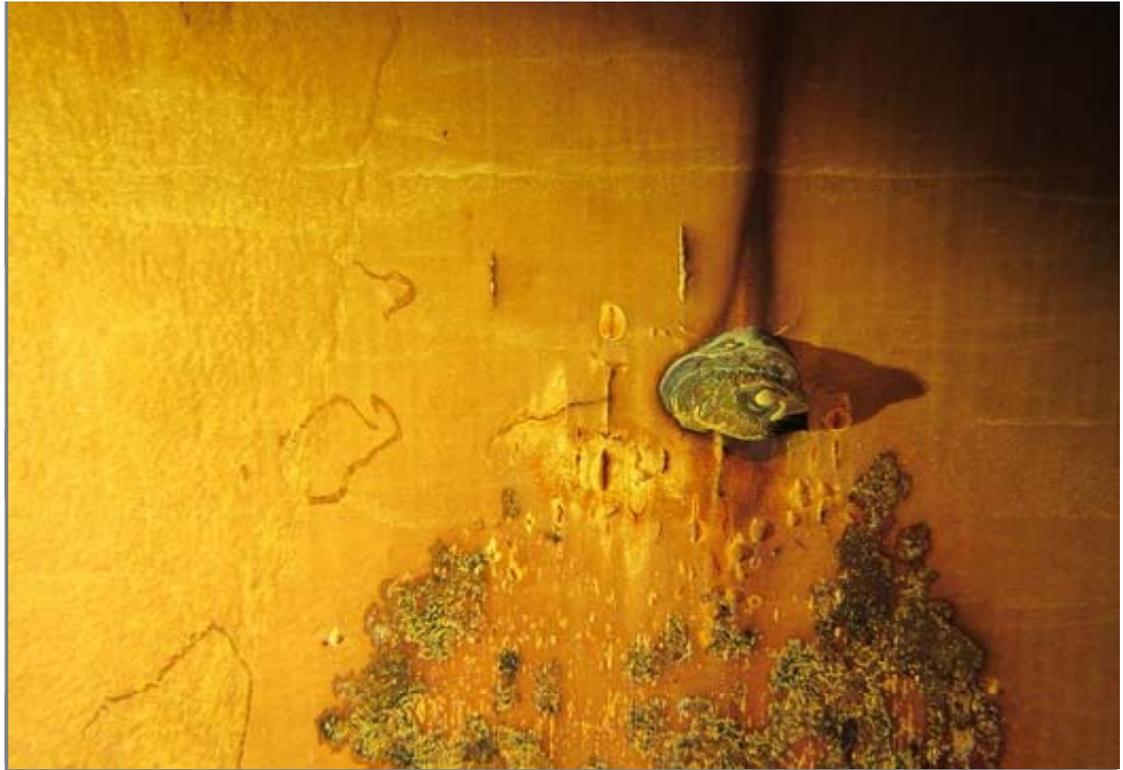
Interior shell in the submersion zone near the manway in quadrant 1. The coatings are cracking and corrosion is present.

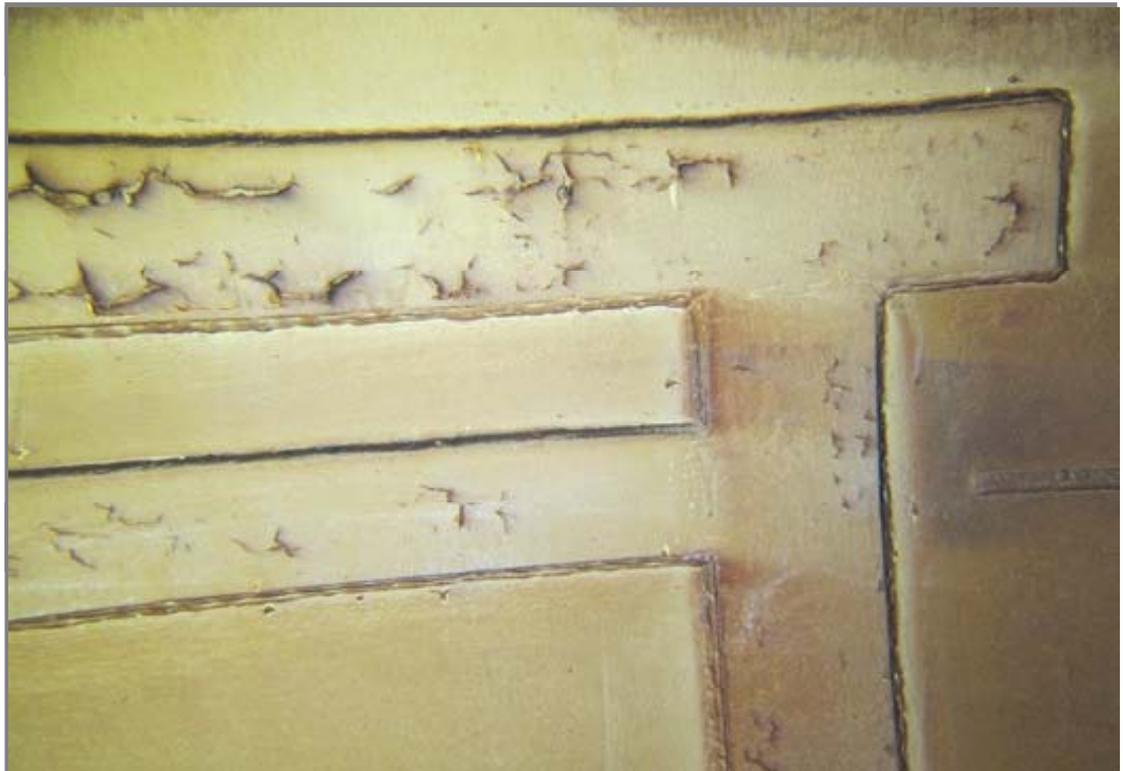
This view of cracked coatings is where a shell opening (door sheet) was cut and re-welded upon completion of the work. This area has a particularly high concentration of coating failures.

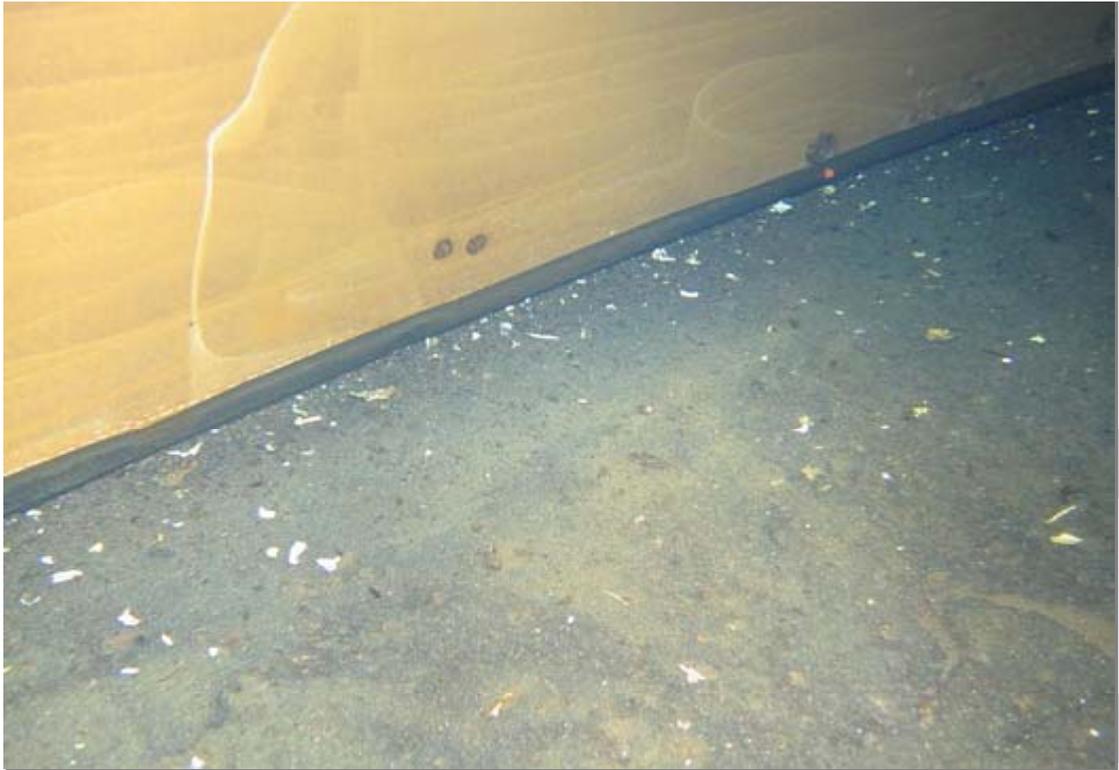
Lower shell and tank bottom. Coatings are in fair condition overall in this zone.

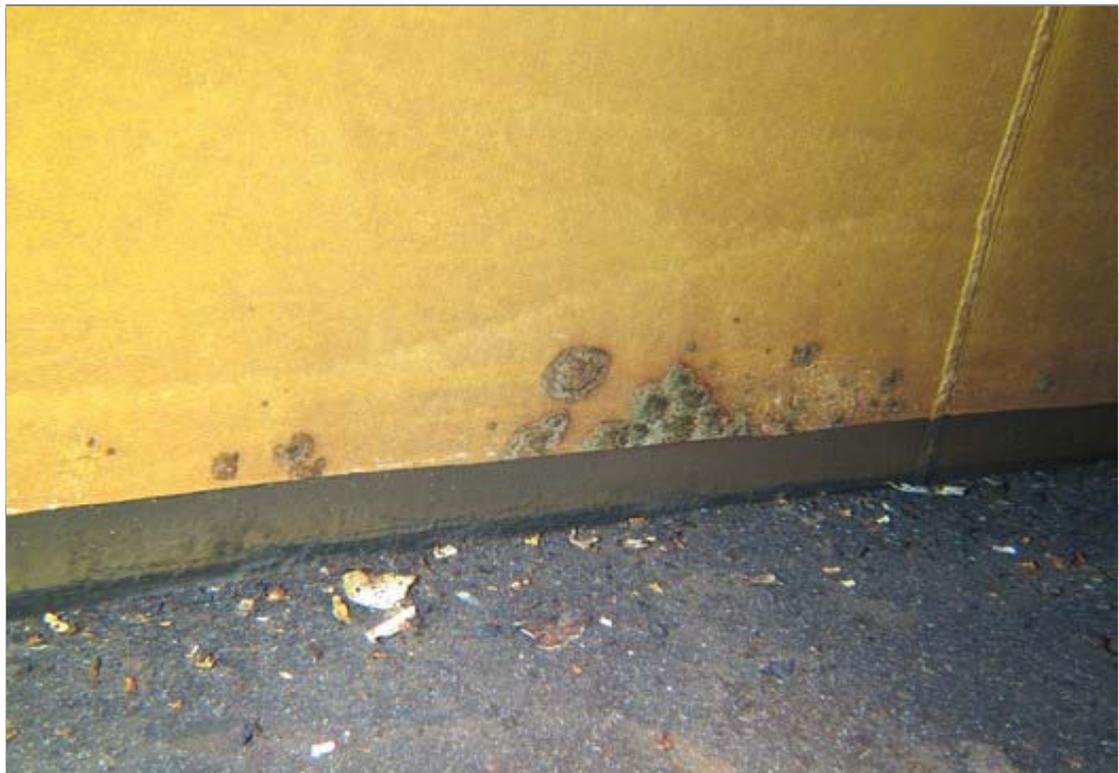
This photo shows an area of the lower shell where coatings are failing. This is an example of the worst condition in this zone.

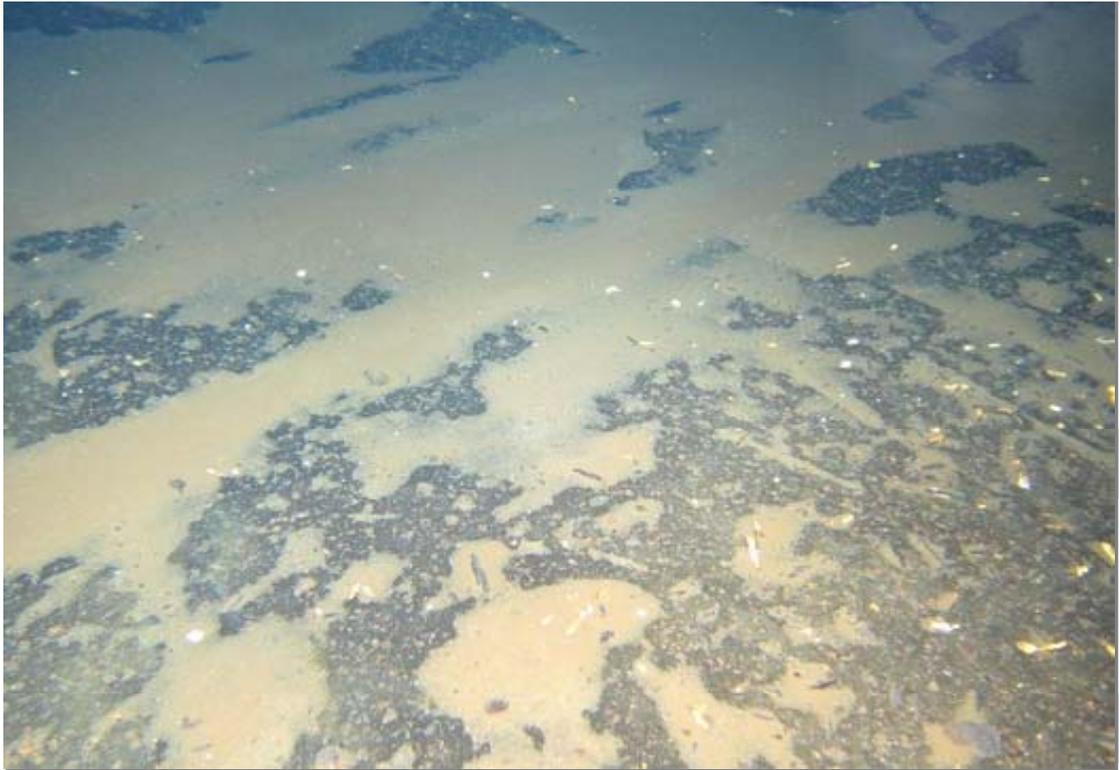
This photo shows the typical condition of the bottom. Sediment removal was not completed with this inspection.

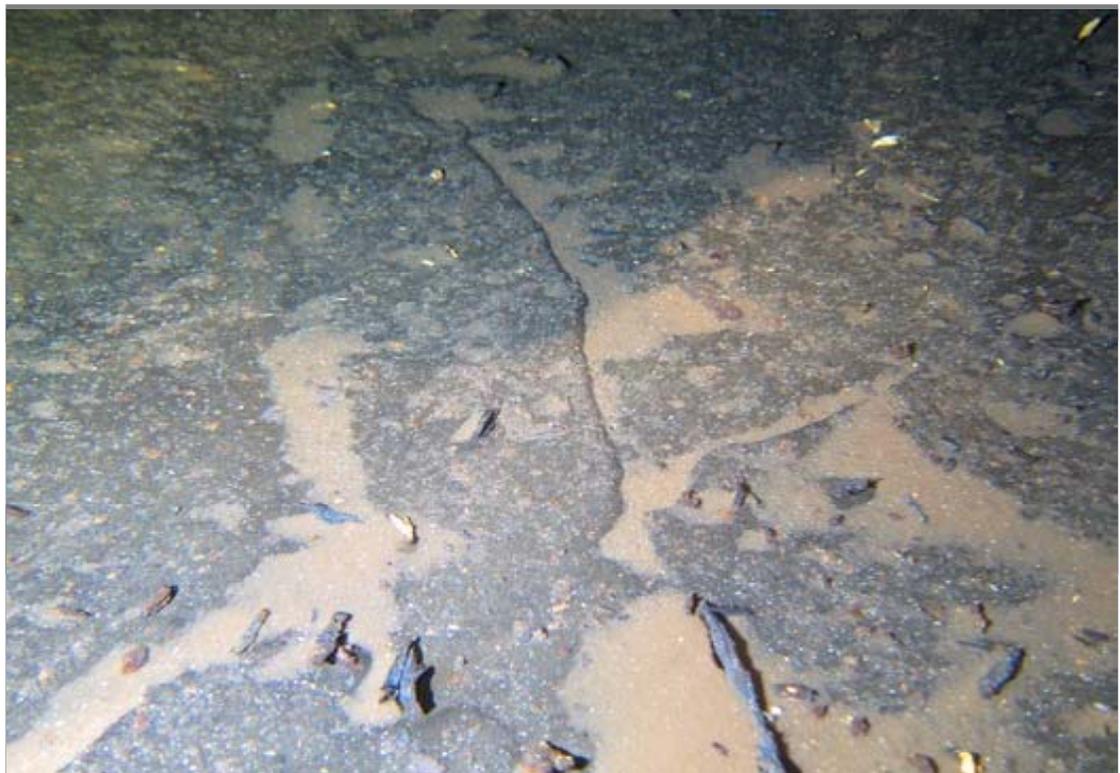
This additional view of the bottom shows some of the corrosion product from the rusting roof rafters above.

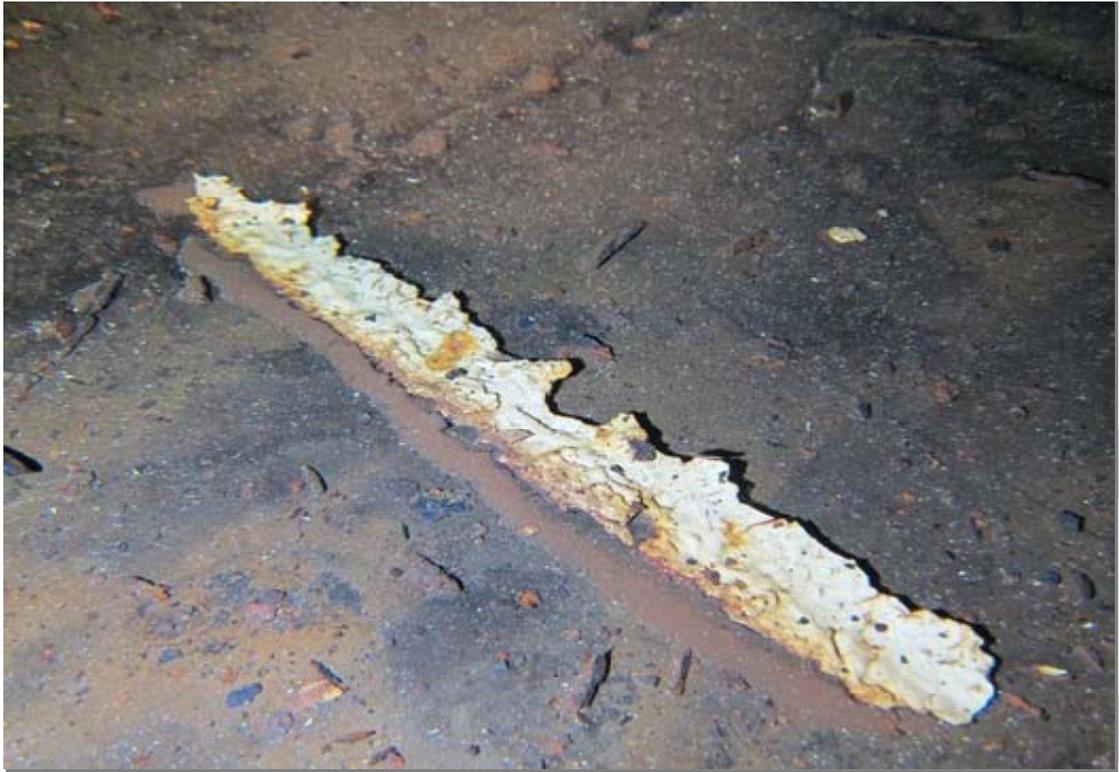
Additional view of interior bottom with coating chip from a roof rafter.

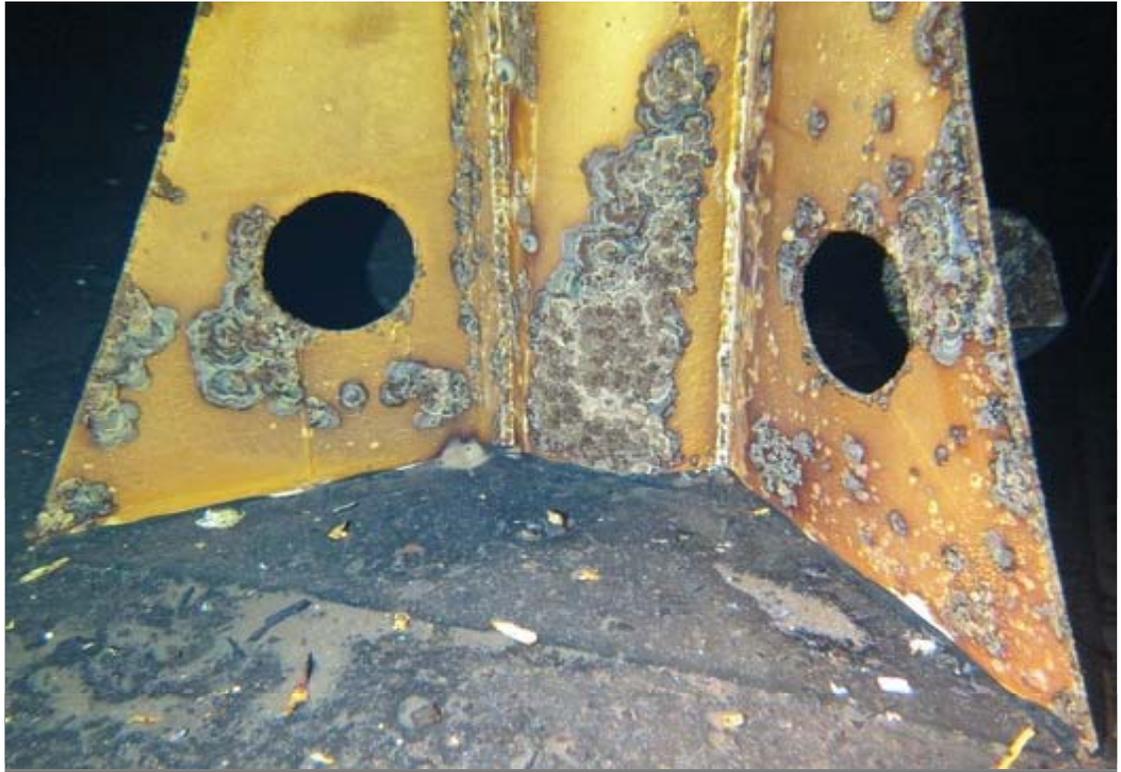
This view shows the column base plate and adjacent bottom plate. Coatings are in poor condition overall on the column and base plate.

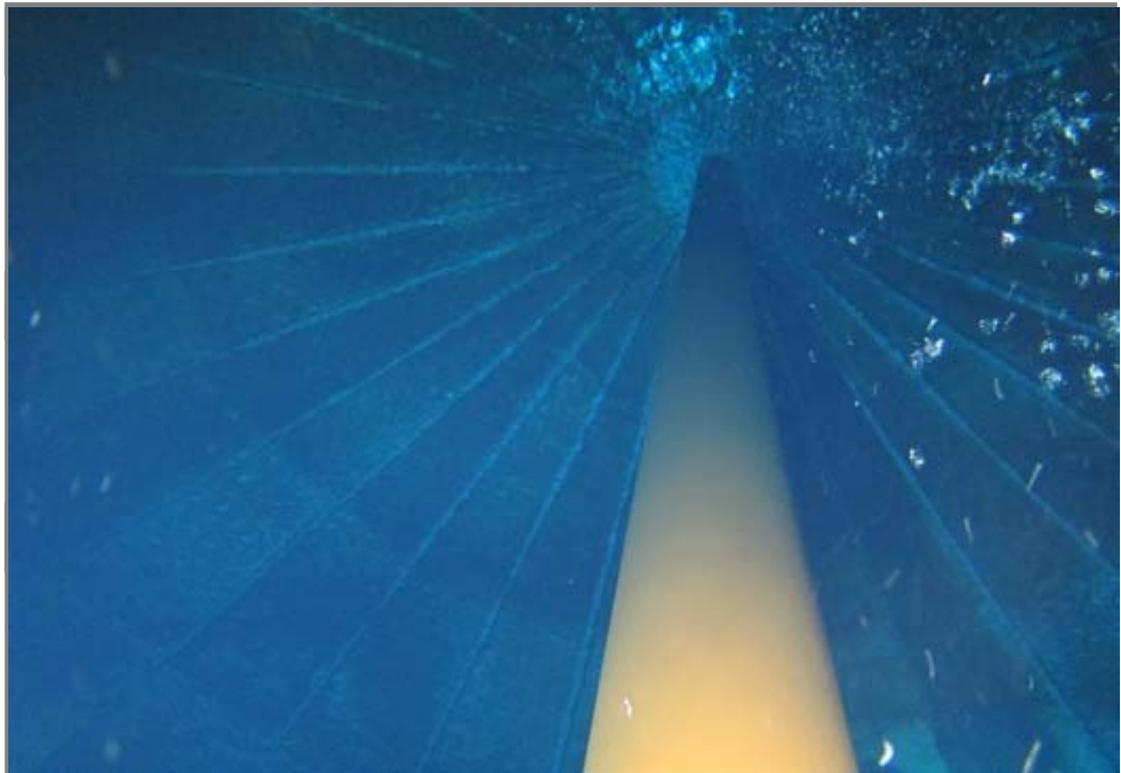
This shot was taken looking upward at the center column. The column is in good condition overall.

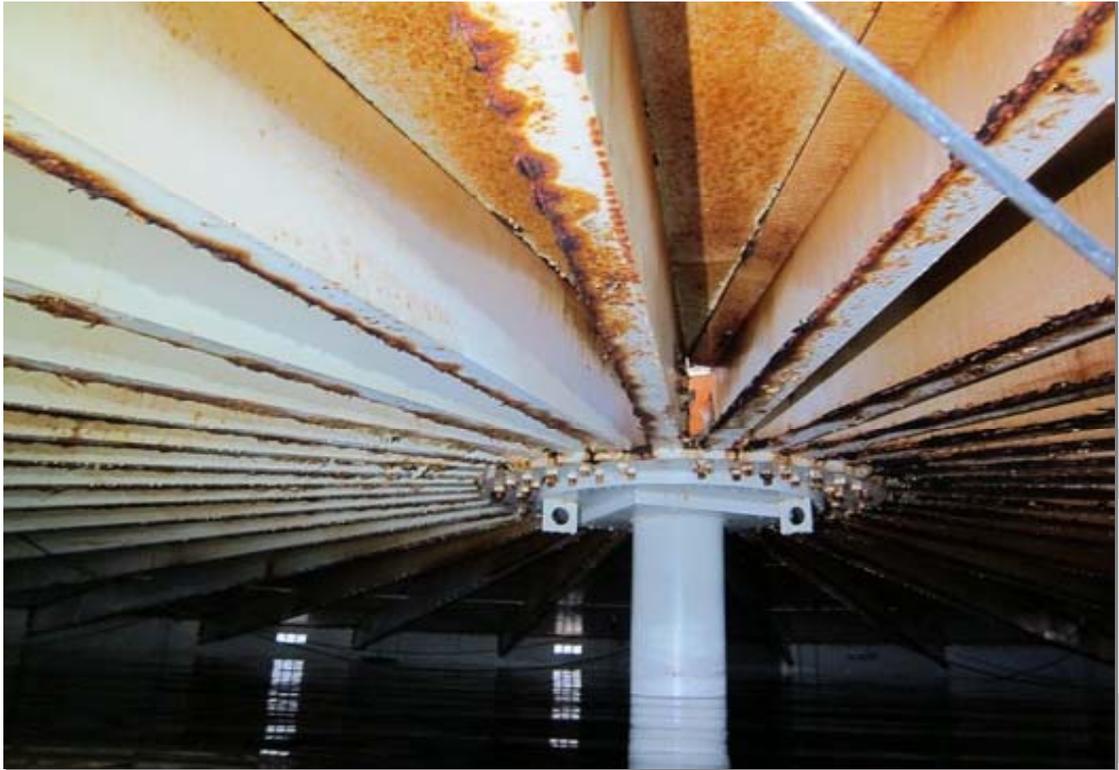
Upper center column, rafters and roof plate. Significant corrosion and associated metal loss are present.

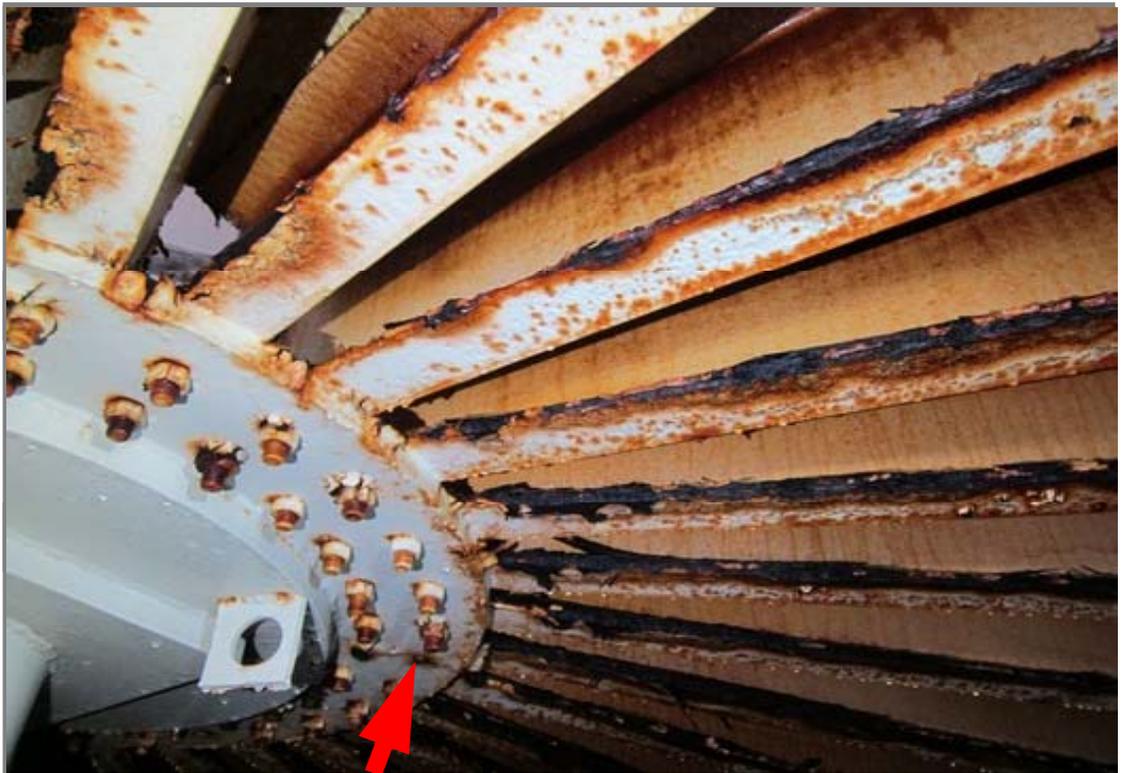
Close view of the center support and rafters. Coating failure and associated corrosion are visible. Several sets of bolts are also missing one of which is shown at the arrow.

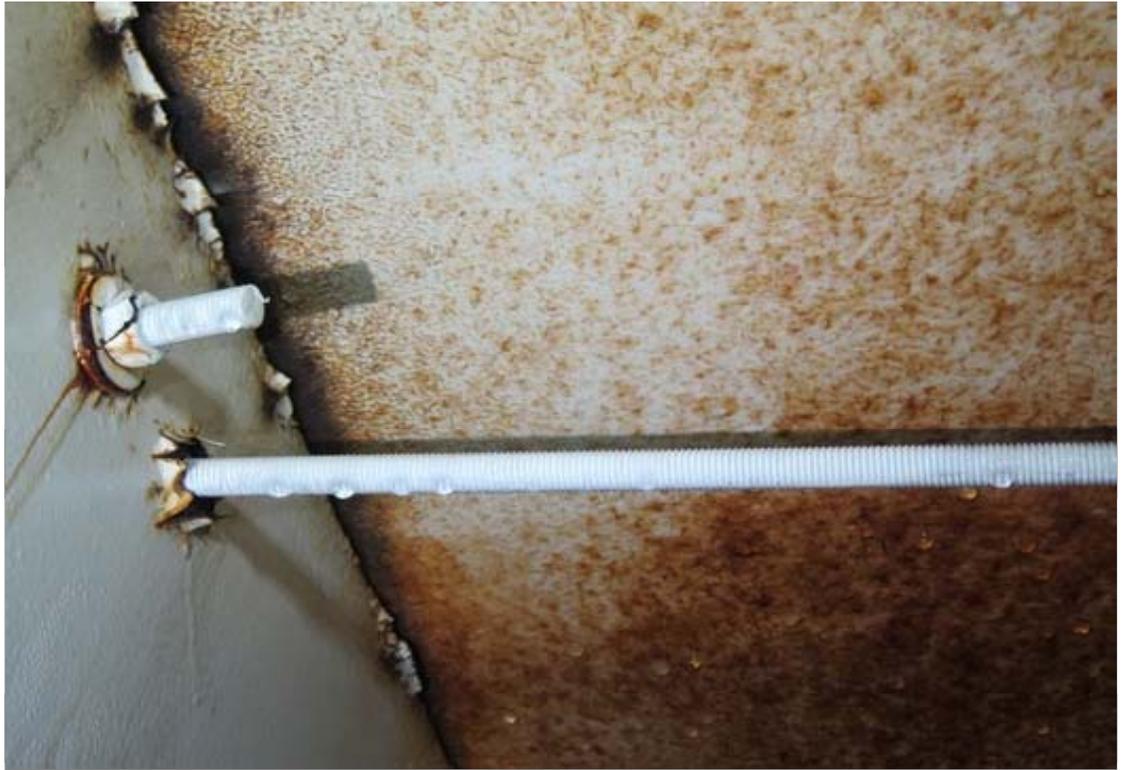
Rafter bracing at the connection to the web of a channel rafter on the interior roof.

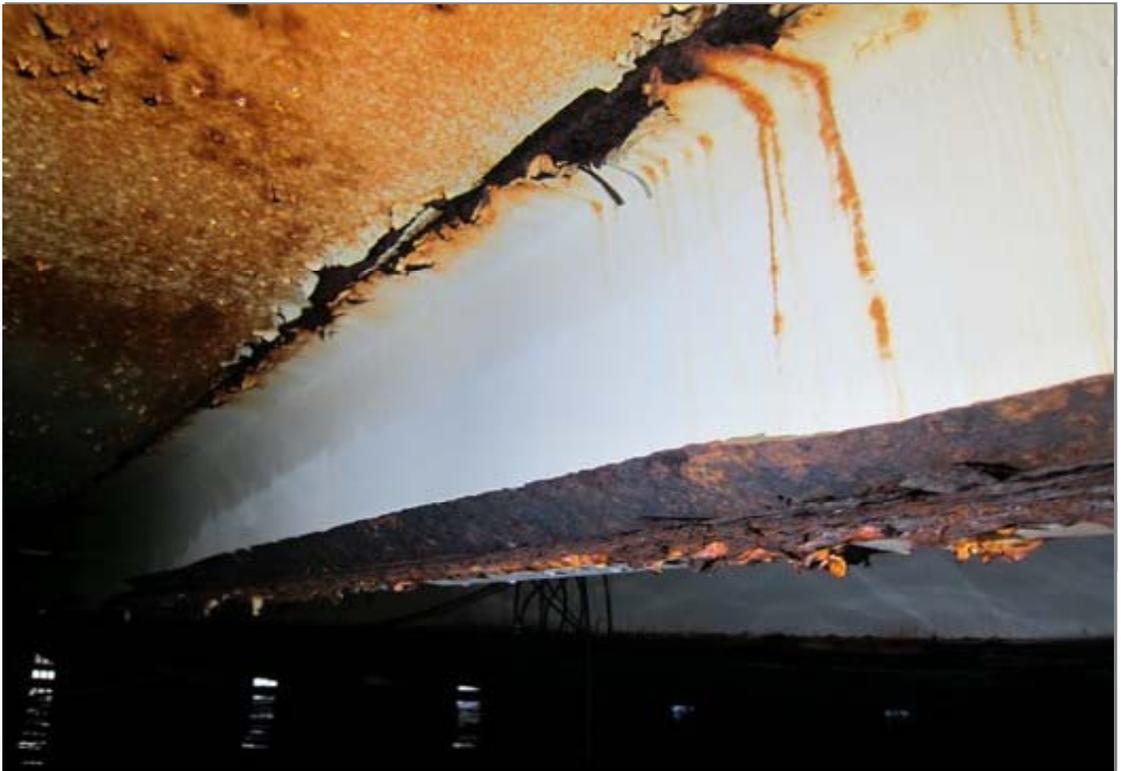
A typical rafter with serious metal loss due to corrosion on the flanges.

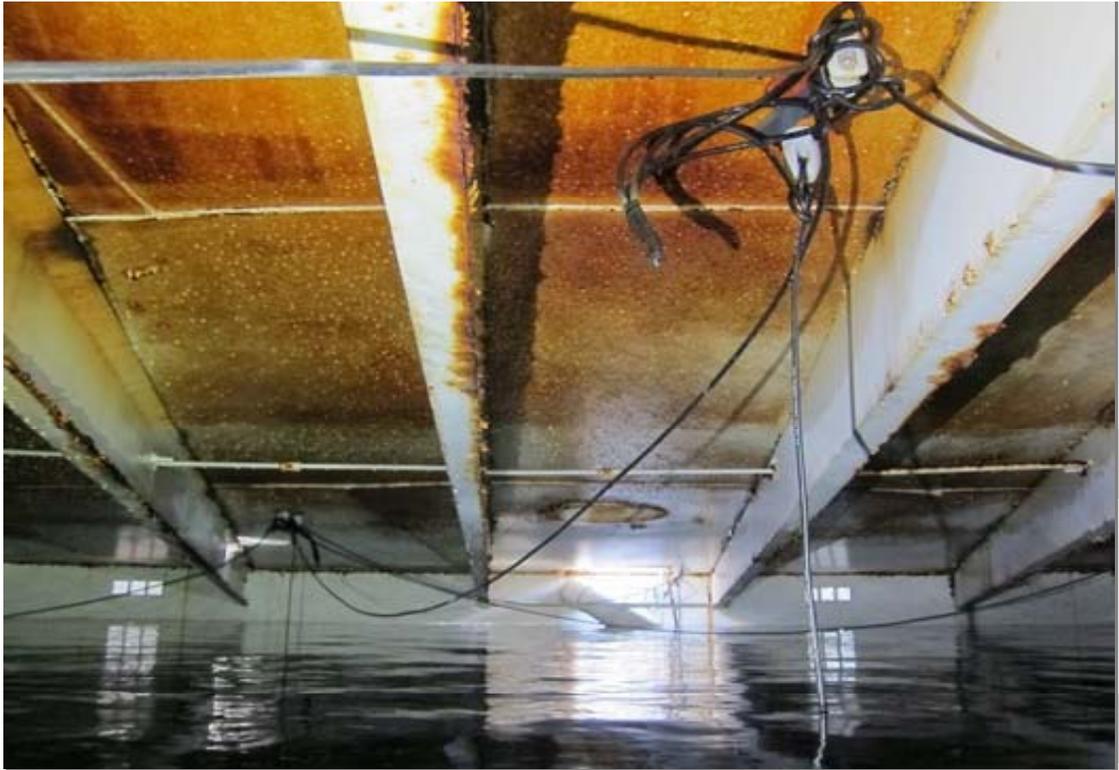
This broad view of the roof is looking toward the roof hatch from near the center.

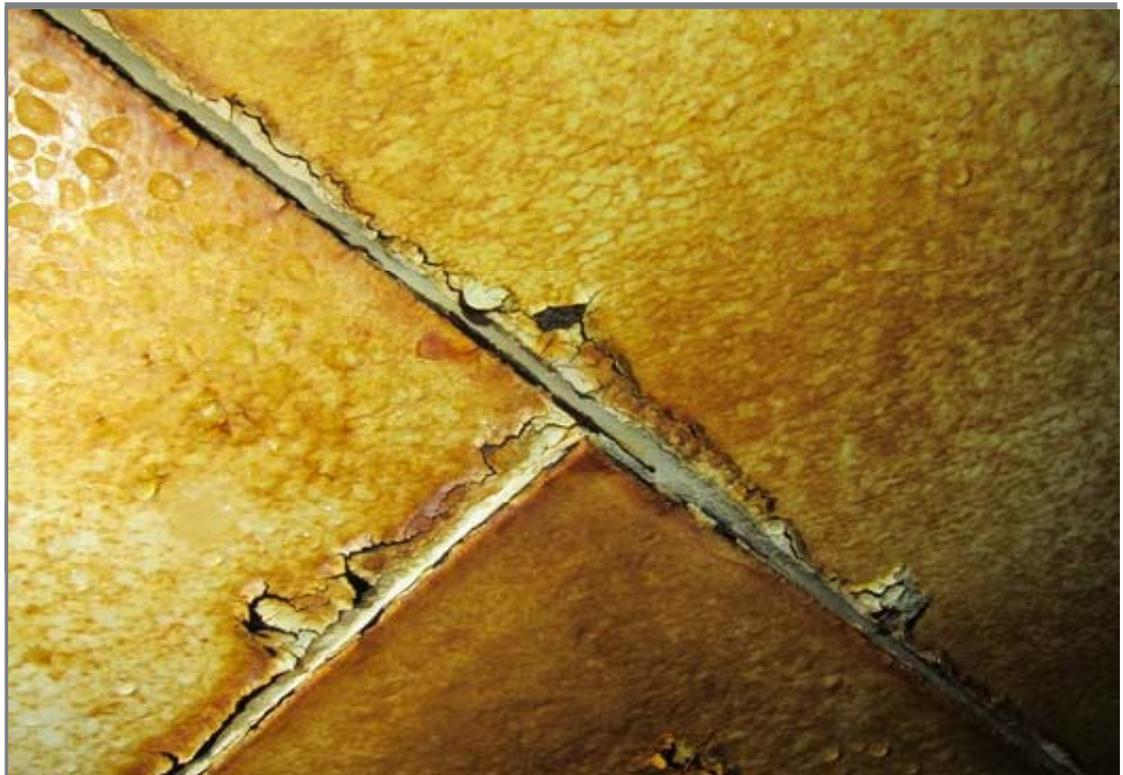
Interior roof plate lap. This view shows the concentrated corrosion that is present at lap joints along with the general corrosion on the plate.

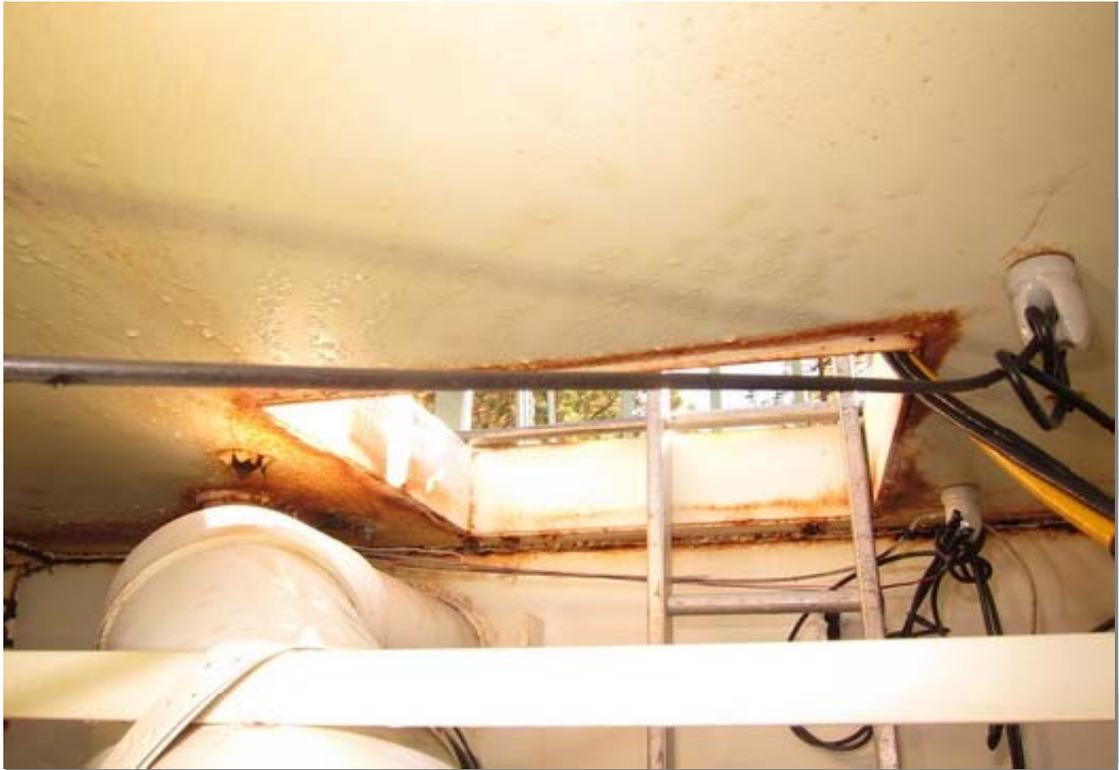
View of the roof hatch from the interior. The diver's entry ladder is visible.

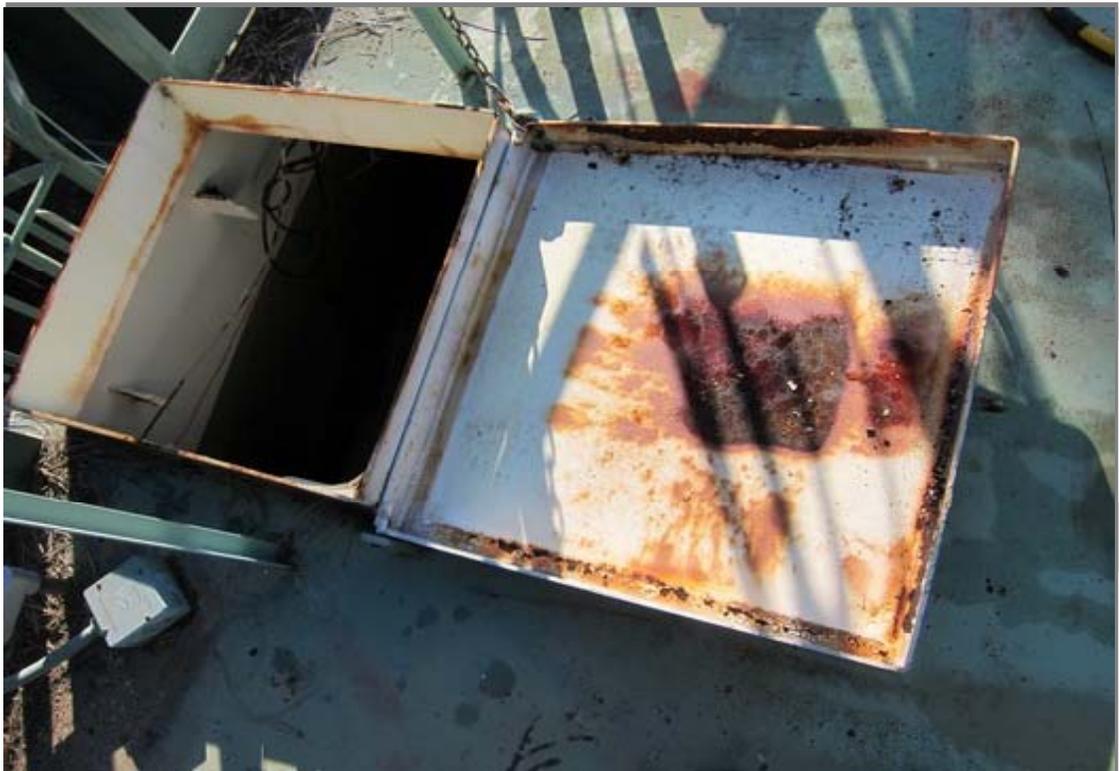
Corrosion on the interior side of the roof hatch.

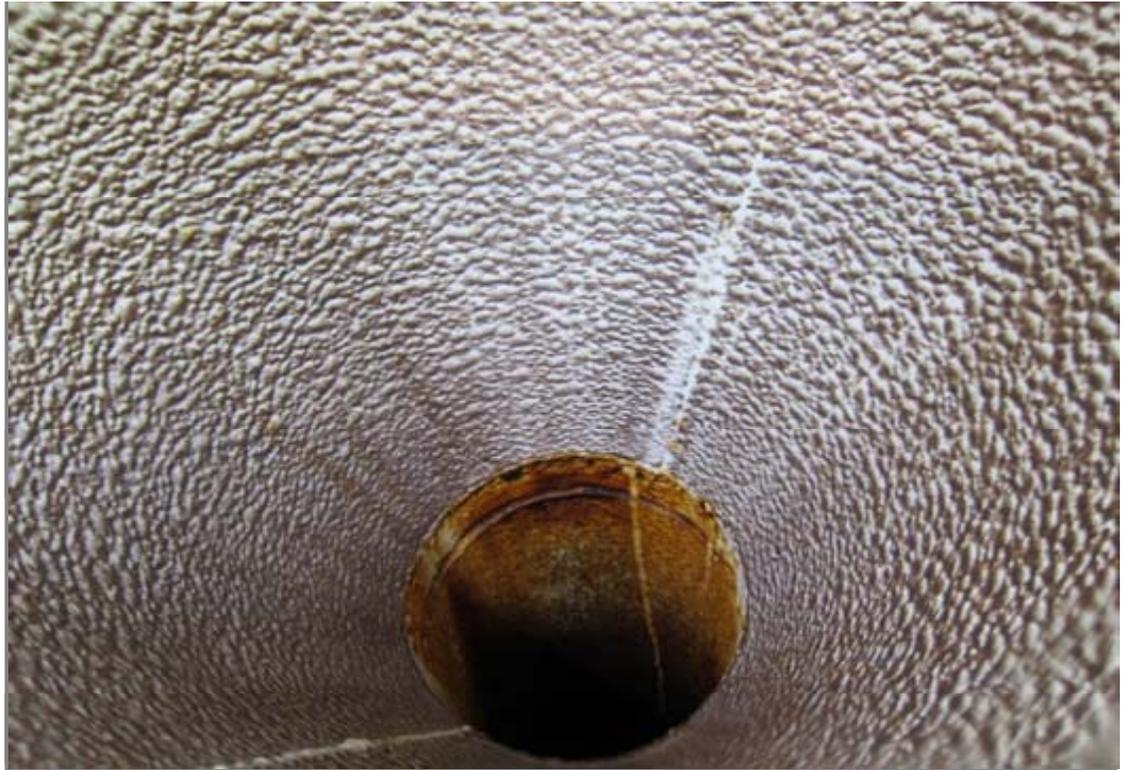
Interior of the overflow weir.

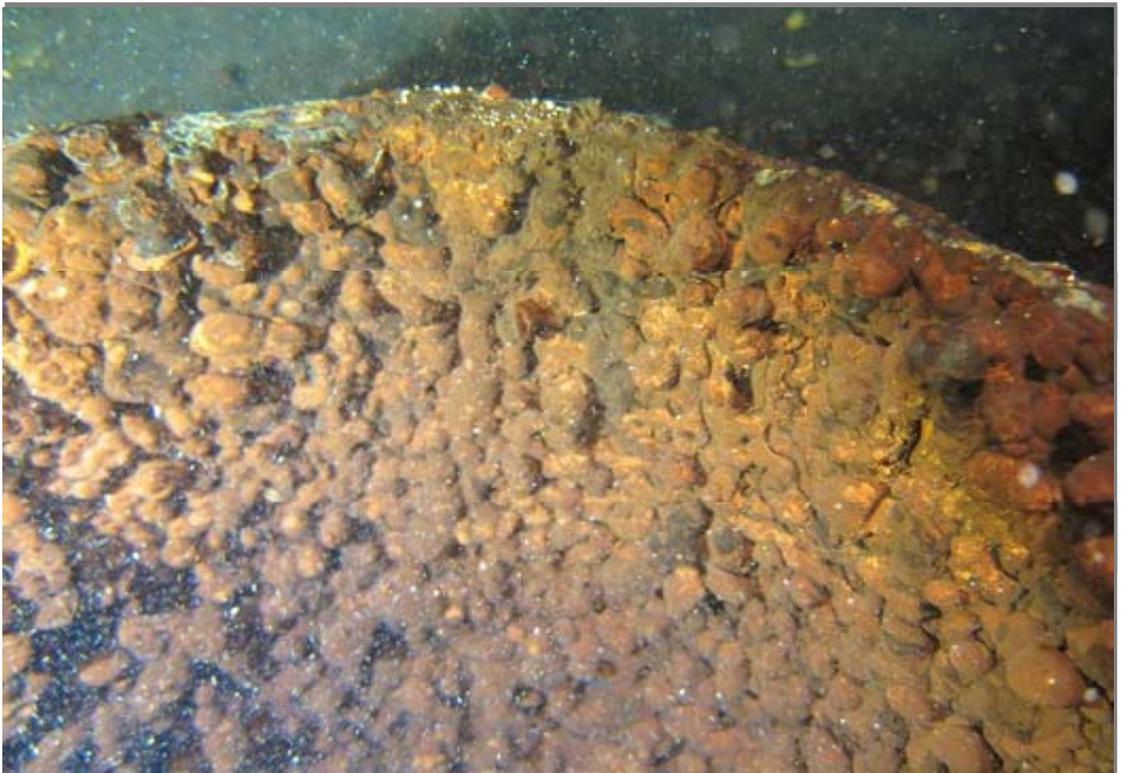
Corrosion nodules on the interior of the outlet pipe.

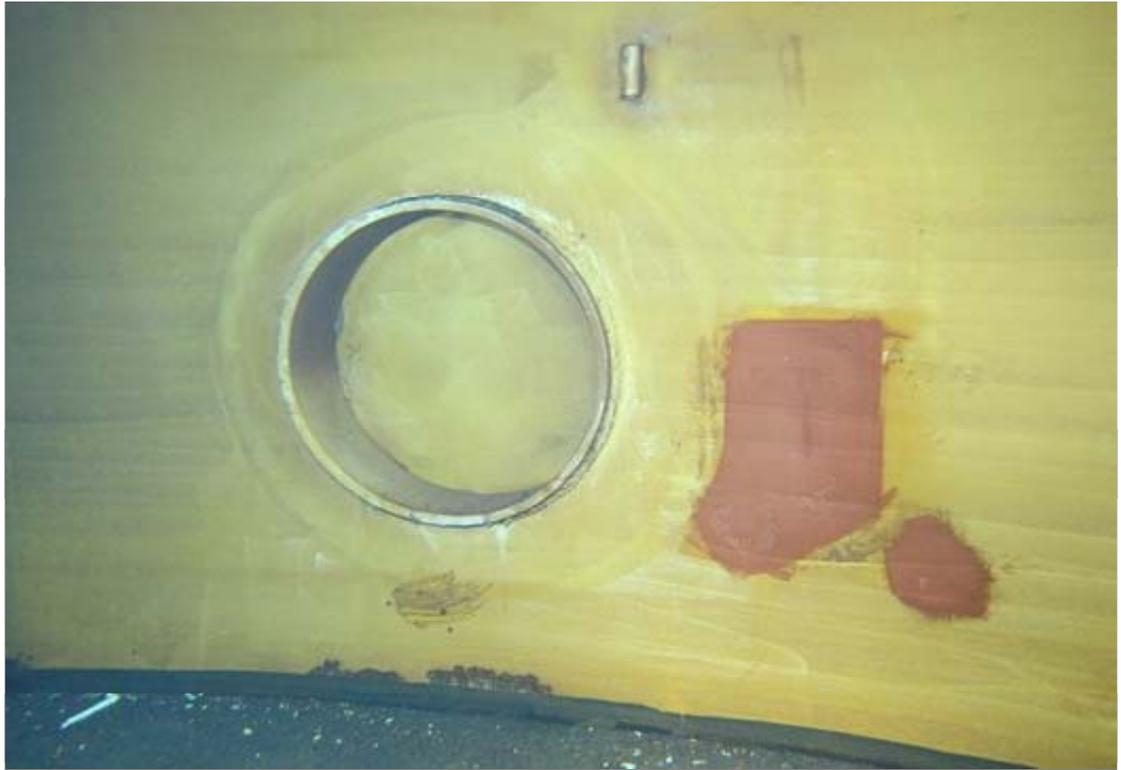
Interior view of the shell manway near quadrant 3. A spot repair is visible to the right and some significant corrosion is present below the manway.

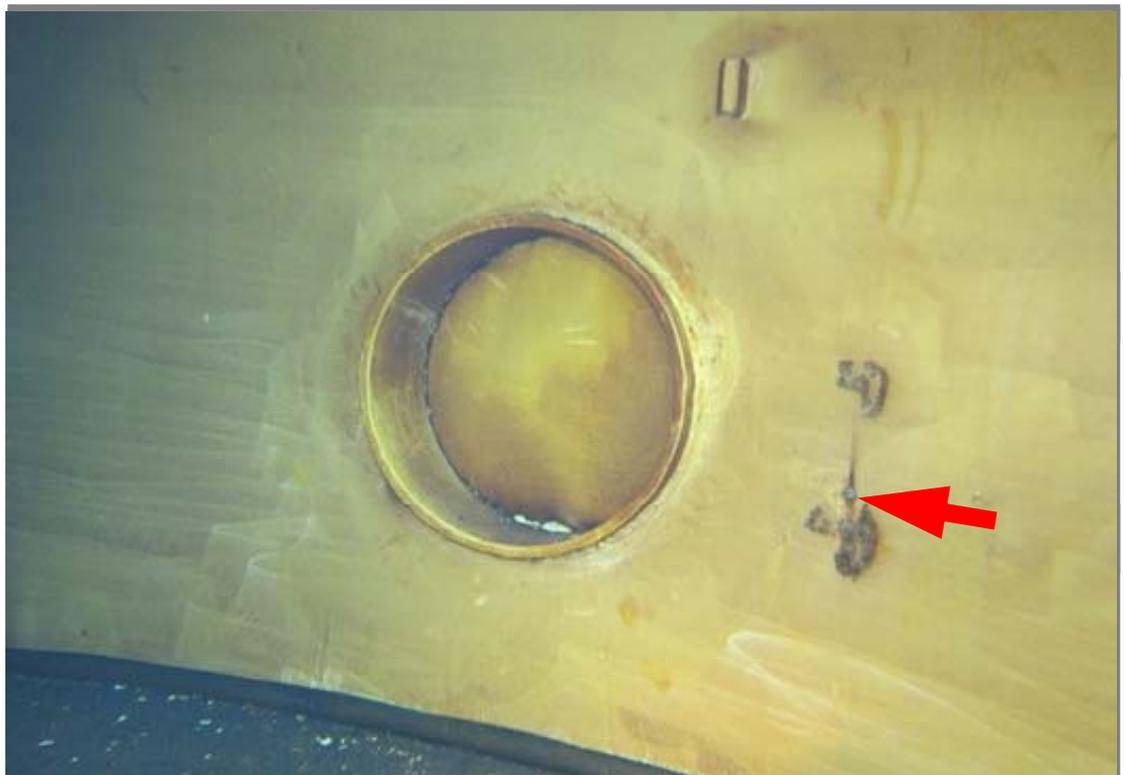
Shell manway in quadrant 1 as viewed from the interior. The spots shown at the right are areas of significant corrosion with a 3/4" diameter nodule at the arrow.

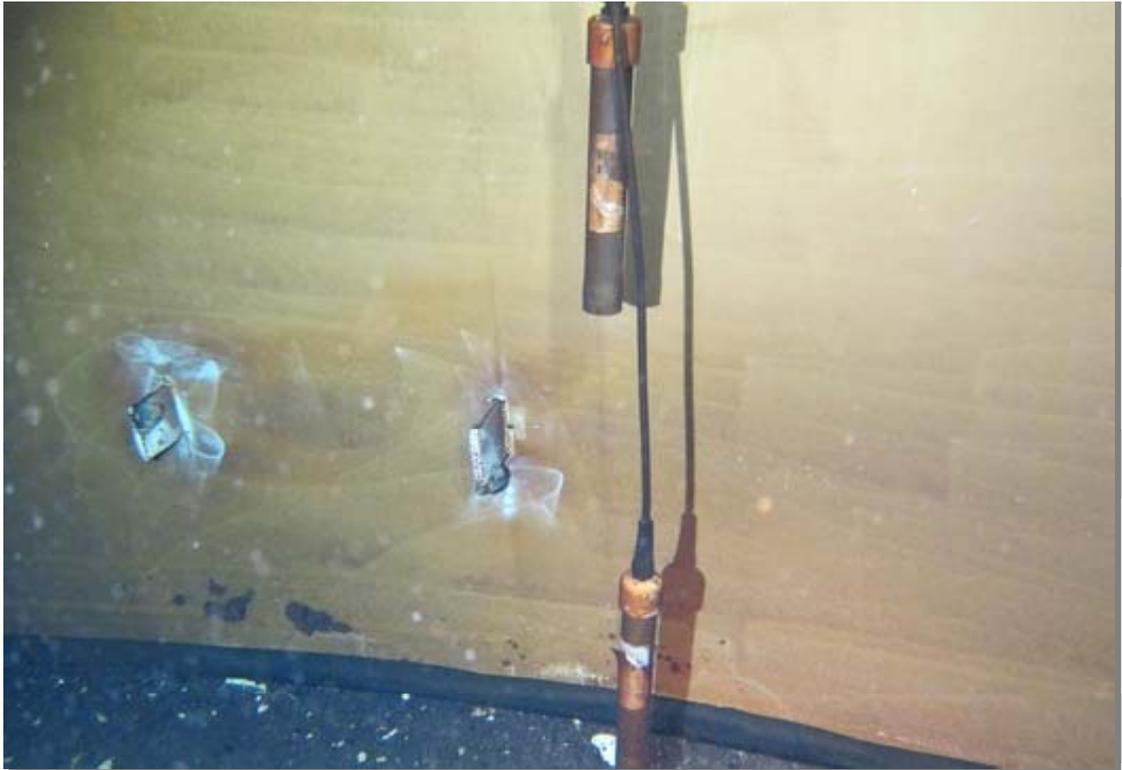
These cathodic protection system reference cells are located below the roof hatch.

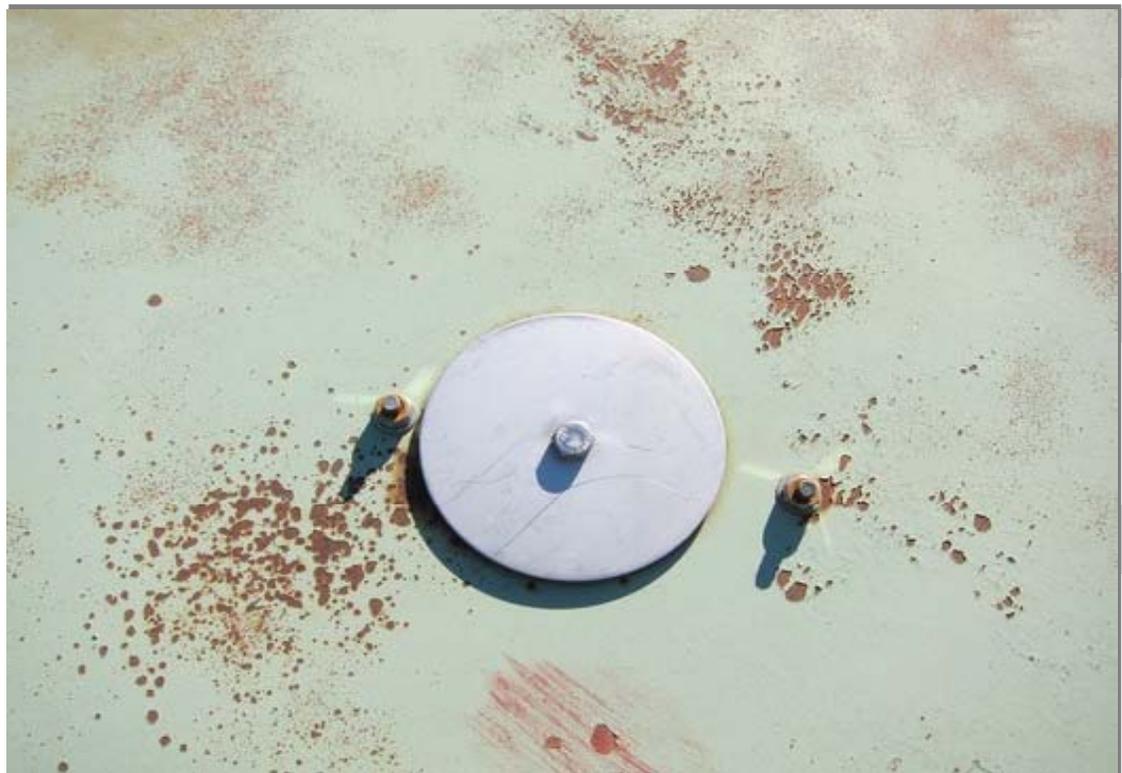
Typical view of a cathodic protection hand hole cover in good condition as viewed from the exterior roof.

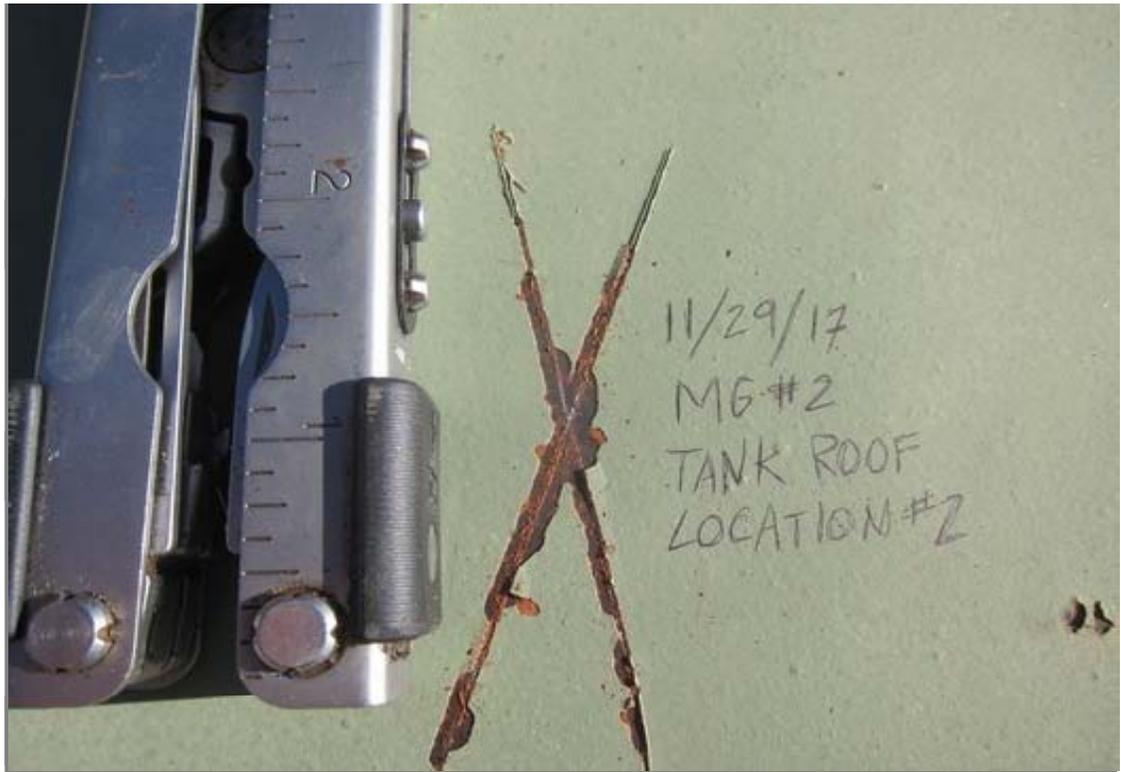
Adhesion was evaluated with a cross cut tape test and found to be 2A-3A.
This location was on the exterior roof.
