APPENDIX C
Dive Inspection Reports – Existing Welded Tanks

**INSPECTION REPORT FOR THE
TWIN HARTE COMMUNITY SERVICE DISTRICT'S
MILLION GALLON TANK #1
DECEMBER 29TH, 2017**

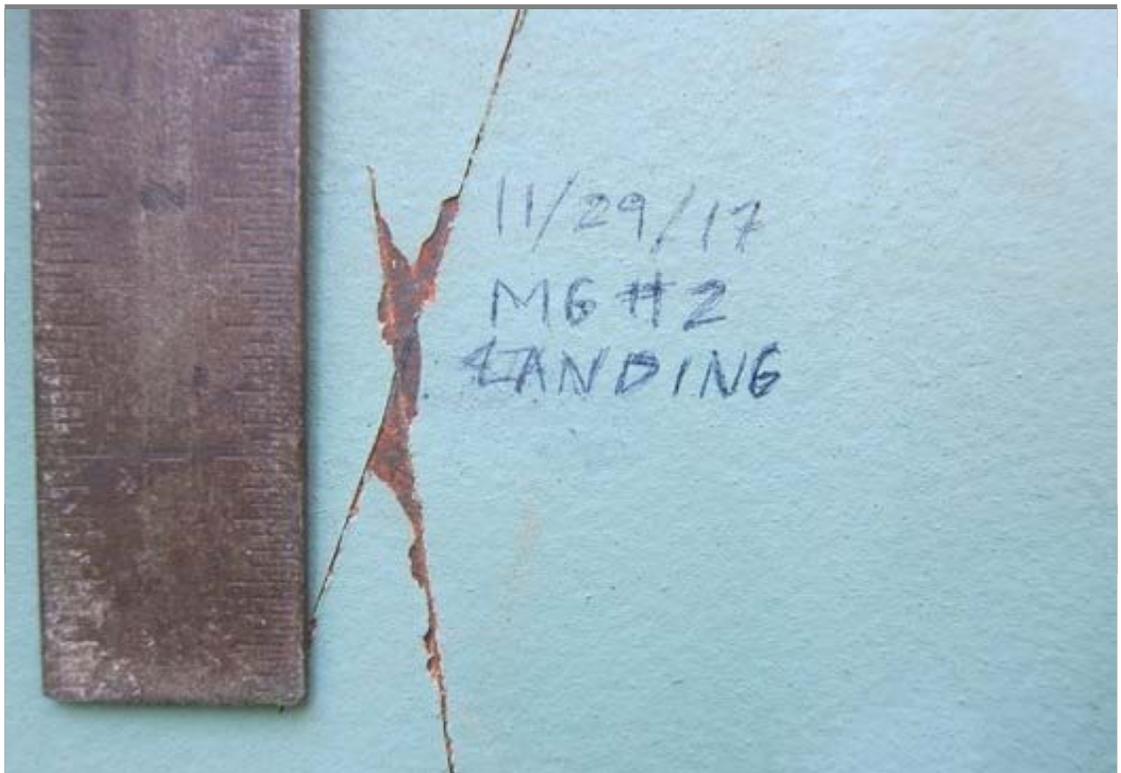
Adhesion was evaluated with a cross cut tape test and found to be 2A-3A.
This location was on the exterior shell at the mid platform.

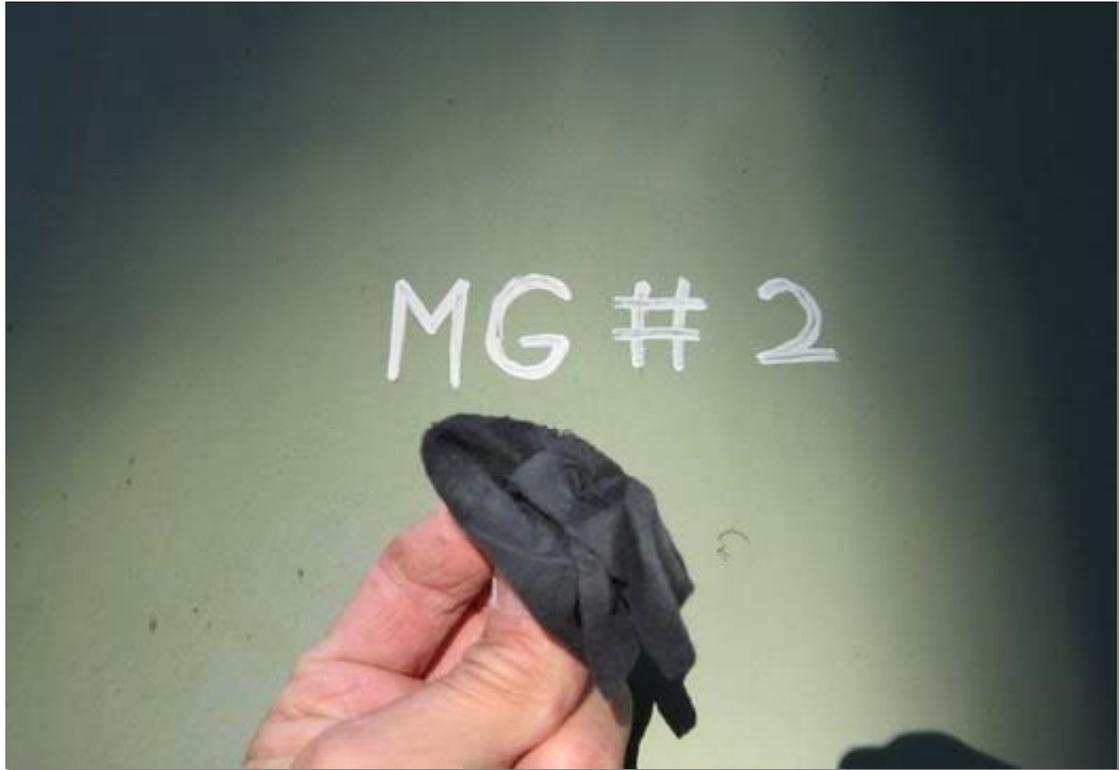
Chalking was evaluated pursuant to ASTM D4214, test method A. Chalking is approximately a No. 7 valuation as compared to photographic reference standard No. 1

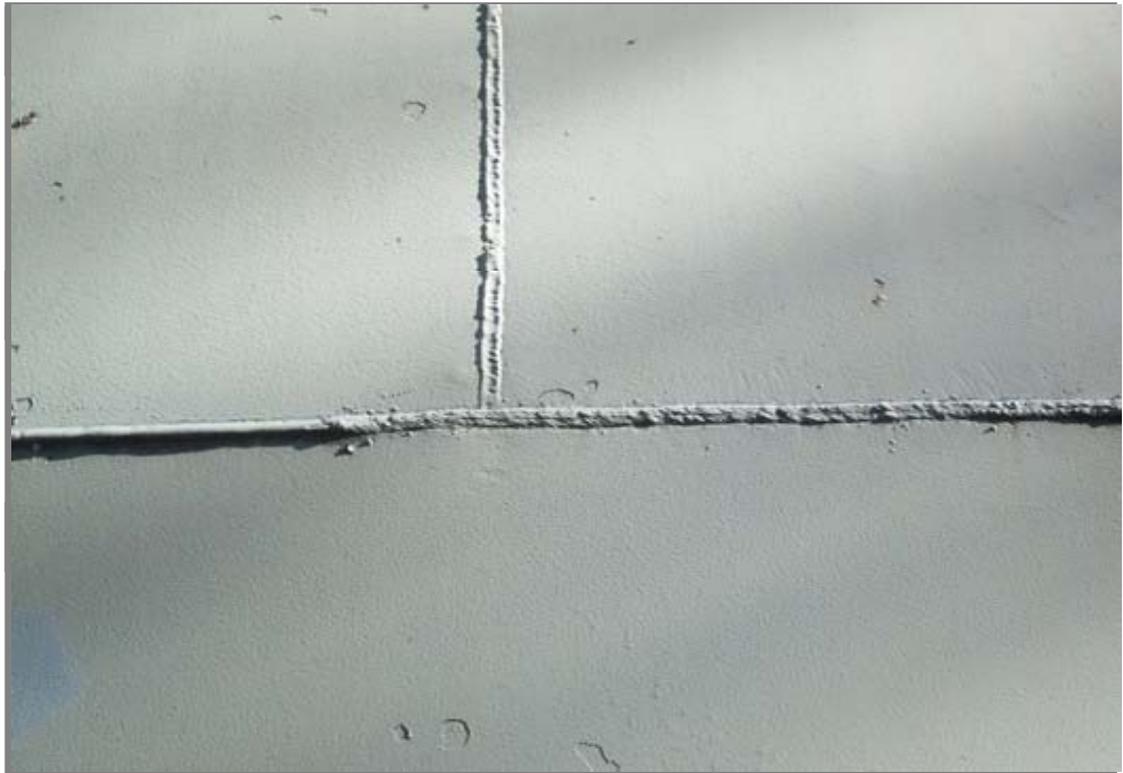
Scattered areas of spatter are present on the shell and roof welds. The area shown above is a repair completed manually. The weld on the left is by a mechanized system.
